Engineering Disasters: Learning from Failure

N. Chawla

School of Materials
Fulton School of Engineering
Arizona State University
Tempe, AZ 85287-8706

TMS Education Resource Awards
November 2007

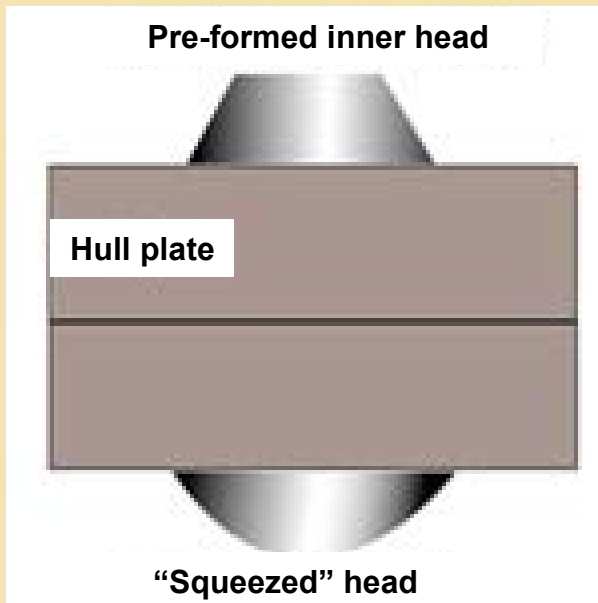
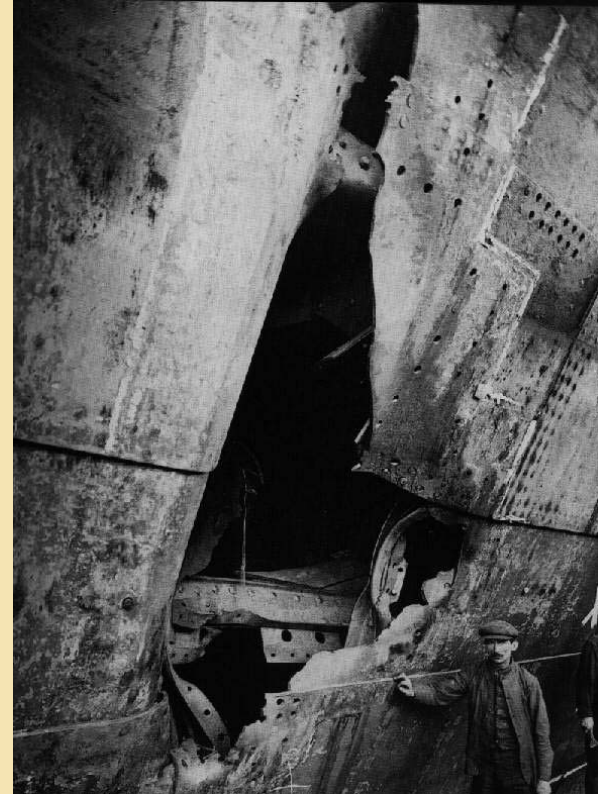
Hull of the *Olympic*, *Titanic's* sister ship after a collision in 1911.

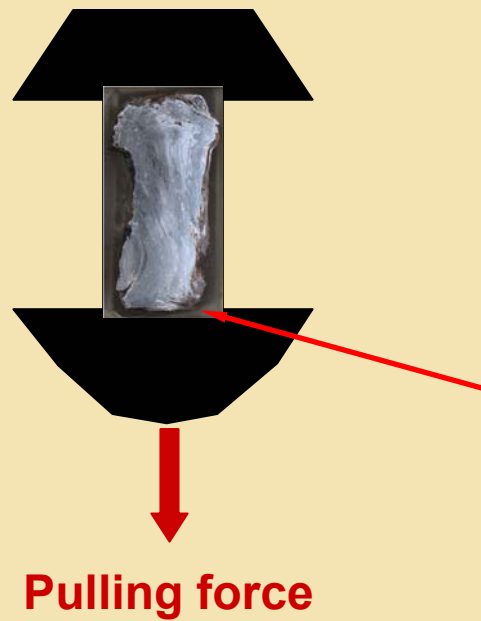
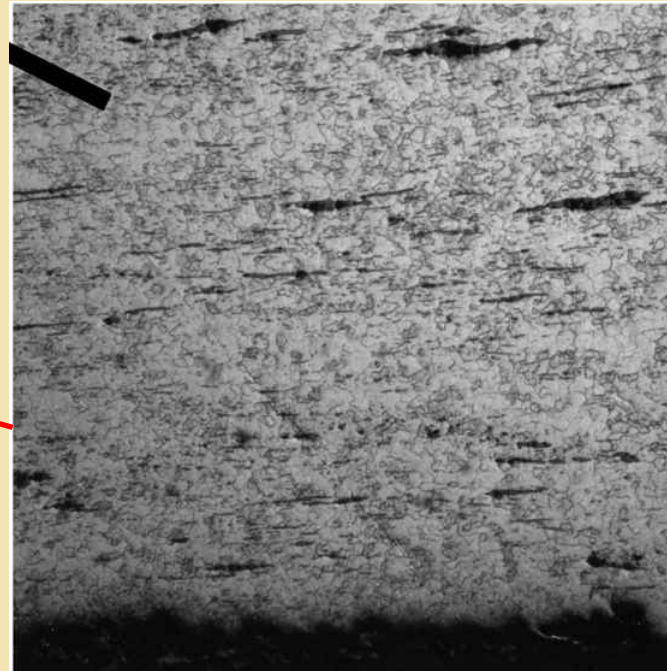
Microstructure of Titanic Rivet

- Orientation of Fe-silicate stringers is perpendicular to loading axis at the end of the rivet
 - Much lower strength and inferior resistance to crack propagation

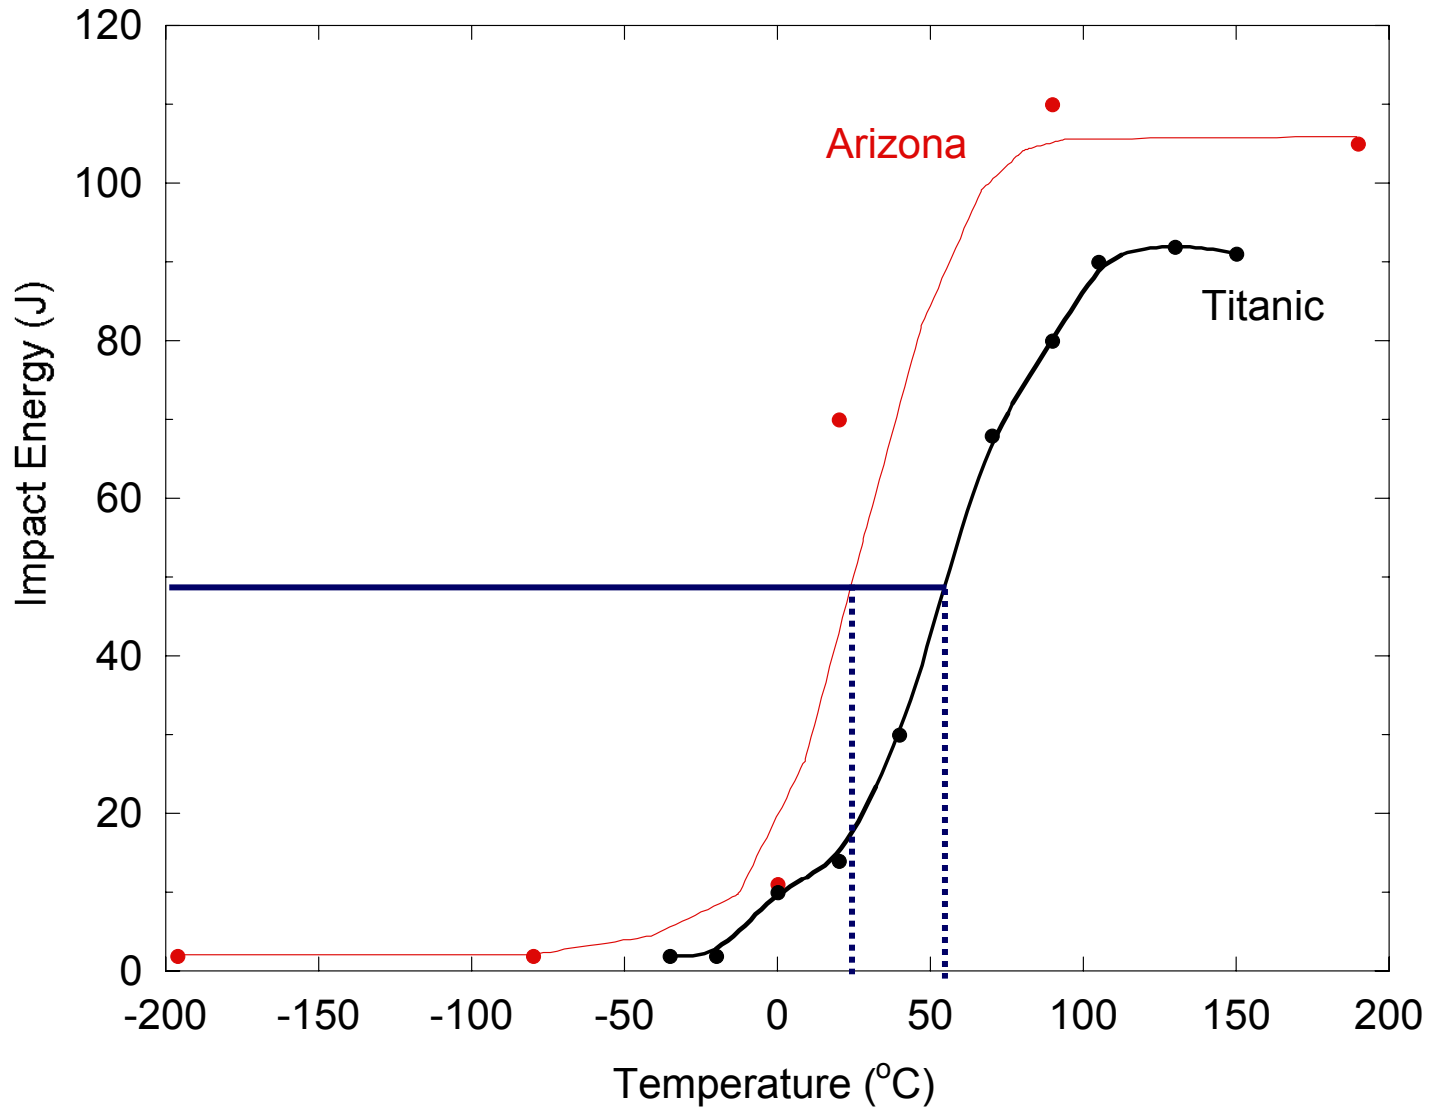
Impact Toughness of Steel in *Titanic* vs. *U.S.S. Arizona*

Steel of U.S.S. Arizona had lower DBTT!

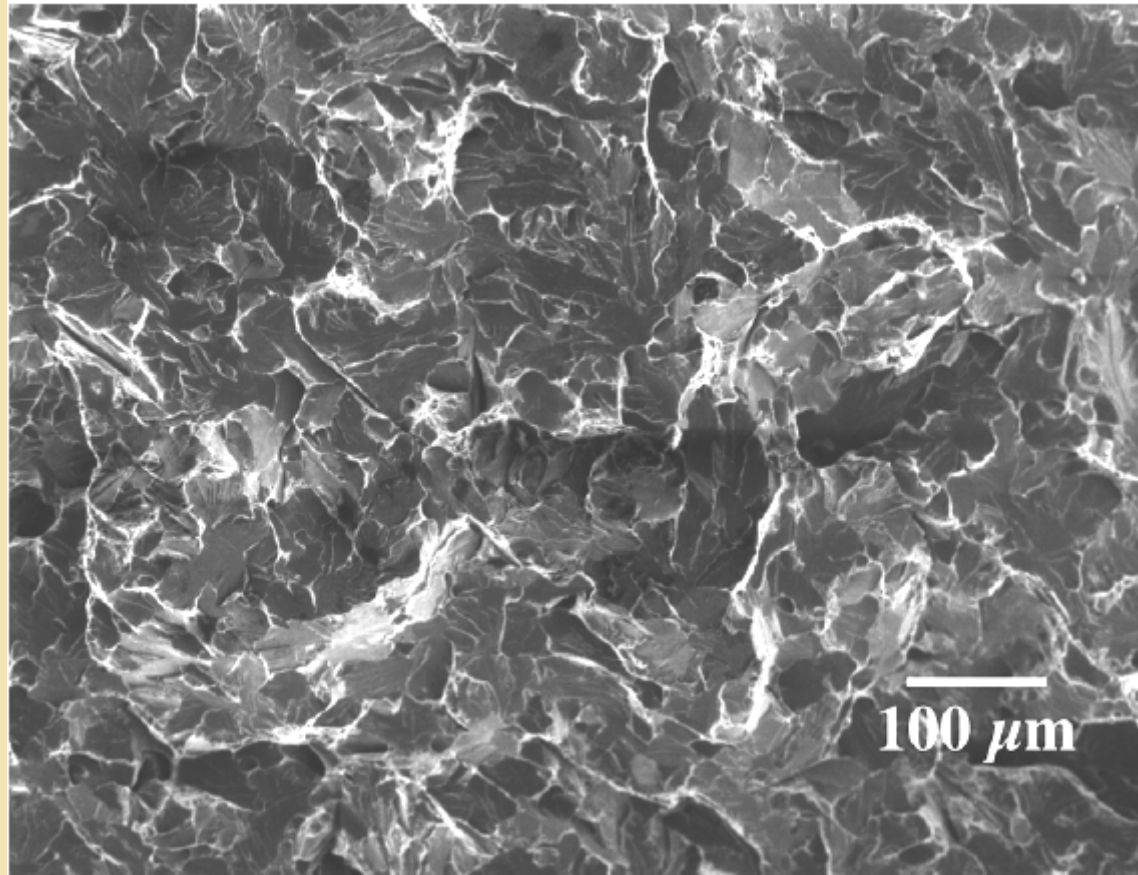
Fracture Surface of Titanic Steel (Longitudinal) Impacted at 0°C

Characteristic brittle fracture is observed

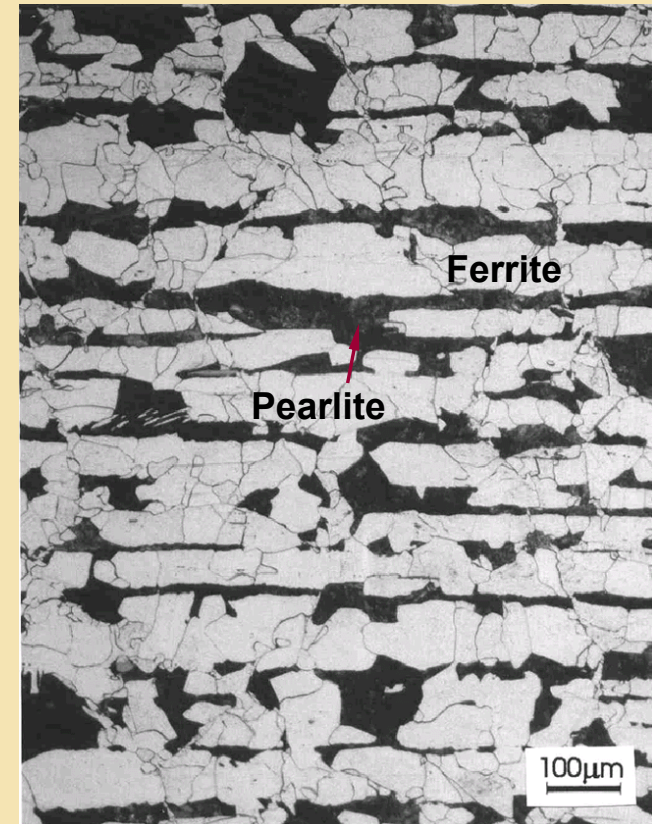
Microstructure of Unaffected A36 Steel

Banding of ferrite and pearlite are observed due to hot working of plate

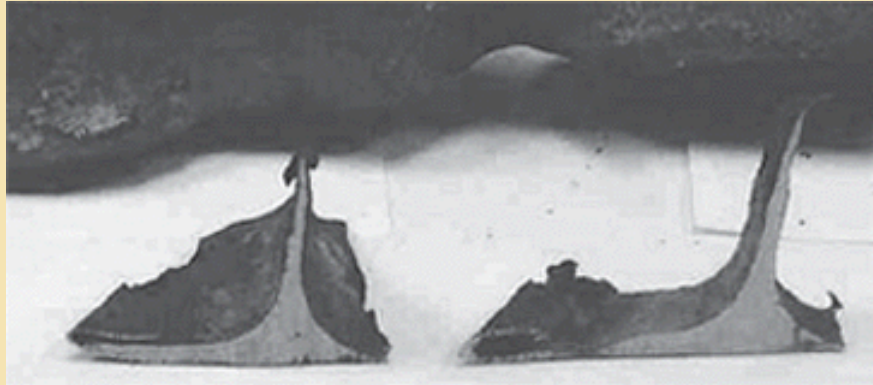
I-Beam Cross-Sections of A36 Steel from WTC 7

The beams appear severely eroded.

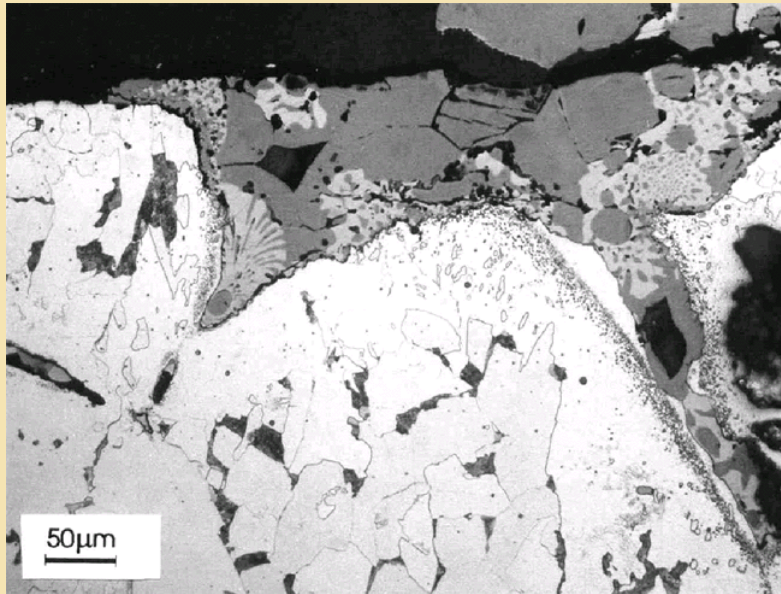
Surface microstructure appears to be eutectic mixture of FeS and Fe₂O₃

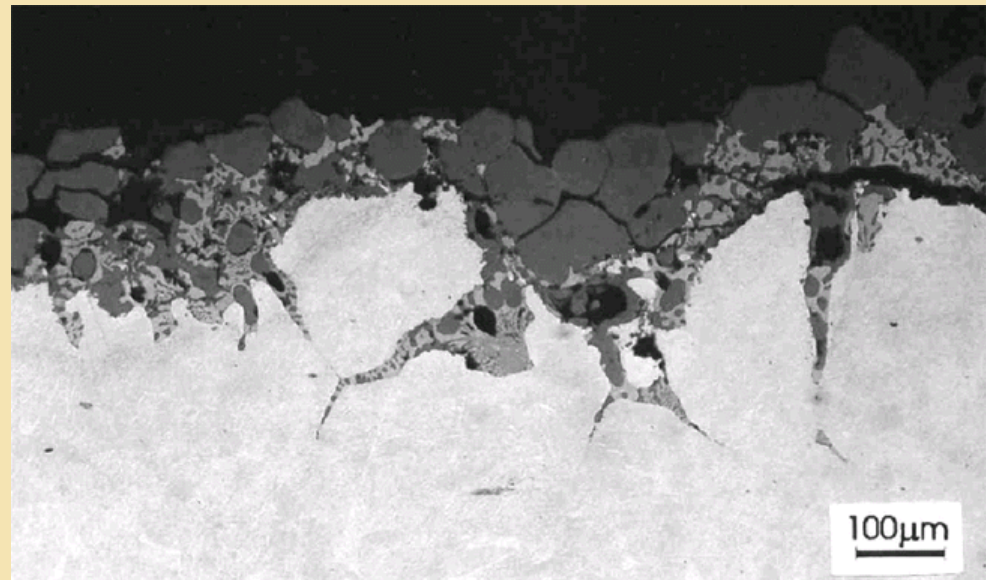
Severe oxidation and intergranular melting is observed

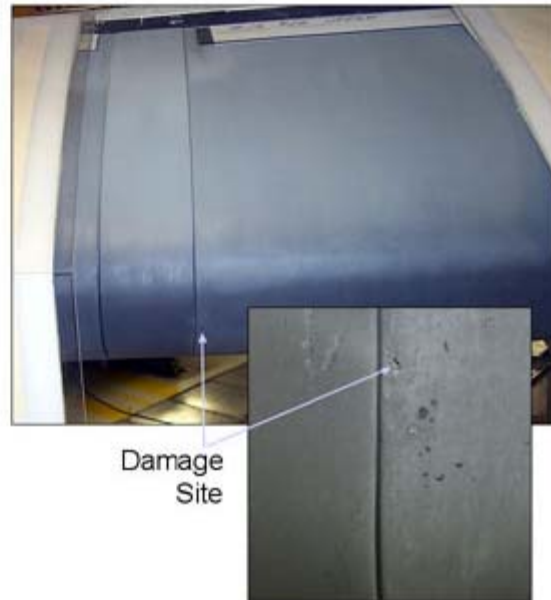
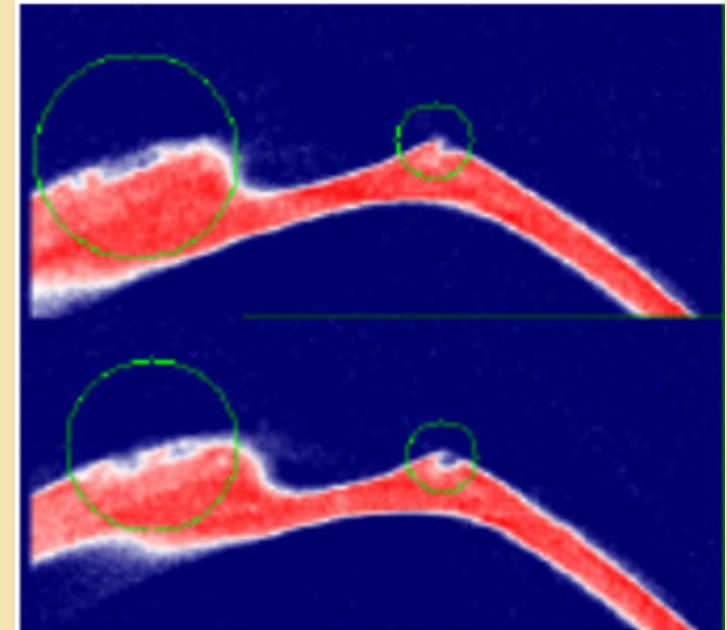
Foreign Object Damage in Previous Shuttle Mission

- Damage was on the upper edge measuring 0.10"L x 0.15"W
- Defect had large cavity with carbon substrate oxidation

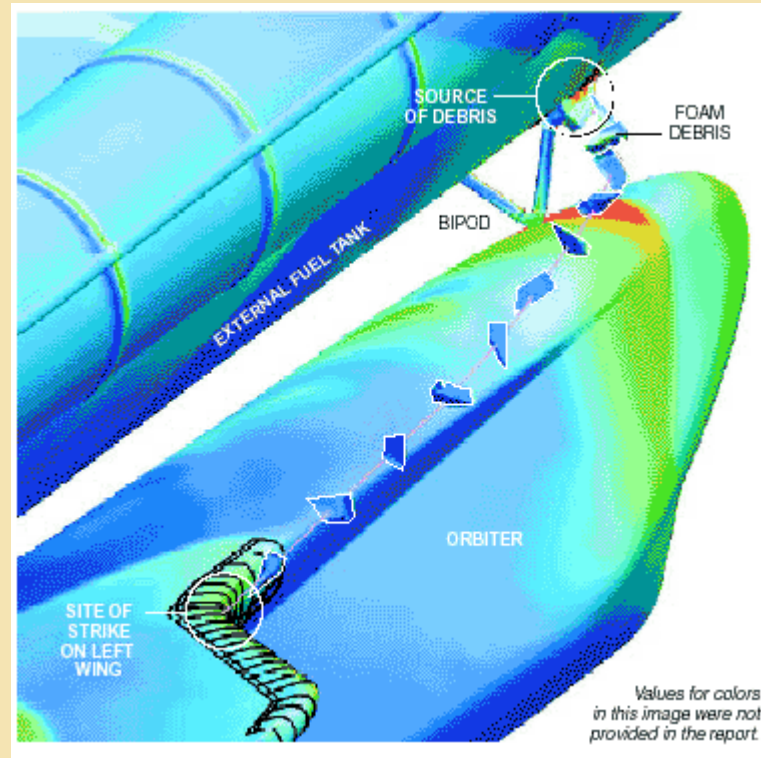
Summary of Damage Sequence

81.9 seconds after liftoff, debris hits wing

Computer models predicted velocity of foam (~1.7 lbs.) to be ~ 500 miles per hour.

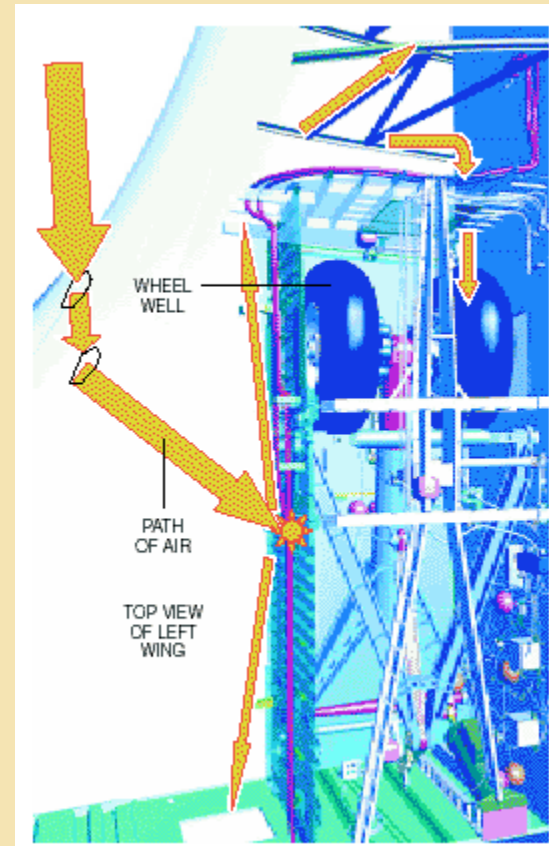
**Superheated air flowed through wheel well
- Al trusses melted, weakening shuttle structure**
