FAILURE ANALYSIS OF WELD-REPAIRED B-1900 TURBINE BLADE SHROUDS

Erik M. Mueller¹, Luis Carney¹, Sun Tai Ngin¹, John L. Yadon¹
¹NAVAIR, ISSC Code 4341, Building 793, NAS JAX, Jacksonville, FL 32212-0016

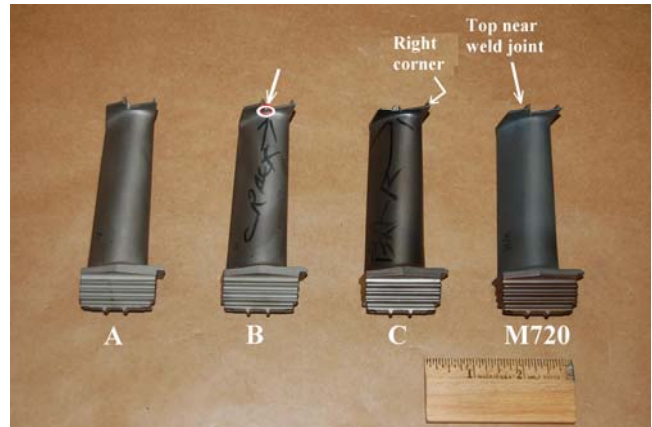
- Blade A: Underneath shroud at concave side
- Blade B: At center of Z-notch on both the convex and concave sides
- Blade C: Above the far right corner on the convex side
- Blade M720: On top of the shroud at weld joint near the fractured Z-notch (see Figure 3)

Figure 1. Image of the convex side of the turbine blades with showing the cracks observed through FPI.

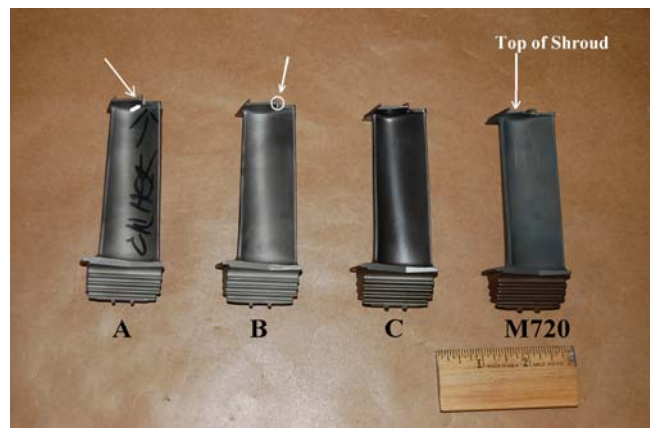
Figure 2. Image of the concave side of the turbine blades with showing the cracks observed through FPI.

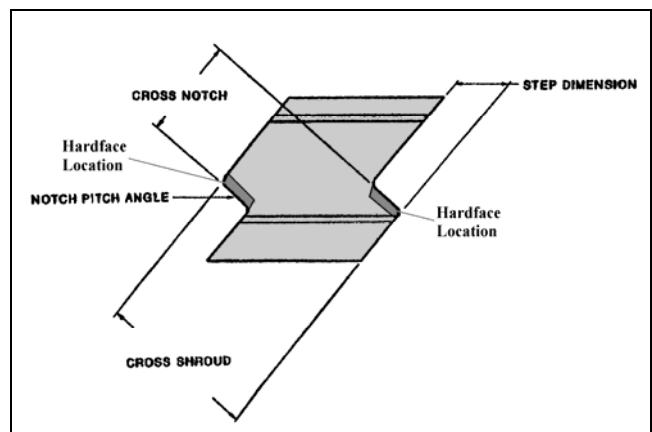
Figure 3. Illustration of the hardface locations of the turbine blade shrouds (dark grey). Other dimensional definitions are also identified for checking compliance with geometrical specifications.

The dimensions of the shroud were compared against the drawing design specifications. The results are listed in Table I and refer to the dimensions shown in Figure 3. While generally conforming to specification, the cross notch is larger than called for, while the step dimension is less. The M720 blade appeared to deviate furthest from specification.

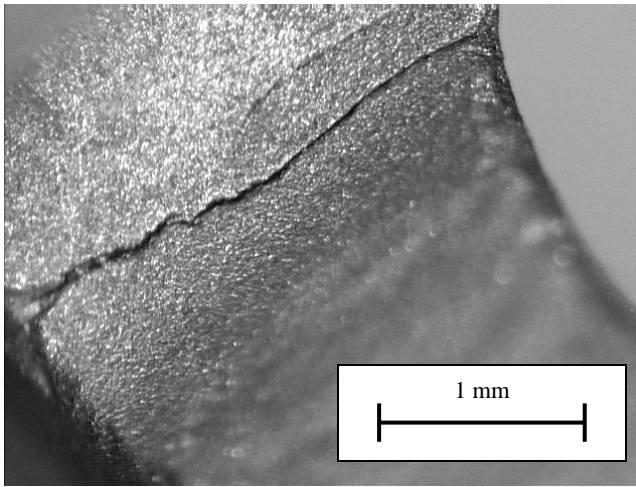
Figure 4. Photograph of the Z-Notch cracks on Blade B on the convex side. The crack was later found to have penetrated into the weld material.

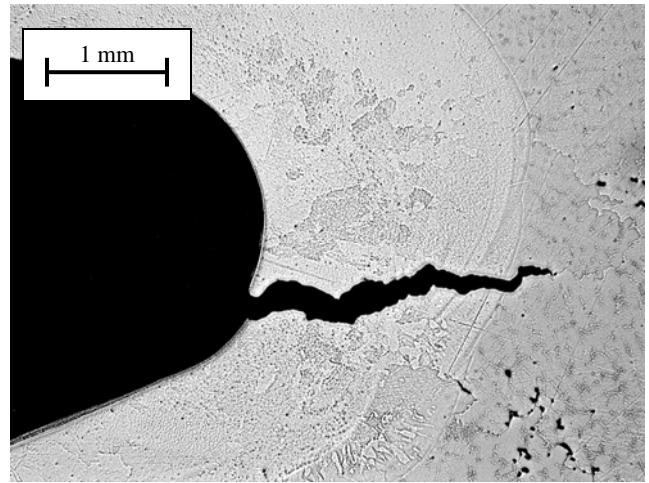
Figure 6. Image of Z-notch surface crack in Blade B (25X).

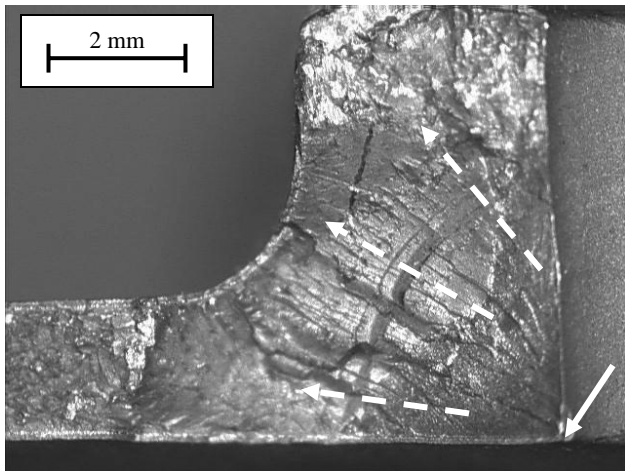
Figure 5. Photograph of the Z-notch fracture surface of the M720 blade. The origin is shown on the lower right corner (solid arrow), and propagates radially (dashed arrows).

Figure 5 illustrates the fracture surface of blade M720 that had failed near the Z-notch. This surface, and the one from blade C (not pictured), ran parallel to the Z-notch tip tangent. The M720 fracture surface exhibited beach marks and fracture lines that ran back to the lower right corner of Figure 5. The fracture surface of the C blade was too damaged to make any conclusive observations at this level.

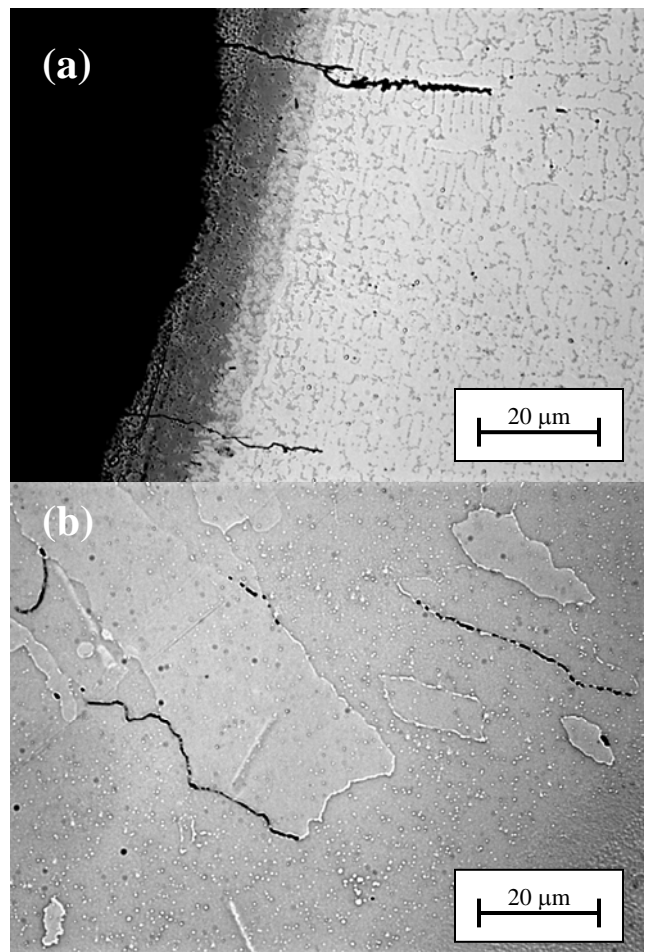
Figure 7. Images of cracks in blade B (a) along the interdendritic regions of the hardface and (b) along the grain boundaries in the filler material (1000X).

cracks were found to penetrate through the filler material as well as into the casting substrate. The cracks appeared to preferentially propagate along the grain boundaries in the base alloy, and along the interdendritic regions in the hardface welds (see Figure 7).

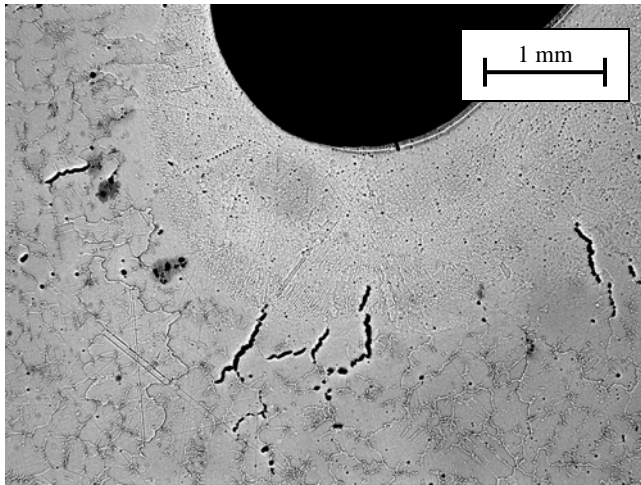
Figure 8. Optical image of hot cracks at the weld-alloy interface in the Z-notch of blade A (25X).

At the weld-alloy interface, hot cracks were observed (see Figure 8). These cracks were always along the alloy grain boundaries (see Figure 9) or interdendritic regions of the hardface, which were generally normal to the surface direction. At the interdiffusion zone between the coatings and the weldments, small microcracks were observed (see Figure 10).

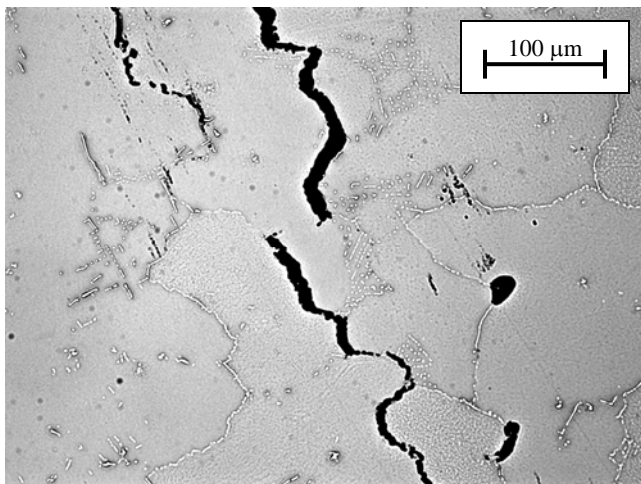
Figure 9. Image of hot cracks along grain boundaries in the heat-affected zone. Carbides are present at the grain boundary (200X).

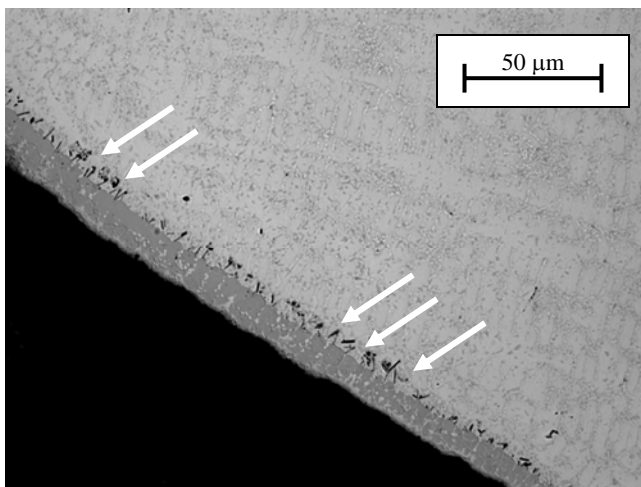
Figure 10. Image of the microcracks in the interdiffusion zone between the coating and the hardface in Blade B (500X). The microcracks are labeled (arrows).

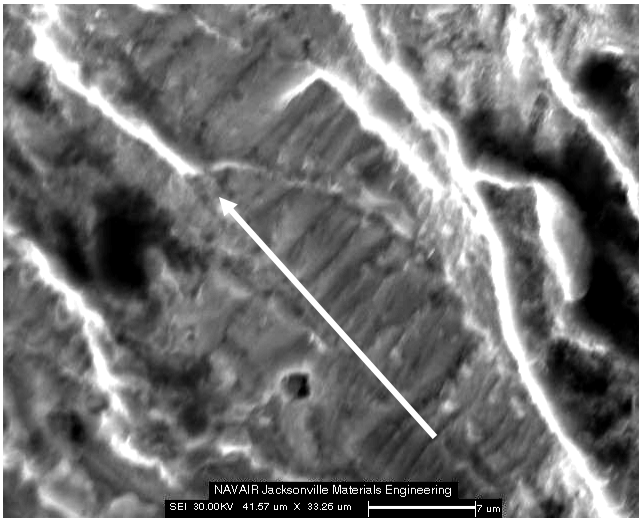
Analysis of the fracture surface of blade M720 suggested failure from fatigue. Figure 11 shows fatigue striations identified on the fracture surface. The initiation site appears to be located, as shown in Figure 6, in the lower inner corner of the fracture surface (see Figure 12). No oxide inclusions or signs of corrosion pitting were found. At the ends of the fracture surface, away from the coating, dimple rupture was observed where the material overloaded. Near the surface, at the interdiffusion zone between the diffusion coating and weld material, signs of intergranular cracking and cleavage were observed (see Figure 13).

Figure 11. Secondary electron (SE) micrograph of the fracture surface of blade M720. The surface shows fatigue striations that propagate from lower right to upper left (arrow).

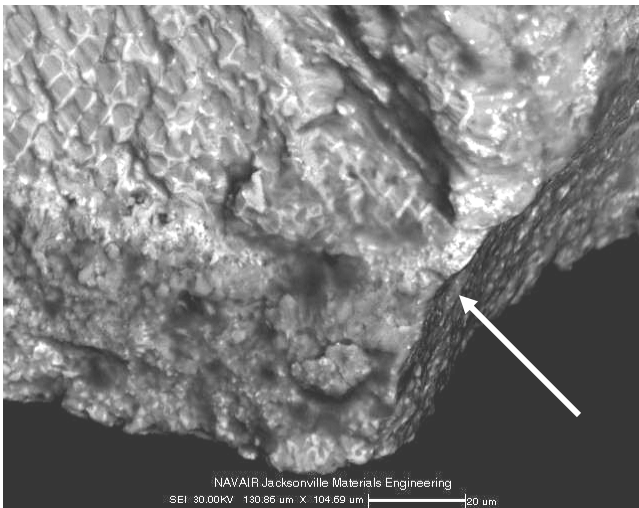
Figure 12. Backscattered electron (BE) micrograph of the fatigue crack initiation site on blade M720 (see arrow).

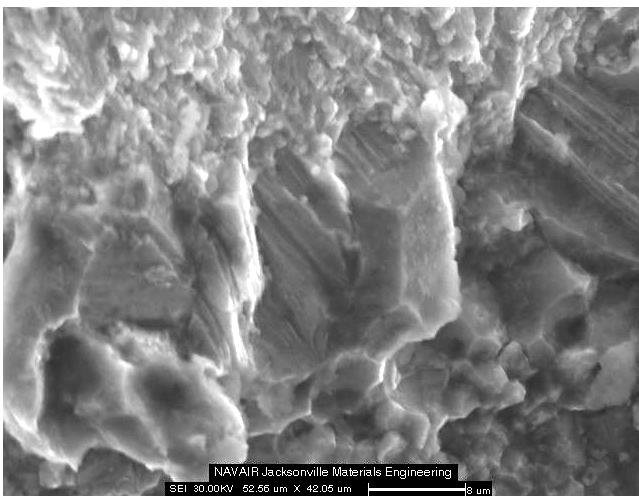
Figure 13. SE micrograph of the fracture surface of blade M720 at the interdiffusion zone between the weldment and coating.

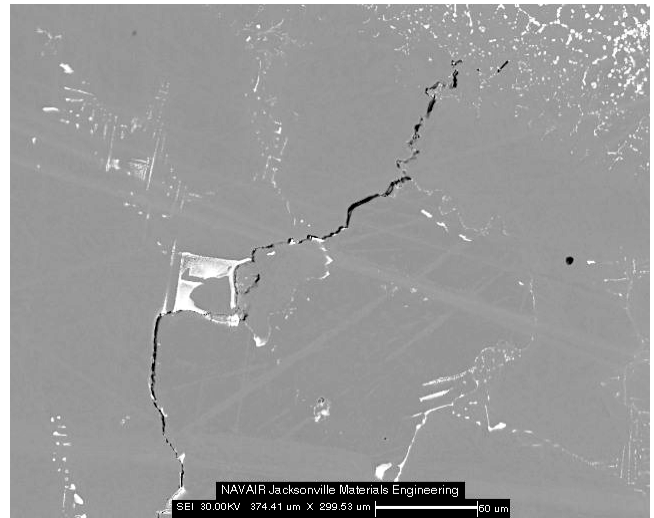
Figure 14. BE micrograph of a blade A hot crack in the HAZ below the weld-alloy interface (upper right). The hot crack proceeds along a grain boundary containing a blocky MC carbide (light phase) and other carbides.

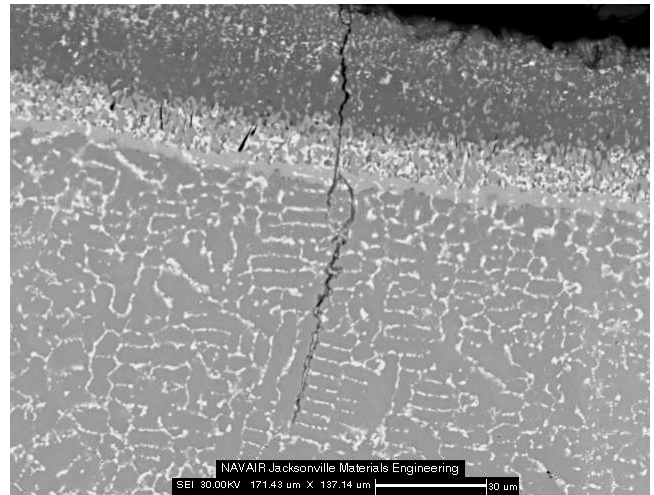
The hot cracks, surface cracks, and porosity discovered through metallographic examination were analyzed using the SEM and EDS. The microstructure of the base metal, as well as the filler, showed blocky TaC and TiC carbides present at the grain boundaries and interdendritic regions. In addition, carbides made from Cr, Mo, and W (either MC, $M_{23}C_6$ or M_6C) were present as well (see Figure 14). Hot cracks propagated along these carbide-rich boundaries in the substrate HAZ, and along the carbide-rich interdendritic regions in the hardface (see Figure 15).

Figure 15. BE micrograph of a blade B surface crack that propagated into the hardface along the carbide-rich boundaries.

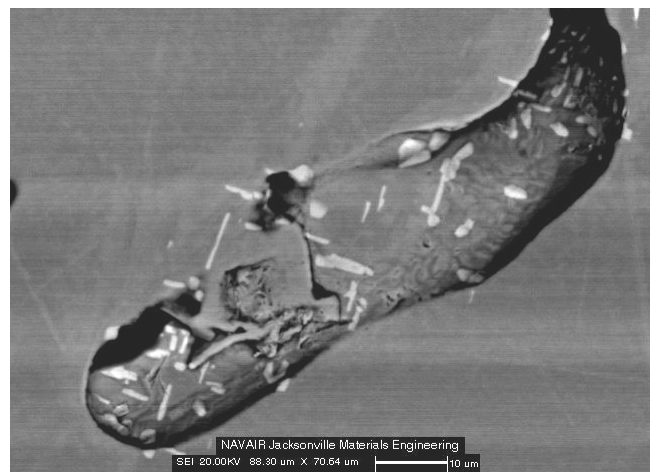
Further inspection of the pores observed previously showed that they had a ruffled internal roughness and multiple blocky carbides on the surface (see Figure 16). EDS confirmed these to be MC (M being Ta or Ti) carbides. Since MC carbides solidify from the melt, these pores were likely present in the original casting before welding.

Figure 16. BE micrograph of a pore in blade A. Light phases are carbides present inside the pore.

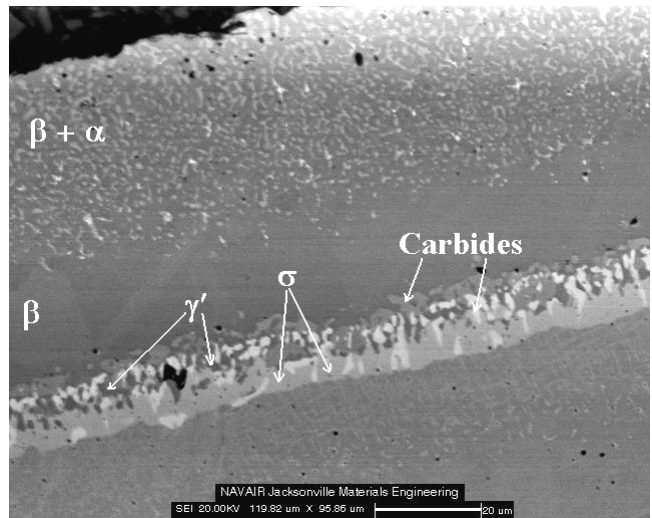
Analysis of the surface at the diffusion coating revealed a multi-layered structure as expected from two diffusion coatings. Figure 17 illustrates this microstructure. The phases were identified using a combination of EDS and WDS. The outermost layer is a β -NiAl layer with some excess α -Cr throughout. The amount of

Figure 17. BE micrograph of the interdiffusion zone layers between the diffusion coatings and the hardface in blade A.

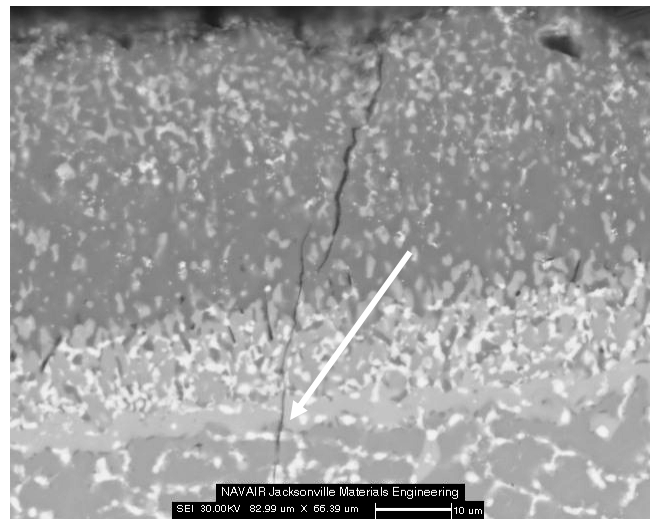
Additionally, a topologically-close packed (TCP) σ phase, with an (Ni,Mo),Cr composition, was detected. No carbon or aluminum was detected in this phase. Multiple pores and cracks were found in this middle layer as well (Figure 18). The innermost layer is a Cr-rich area of the γ -Ni matrix. The Cr content decreases away from the interdiffusion zone until it is the same as the base alloy.

Figure 18. BE micrograph one of the interdiffusion zone cracks (arrow) is found in the σ phase (light grey phase near arrow).
