Improving Repair Quality of Turbine Nozzles Using SA650 Braze Alloy

Wayne A. Demo, Stephen Ferrigno, David Budinger, and Eric Huron
GE Engine Services, Cincinnati, OH

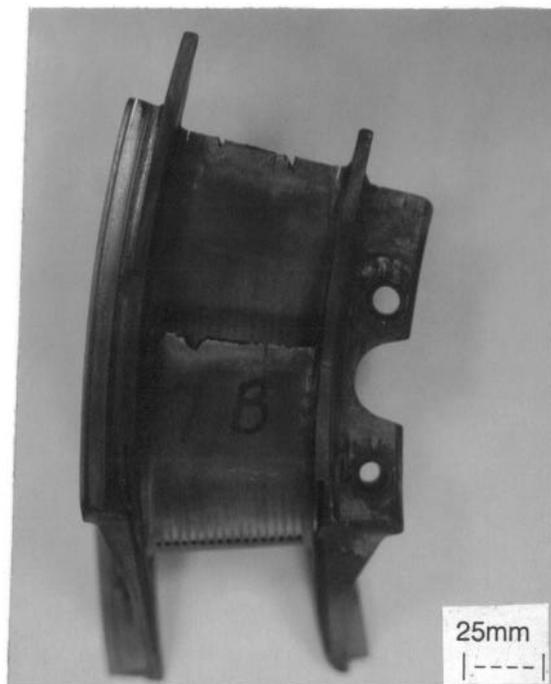
The operating environment within a gas turbine engine presents severe temperature and environmental conditions. Cobalt-base and Ni-base superalloys are used for these components; however, even components made from these alloys are subject to degradation. A common condition is cracking due to thermal fatigue. Figure 1 shows a typical example of this condition in a HPT nozzle. The cracks occur in part to

relieve stresses generated by the thermal fatigue; they typically reach stable lengths and do not propagate to lengths sufficient to cause failure. However, after the engine reaches its next service increment these cracks need to be repaired to allow the part to be returned to service.

Figure 1: CFM56-3 Stage 1 HPT Nozzle showing typical thermal-mechanical fatigue cracks at airfoil trailing edge region

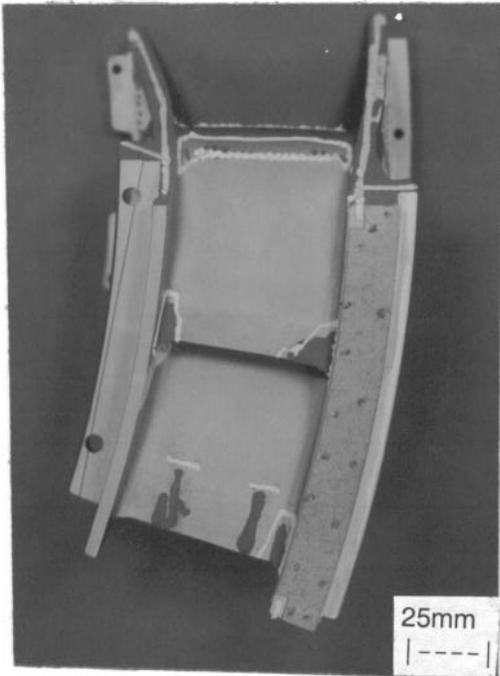
Figure 3: Appearance of part after braze application. Cracks are repaired with braze paste. Stop off paste is applied to prevent braze run in areas not needing restoration.

After all initial cleaning and preparation for final dimensional restoration steps are repaired, the part is ready for brazing. The braze alloy is applied as a powder mixture, within an organic binder to make a paste. Figure 3 shows an example of a part after braze application. The paste is applied to the cracked areas. Pre-sintered preforms for wear dimensional buildup are applied as well. The entire part is brazed using a cycle that allows diffusion of the braze alloy into the part. After brazing, final dimensional features are re-machined into the part. Fluorescent Particle Inspection (FPI) is performed to ensure successful crack repair. The part is re-coated as appropriate, final inspected for dimensional quality, and readied for shipment.

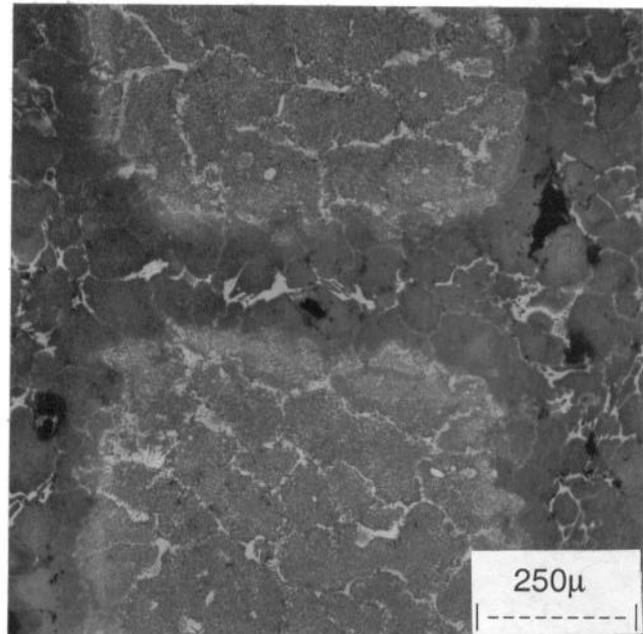
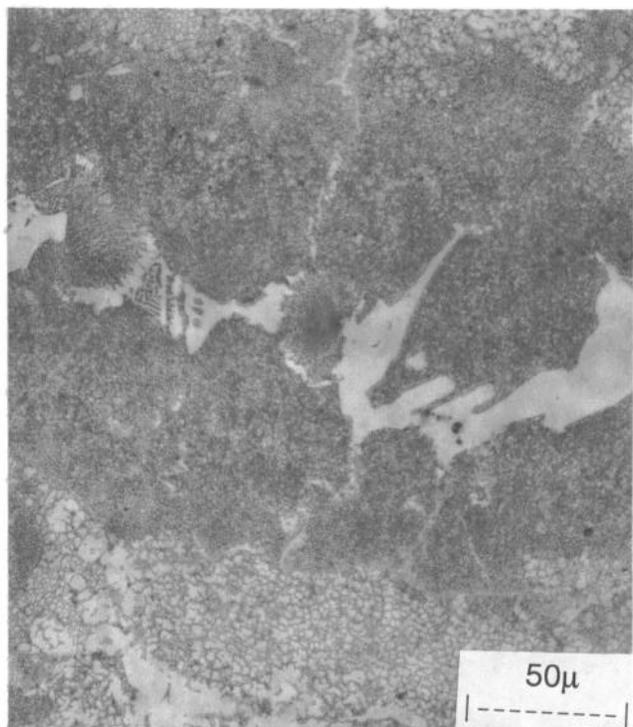
Typical microstructures of cracked regions repaired by SA650 are shown in Figure 4. Note the excellent fill of braze alloy along the crack and minimal porosity.

Figure 4: Typical microstructure of crack repaired using SA650 braze repair. Note excellent alloy fill and minimal porosity.

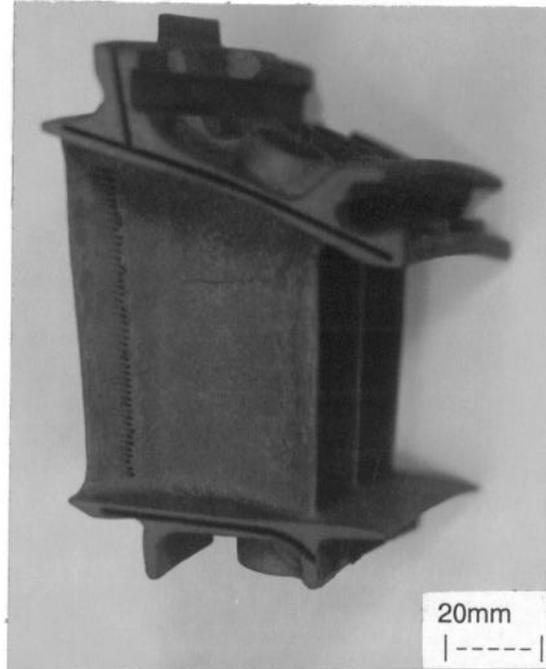
Figure 10: Results of FCT testing of an advanced braze alloy. This part had been engine run in service, repaired using techniques described in the text, and Furnace Cycle tested. Eventual part failure occurred at a crack away from any previous repaired regions, demonstrating the capability of braze repair.

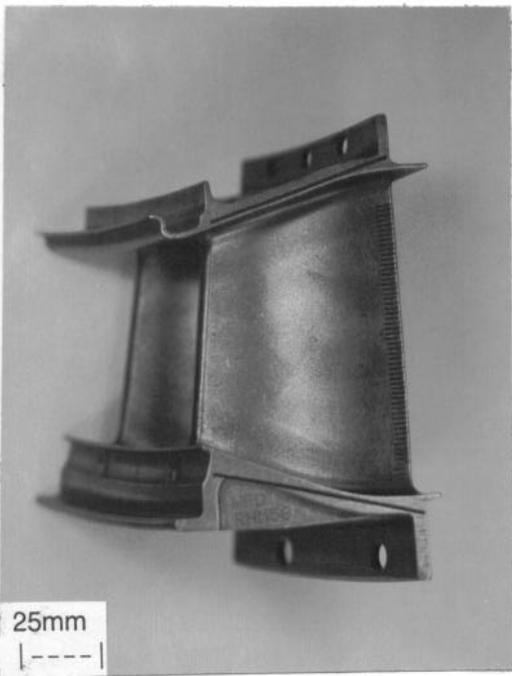
Figure 9: Typical part at completion of repair process.
