## CHARACTERIZATION OF FRECKLES IN A HIGH STRENGTH WROUGHT NICKEL SUPERALLOY

Paul D. Genereux and Christopher A. Borg

Pratt & Whitney  
United Technologies  
400 Main Street  
East Hartford, Connecticut 06108

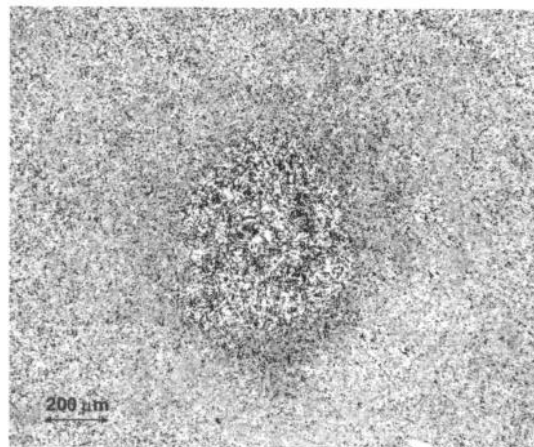
During the process development program, a point indication (Figure 1) was discovered during final macro-etch inspection of a Gatorizable Waspaloy low pressure turbine (LPT) shaft. Replica metallography showed a structure, of what appeared to be, a high density of  $\gamma'$  and large blocky ribbon-like precipitates of an unknown origin. This was believed to be a freckle melt segregation defect. This freckle indication had a diameter of 1.5 – 2.0 mm and was traced back to the 18 cm diameter billet running longitudinally equivalent to, or greater than 188 cm of billet length. This indication was located at a radial position of approximately 6 cm from the center line. The shaft was

Figure 1: Photomicrograph of low density freckle found in Gatorizable Waspaloy LPT development shaft.

The freckle appeared darker than the matrix in a macroetched condition and microstructurally was found to contain a high volume fraction of large blocky ribbon-like and spheroidal precipitates that resembled overaged  $\gamma'$ . This was all contained in a matrix of what appeared to be fine  $\gamma'$  in a gamma ( $\gamma$ ) matrix.

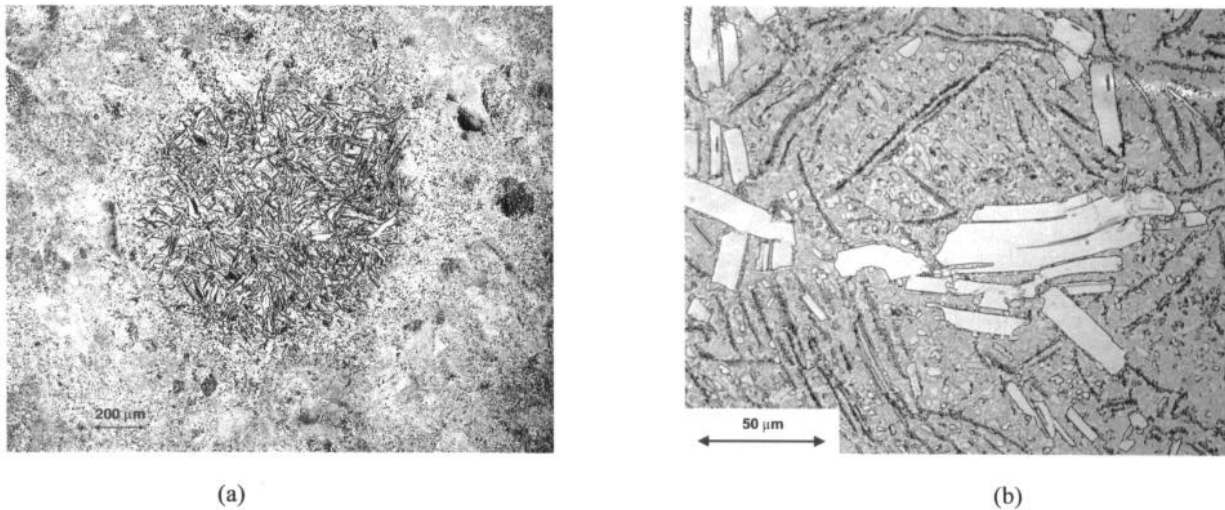
Optical micro metallography was performed in both a transverse and longitudinal orientation to the axis of the VAR ingot. In the as polished condition, an increase in MC carbides in the location of the freckle was observed, as compared to the base metal matrix location. Figures 2 & 3 are photomicrographs of the freckle in the transverse and longitudinal orientation. Common  $\gamma'$  etchants clearly define all features within the freckle. The suspect  $\eta$  phase appears particularly Widmanstatten in the longitudinal etched condition.

Figure 2: Photomicrographs of transverse section of freckle (a & b) from Gatorizable Waspaloy billet.

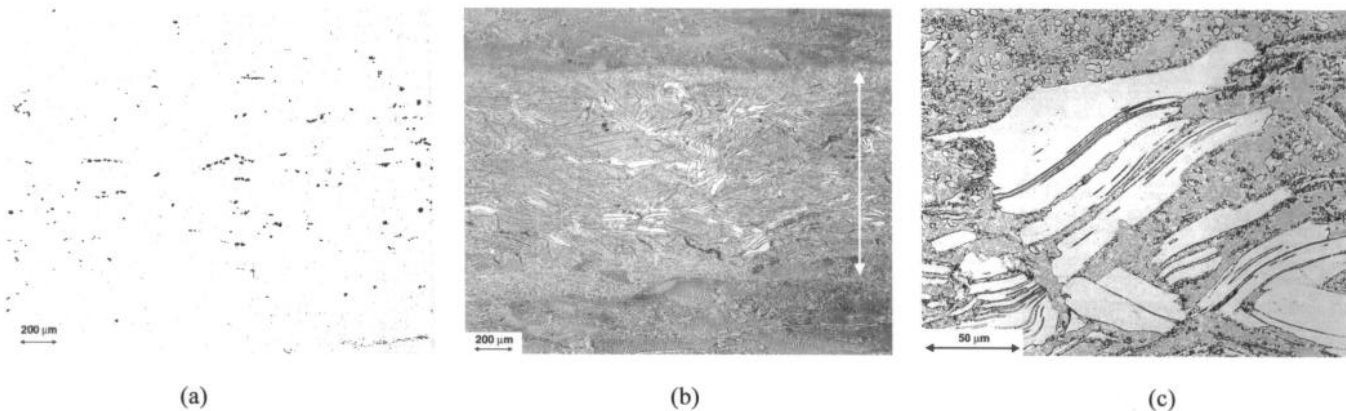
Figure 3: Photomicrographs of longitudinal section (a) as polished and (b & c) etched of freckle from Gatorizable Waspaloy billet. Arrow in (b) denotes freckle width.

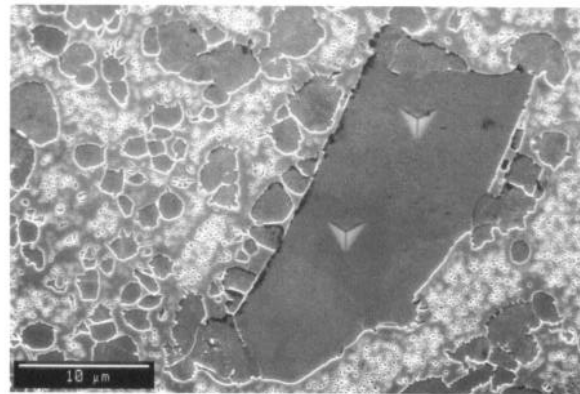
When hardness measurements are performed on a micro scale as shown in Table III a dramatic difference is observed. Because the three dimensional morphology of the blocky ribbon-like phase was unknown (may be blocky or thin), and the difficulty of placing indentations in very small precipitates, nano hardness techniques were employed. Results from the nano hardness work show both phases within the freckle region, the blocky ribbon-like precipitates and the smaller spheroidal precipitates, exhibit similar high hardness values. Whereas, the matrix surrounding these precipitates, still within the freckle, the hardness is considerably lower than the precipitates and more inline with the typical bulk hardness for this material. The hardness readings of the precipitates within the freckle were approximately twice that of the matrix locations both within the freckle and in the base metal. The discrepancy in results, between the micro and nano hardness values, may be due to the size of the micro indenter relative to the precipitate size. This may have caused erroneous results due to the influence from the surrounding matrix. Thus, the nano hardness may be a better representation of the true hardness differences between the precipitate and the matrix. Table IV summarizes the hardness at several locations using nano techniques. Figure 4 shows a typical nano hardness indenter mark within the blocky ribbon-like precipitate.

Figure 4: FESEM image of nano hardness impressions located in blocky ribbon-like precipitate within the freckle.

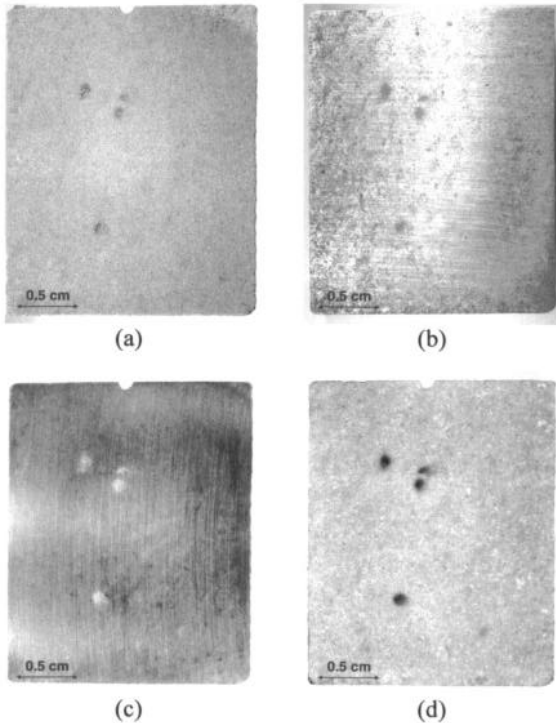
Figure 5: Coupon from billet containing freckles in macro etched condition: (a) Production mill etch, (b) finished machine part etch, (c) HCl + H<sub>2</sub>O, and (d) HCl + H<sub>2</sub>O<sub>2</sub>.

The typical mill billet inspection etch turned the base metal uniformly gray while the indications appear darker. The freckle contrast can be poor and may go undetected, as was the case in the LPT development shaft. When the finished machined part etch was applied to a coupon, as is required for production, the matrix became spotty and non-uniform. The three freckle indications are difficult to see and can be confused with details within the matrix. The results of a diluted 2:1 HCl and water trial show the background has become very dark and the three freckle indications appear lighter. This high contrast makes detection relatively easy; however, good lighting is necessary to insure reliable detection. The HCl + H<sub>2</sub>O<sub>2</sub> etch was similar in appearance to the production billet inspection etch but with better contrast. This etch effectively attacks the matrix while darkening the freckle. Generally, it was found that the surface roughness and amount of surface residual work influences the effectiveness of the macro-etchant.

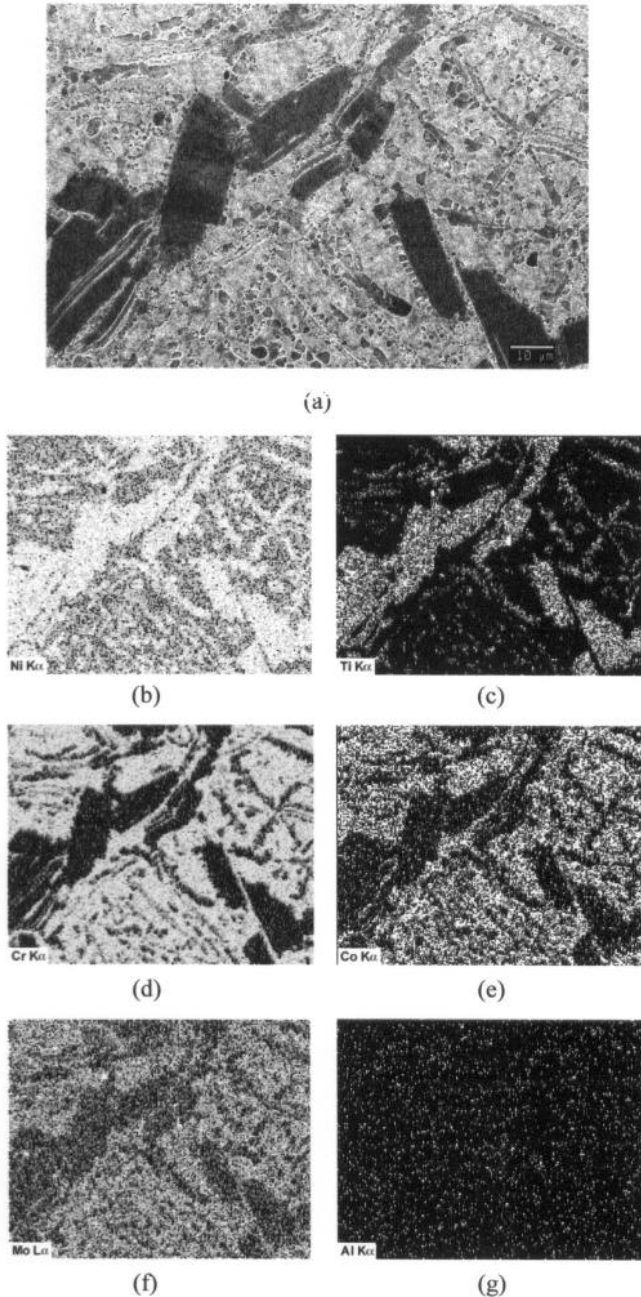
Both field emission scanning electron microscopy (FESEM) and electron microprobe analysis (EMP) were employed to obtain high magnification high resolution photomicrographs. Additionally, energy dispersive spectroscopy (EDS) and wavelength dispersive spectroscopy (WDS) techniques were used in an attempt to get qualitative and semi-quantitative chemical data from the phases associated with the freckle indication. High resolution photomicrographs using the FESEM are shown in Figure 6a. Qualitative x-ray maps (Figures 6b – 6g) show that the blocky ribbon-like and spheroidal precipitates are enriched in nickel and titanium while depleted in chromium, cobalt, and molybdenum as compared to the base metal matrix. The level of aluminum is relatively constant throughout.

Figure 6: FESEM image (a) of freckle indication with associated x-ray maps for (b) nickel, (c) titanium, (d) chromium, (e) cobalt, (f) molybdenum, and (g) aluminum.

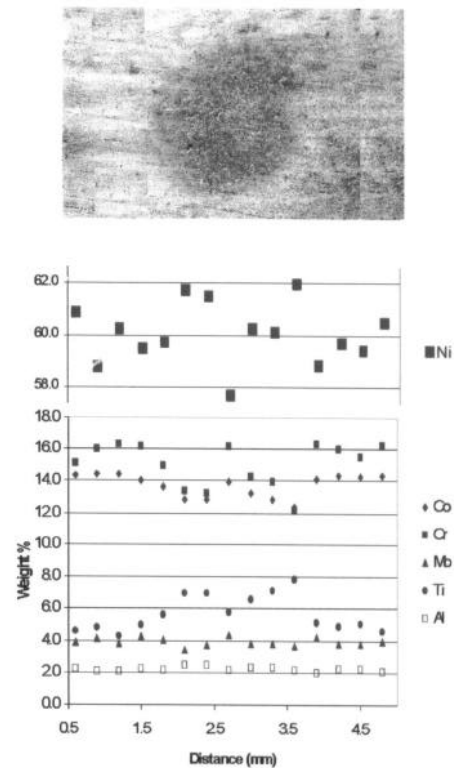
Using the EMP, a WDS chemical trace across the freckle highlights the concentration variations within this region. This semi-quantitative chemical analysis (Figure 7) illustrate the difference in the nickel, cobalt, chromium, molybdenum, titanium, and aluminum amounts within the freckle when compared to the base metal matrix.

Figure 7: WDS compositional traces with corresponding image of area analyzed. Note the spikes in Ni and Ti and depressions in Co, Cr, and Mo at locations corresponding to the freckle indication.

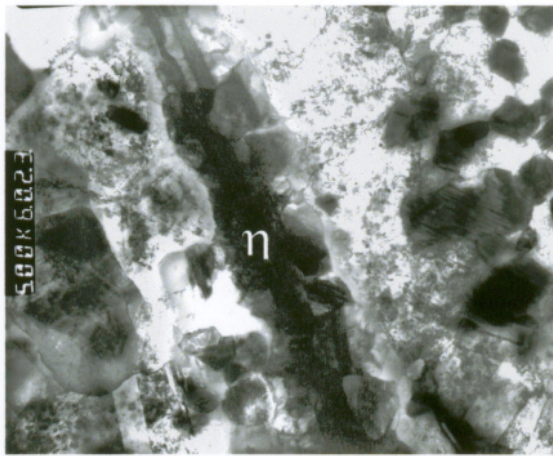
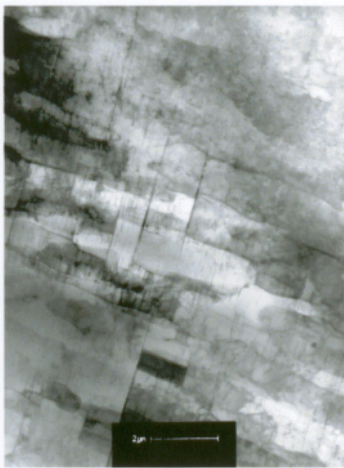
Thin films were sliced from polished coupons, electro polished and ion milled to obtain an electron transparent surface for the analysis. TEM bright field images and electron diffraction patterns taken in the blocky ribbon-like precipitate are shown in Figures 8a – 8d. Electron diffraction pattern analysis indicate the blocky ribbon-like precipitate to have an ordered hexagonal crystal structure. This is significant in that it rules out the possibility of these precipitates being  $\gamma$ ,  $\gamma'$ , or carbide, all of which are FCC. Because of their smaller size, spheroidal shape and chemical composition the smaller round precipitates that showed slightly reduced hardness are believed to be overaged  $\gamma'$ . Further analysis is needed to confirm this.

Figure 8: TEM bright field images (a & b) with associated electron diffraction patterns for the (b) 010, and (c)  $10\bar{1}$  zone axes. The  $\eta$  phase is designated on image (a).

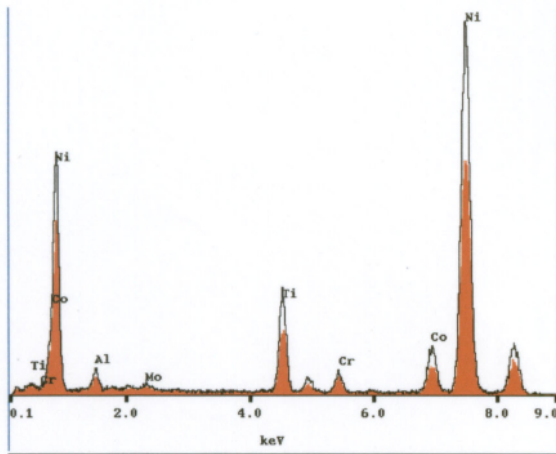
Chemical analysis performed in the TEM using EDS (Figure 9) showed a small amount of solubility for cobalt, aluminum and chromium. This is in contrast to what was stated in literature, that  $\eta$  forms near the  $Ni_3Ti$  stoichiometric composition and should consist only of nickel and titanium. This may be alloy composition dependent and may not hold true in every alloy system.

Figure 9: TEM EDS spectra of  $\eta$  phase within freckle.

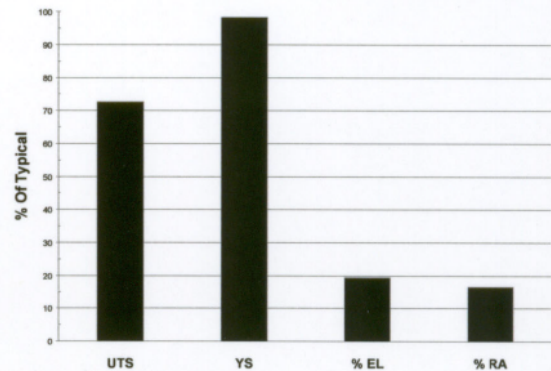
Tensile specimens were tested at room temperature. Results of the tensile testing show yield strengths equal to baseline and typical for this alloy. Ductility, however, was on average 20% of baseline and in some cases approached zero. This poor ductility resulted in the ultimate tensile strength being roughly equal to the yield strength. Figure 10 summarizes the tensile results as compared to baseline. Metallography of the tensile fracture in the area of the freckle is shown in Figure 11a. There is evidence of fracture at the blocky  $\eta$  precipitates as well as secondary cracking between this phase and the matrix as shown in Figure 11b.

Figure 10: Tensile properties of specimens containing freckle as compared with specimens having normal Gatorizable Waspaloy microstructure.

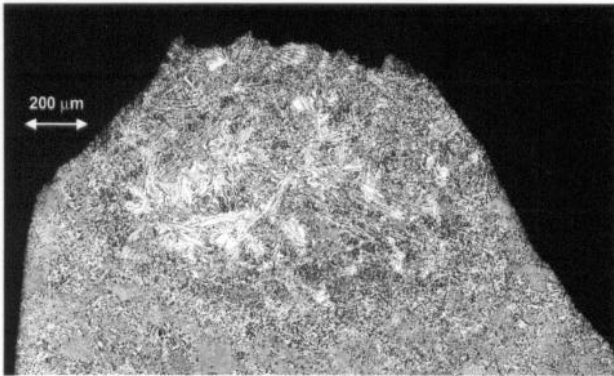
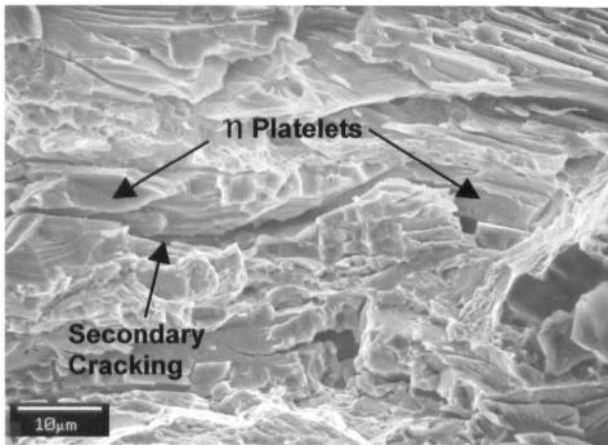
Figure 11: Photomicrograph in gage of failed tensile specimen (a) note freckle at fracture location, and SEM image (b) showing fracture occurred on  $\eta$  platelets and the presence of secondary cracking associated with  $\eta$  phase.

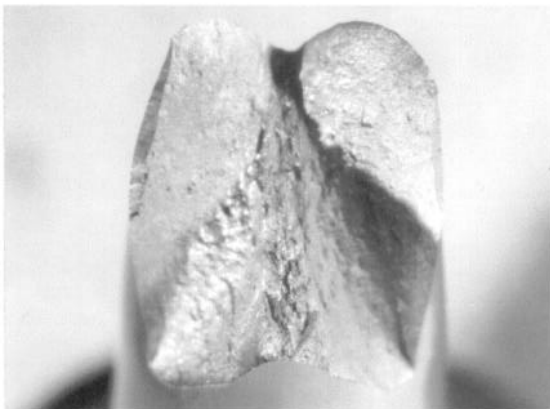
Both smooth and notched low cycle fatigue specimens were tested to approximate engine relevant conditions. A typical fatigue fracture surface is shown in Figure 12, where the freckle location is clearly visible as a bisected cylinder through the gage section illustrating the brittle nature of this defect. Results of the fatigue testing indicate a smooth life debit of 4X, based on B0.1 lives, with failure origins at freckle sites. Figure 13 shows a plot comparing smooth fatigue life of specimens containing freckles vs. specimens free of freckles, both extracted from the same billet slice. It was not possible to assess the effect of freckle segregation on notch fatigue life on a B0.1 basis. Post test analysis show that the accuracy of locating the defect at the notch location corrupted the data. This likely contributed to the high scatter observed resulting in an artificially large debit. On a mean life basis an approximate debit of 2X, compared to baseline, is shown.

Figure 12: Typical fatigue fracture surface of specimen containing freckle defect.

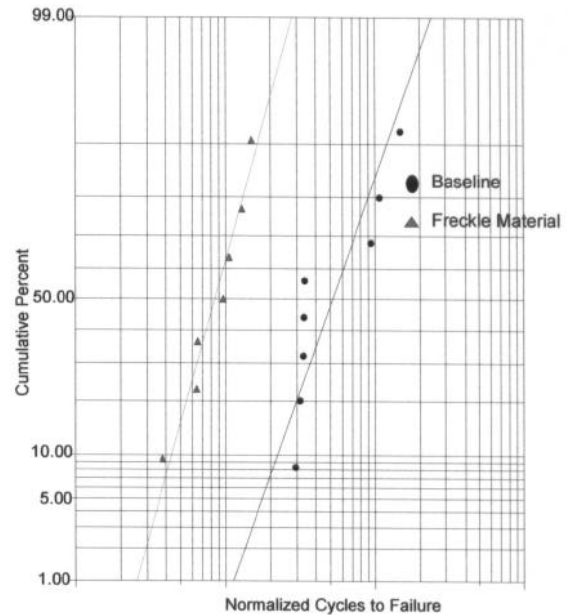
Figure 13: Lognormal plot of smooth fatigue life from specimens containing freckles compared to normal Gatorizable Waspaloy microstructure.

Mechanical property debits caused by the freckle defect were shown to be dramatic in both tensile and fatigue. Room temperature tensile ductility was reduced by 80%, as compared to baseline, and in one case approached zero. The ultimate tensile strength, at room temperature, was roughly equal to the yield strength, which did not differ significantly from baseline yield strength properties. Smooth fatigue properties of specimens containing freckles were debited by 4X, as compared to typical base metal results. On a mean life basis, notch fatigue specimens showed debits of 2X.

Because of the dramatic reduction in mechanical properties that were seen in this investigation, freckle defects of this type clearly must be eliminated in the VAR melted product. The only effective means for in process removal of freckles through inspection is with the use of billet macro plate etch inspection. The elimination of segregation defects such as freckles has principally been accomplished through tighter controls on the VAR melt process.
