In-Situ Tensile-Creep Testing of Structural Alloys

C.J. Boehlert

Michigan State University

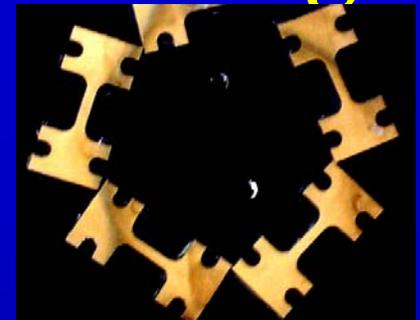
Sample ~38mm long

- Specimens EDM machined to custom geometry
- Screw driven actuator: Load or displacement controlled
- Load capability = 1000lbs; smaller load cells available
- Tensile Stage can tilt 45 degrees
- *In-situ* EBSD possible through SEM stage tilt, Hikari Camera used: 150pts/sec indexing rate. It took 20 minutes to map a 200umx200um area (1kX magnification)
- Sample heated using 6mm diameter W-based radiant heater/power supply
- Steel grips are not heated
- Vacuum maintained at 10^{-6} torr throughout experiment (longest~14days)
- Heater cooled through Cu lines

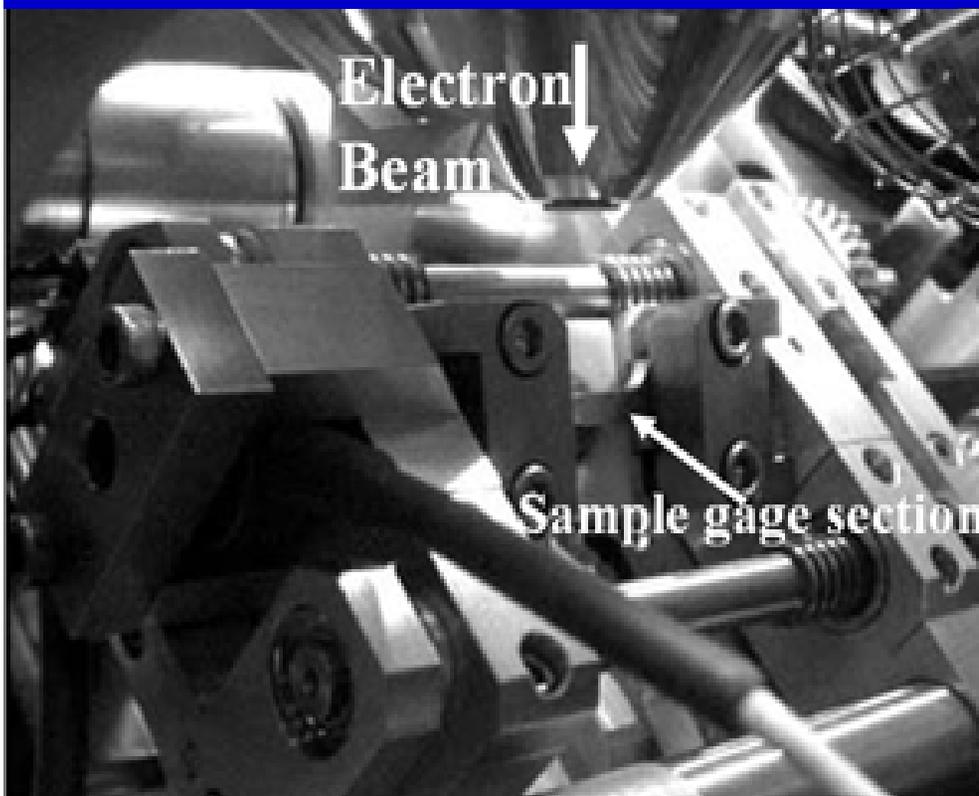
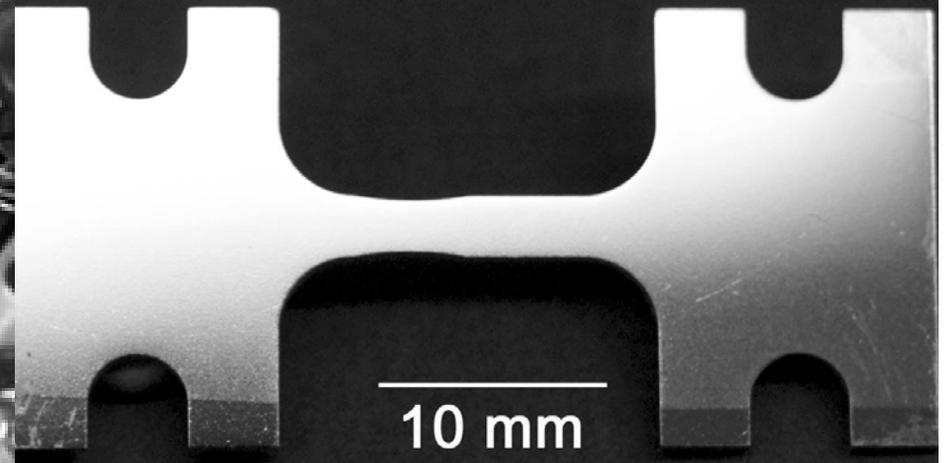
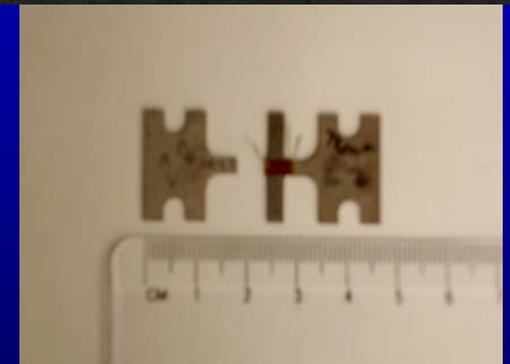
Experimental Procedure *In-Situ* Testing

A specially-designed specimen was used along with an Ernest Fullam Tensile Stage to perform creep experiments at temperatures up to 760°C and loads up to 1000lbs. EBSD orientation maps can be performed both before and after creep deformation as well as *during* the creep deformation experiment.

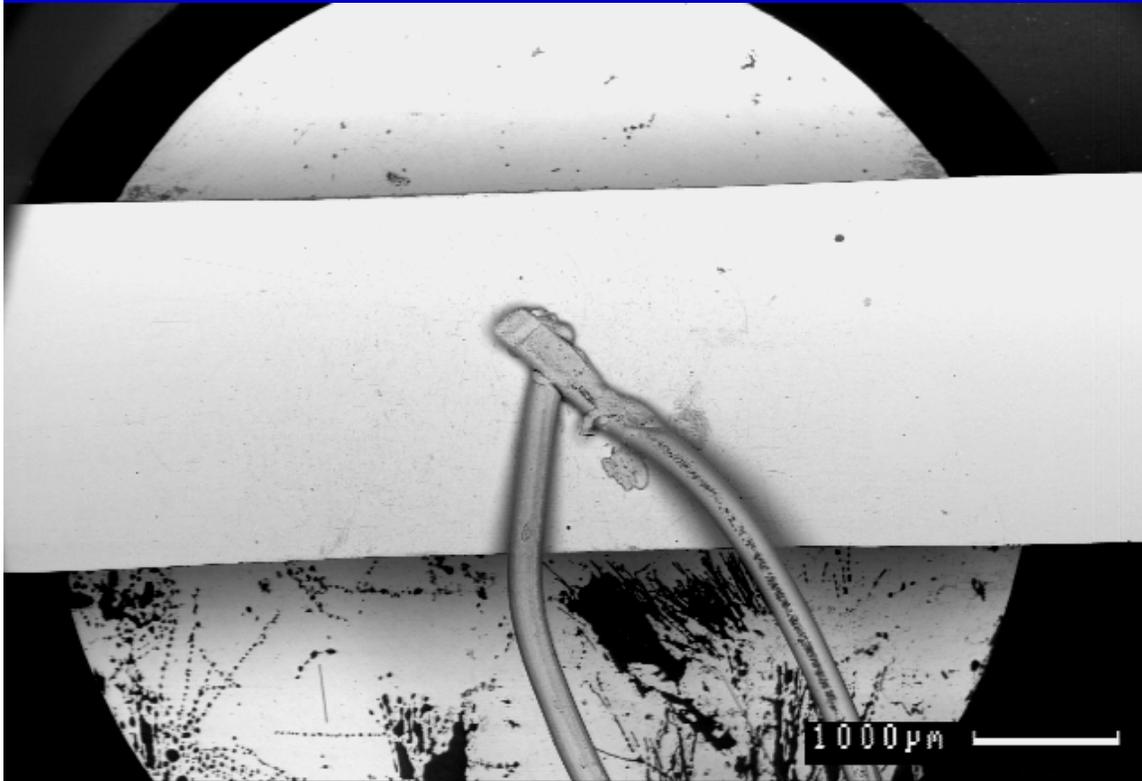
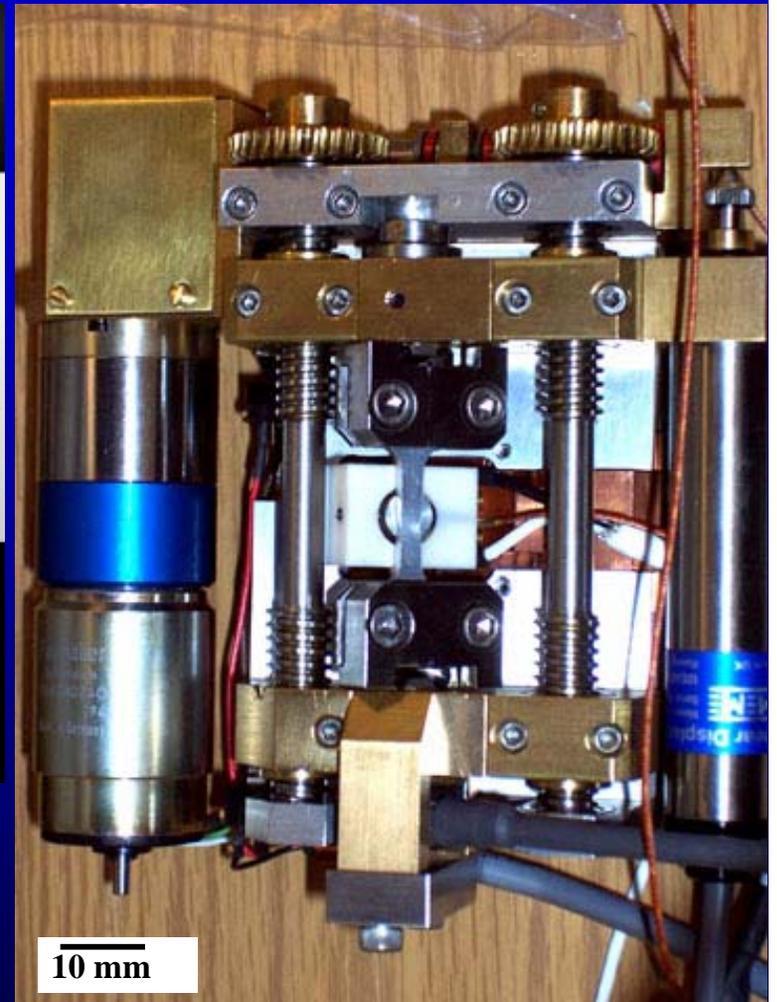
Temperature Measurement

6mm diameter W-based heater was located just below the gage section of the sample. Fine-gage type-K TC monitored the temperature and SEM BSE micrographs were taken within the heated section during creep.

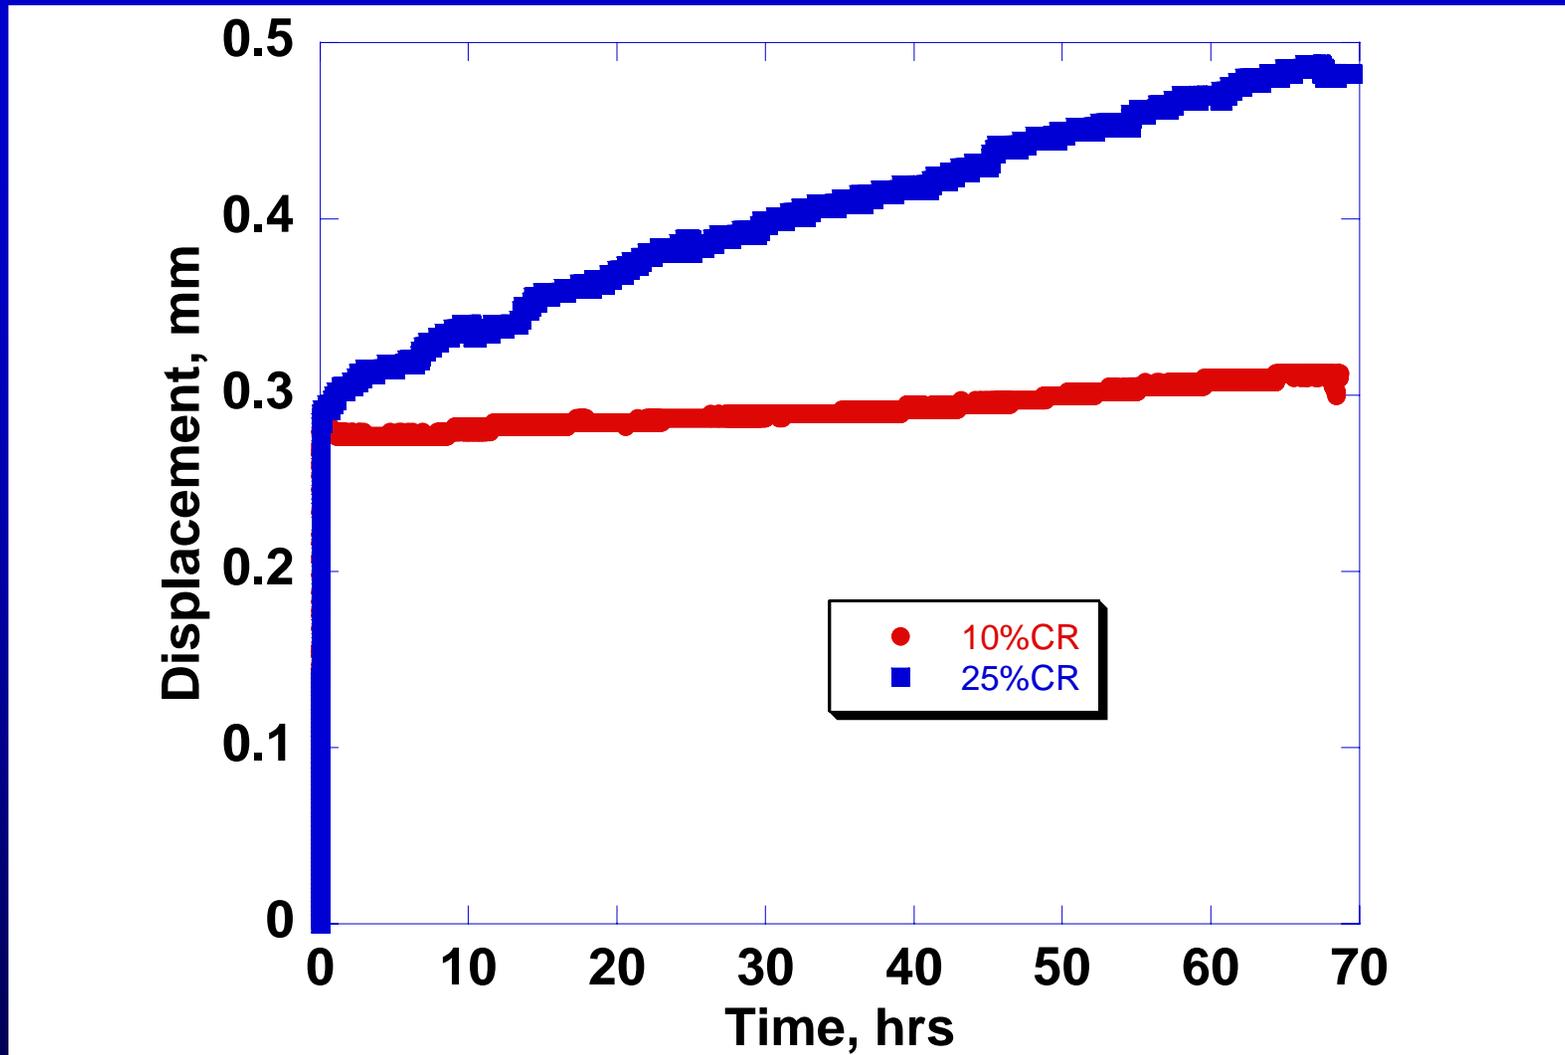
Displacement versus time curves for creep experiments performed at $T=650^{\circ}\text{C}$ and $\sigma=300\text{MPa}$.

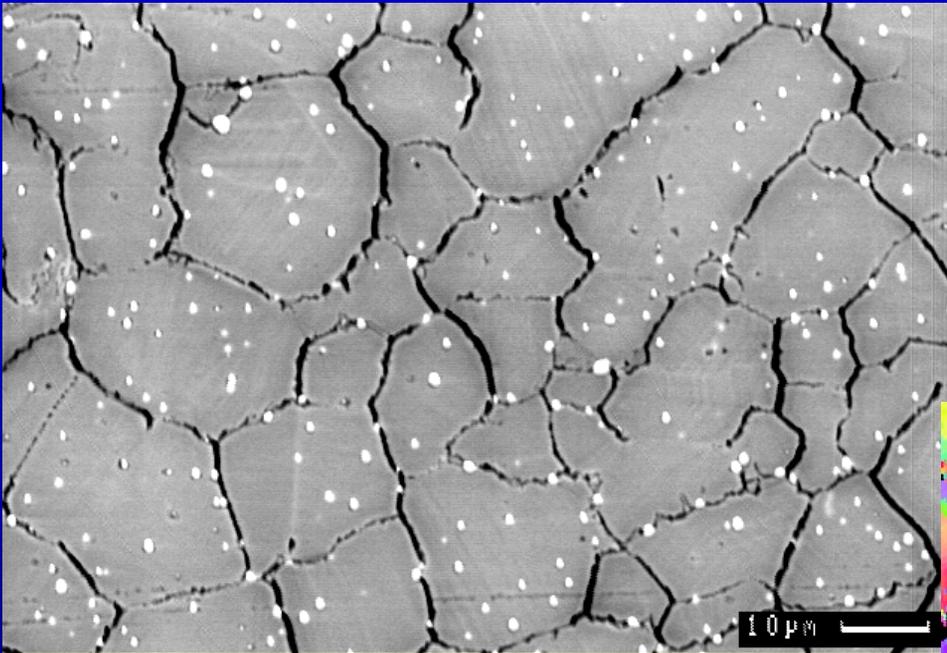
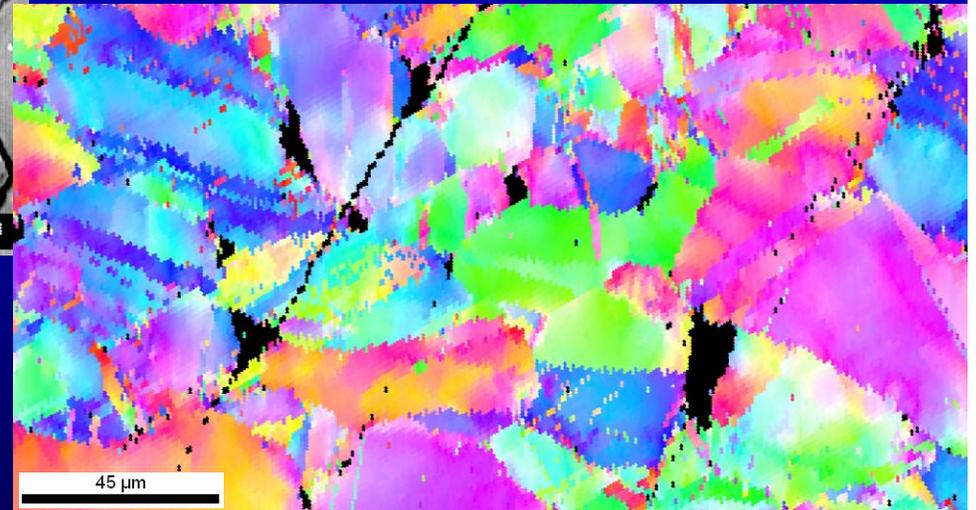
Cracking at HABs

BSE SEM image of a 25% cold rolled sample that was tested *in-situ* at 650°C and 300MPa and an EBSD map of a 25% cold rolled sample that had undergone a creep rupture experiment at 815°C and 165MPa and exhibited over 20% strain to failure. This area was from a subsurface polished section near the fracture surface. Substantial lattice curvature is evident in the color gradients within most grains. The loading direction was horizontal.

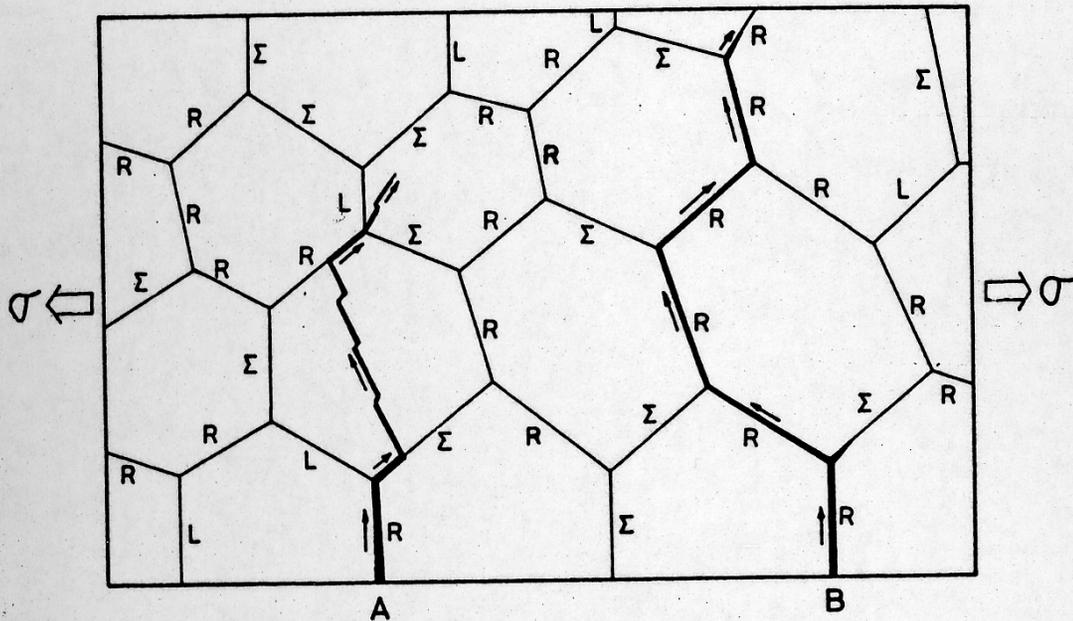
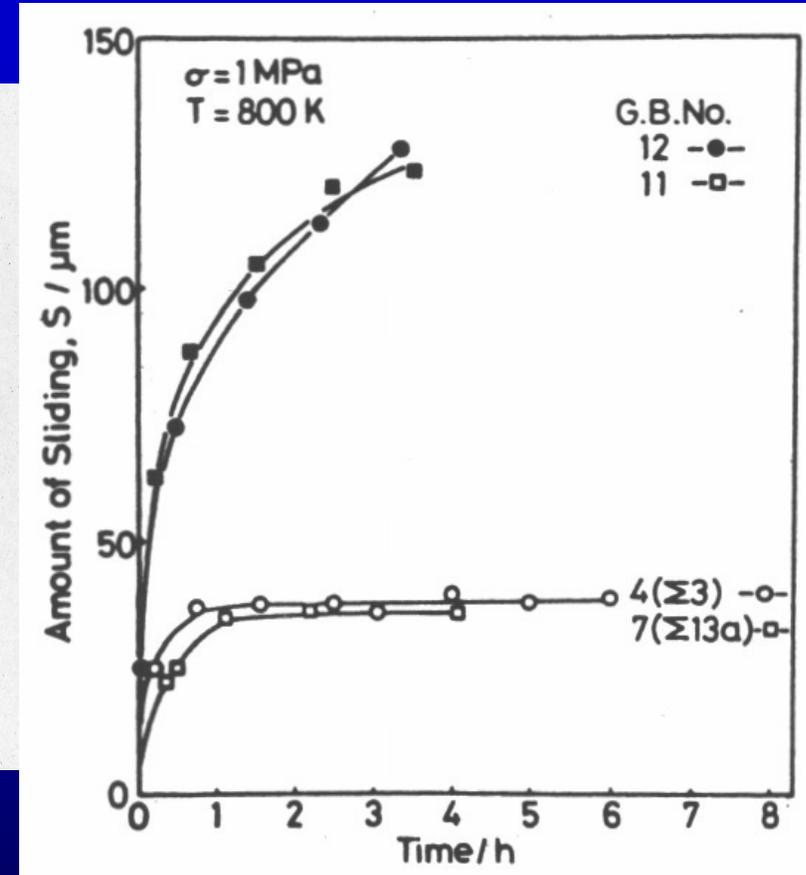
Effect of Grain-Boundary Structure on the Fracture Process

Random boundaries are susceptible to intergranular degradation. Increased proportion of special boundaries can improve fracture resistance by preventing intergranular degradation and decreasing diffusion across grain boundaries

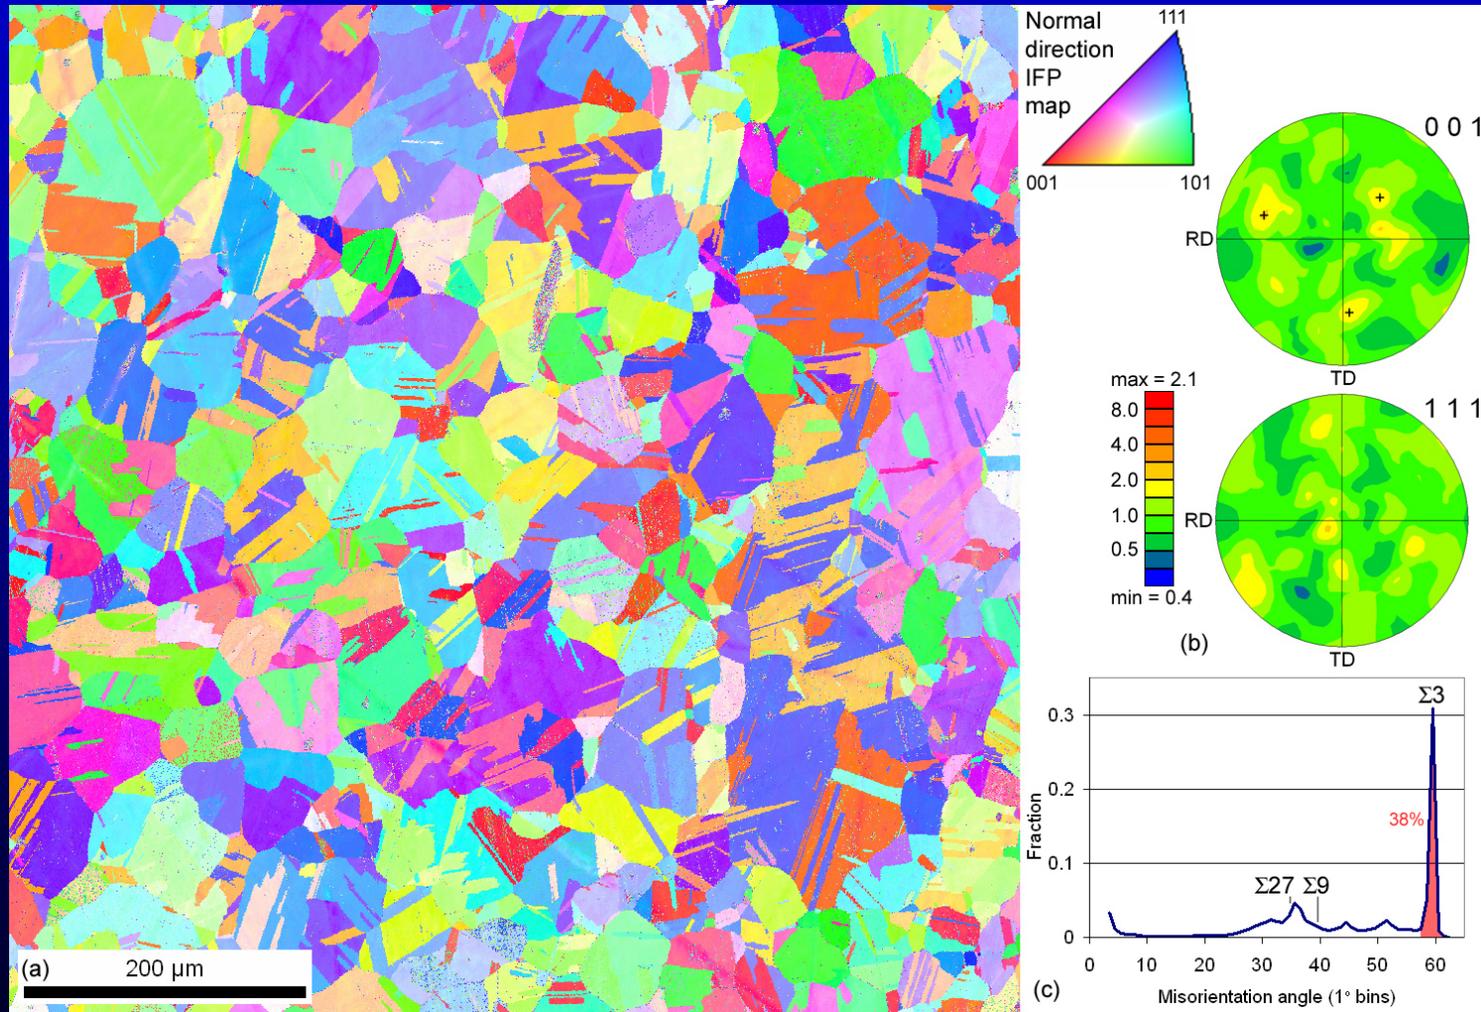
Grain Boundary Character Distribution

- Weak texture, but lots of annealing twins occur in Udimet alloy 188 after TMP

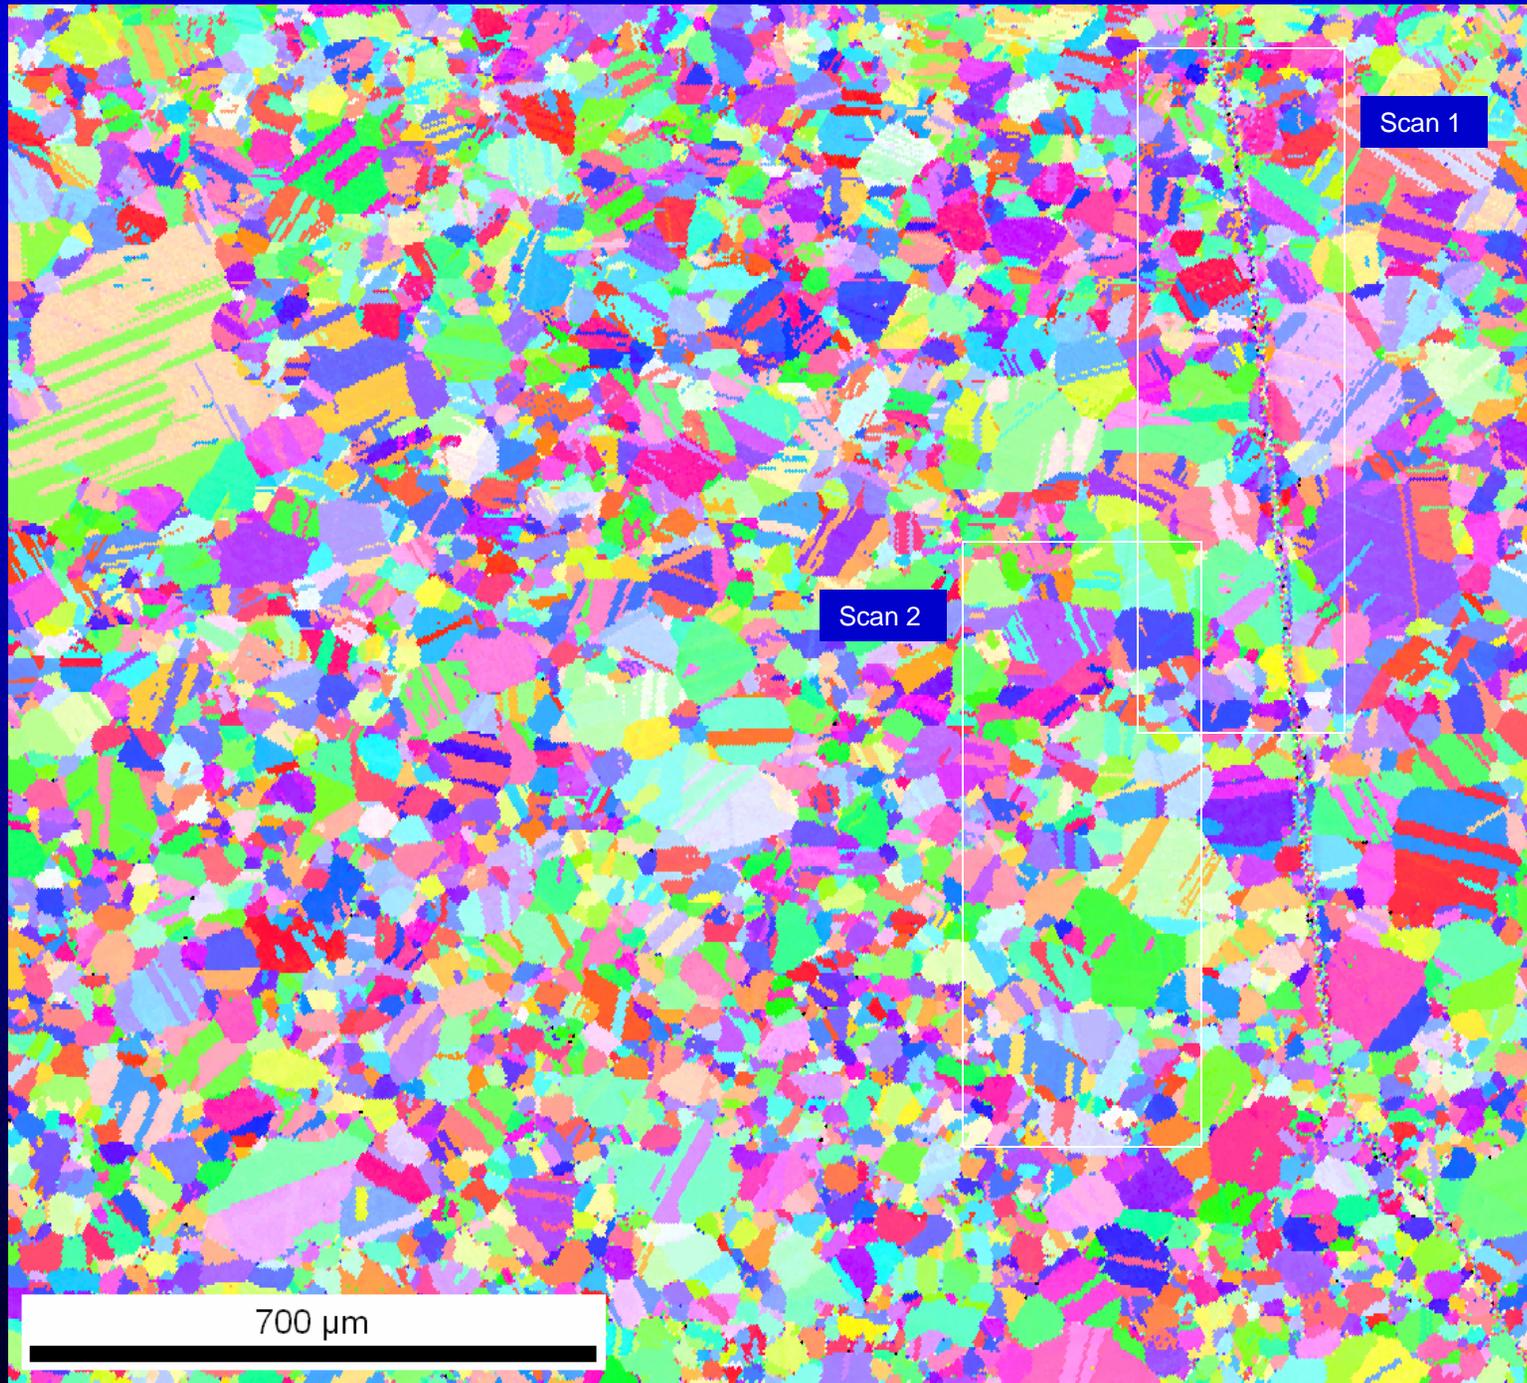
Before –
Scan 1
4um step
size

- EBSD Maps were performed on the specimen prior to testing
- Fiducial markings were positioned so that after creep testing the same areas could be mapped after creep testing to a given strain
- The sample was tested so that the sample surface was perpendicular to the incident beam.
- After the experiment the sample was removed from the tensile stage and placed on a separate holder then EBSD mapping was performed.
- Additional Creep Experiments could be performed on the same sample, however the sample would need to undergo heating and loading each time.

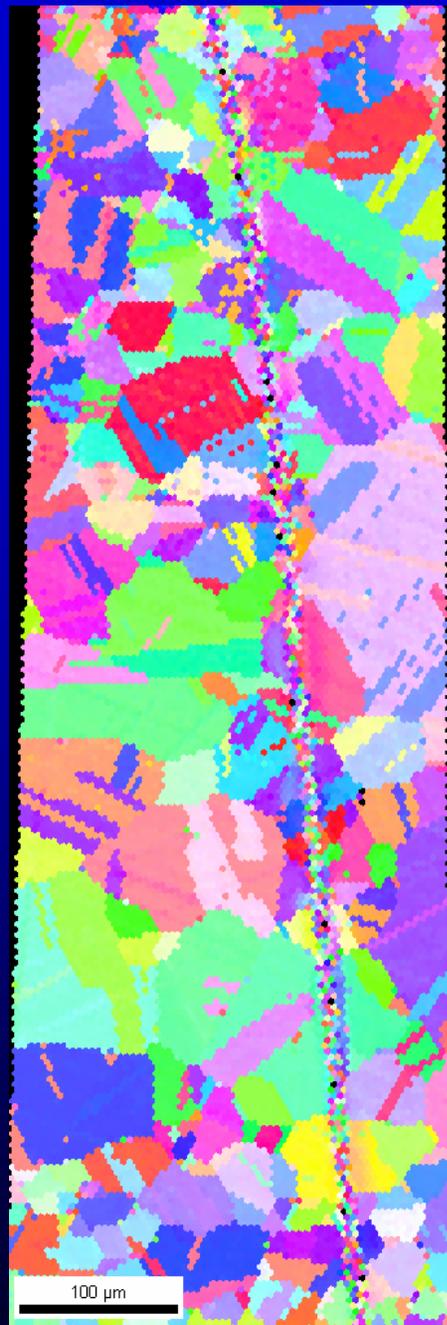
After – Scan 1;
0.75um step size

Of the more than
20 cracked
boundaries only
one was a special
boundary ($\Sigma 9$ see
black arrow). All
others were
GHABs (R). Two
were LABs.

06-17 35%cr
760°C, 220MPa;
4-10%cr str

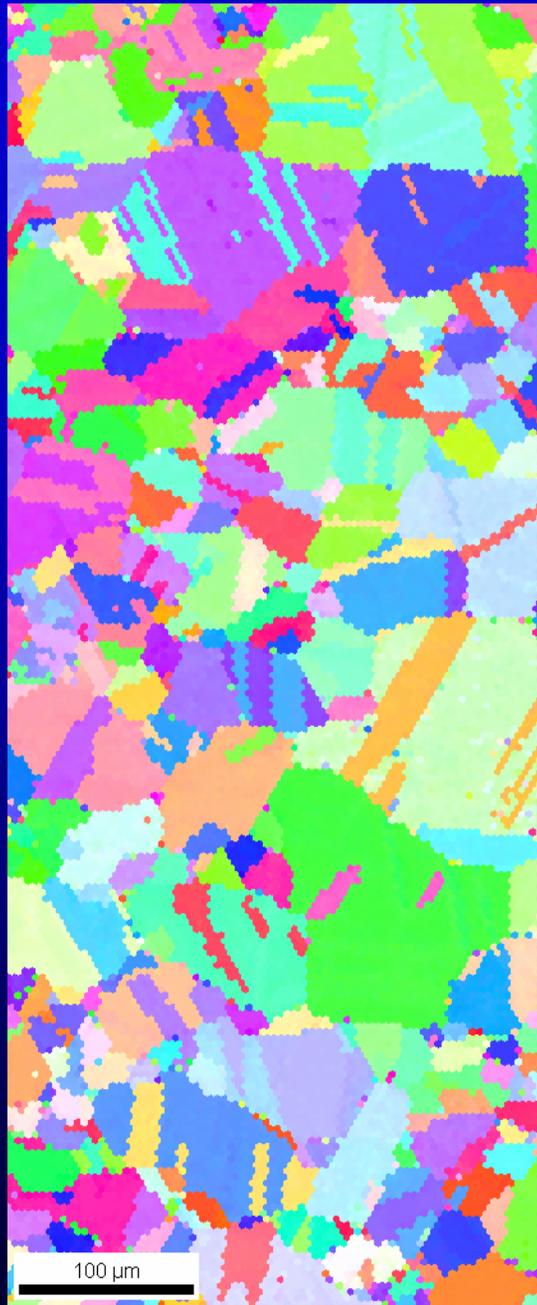
After – Scan 2;
0.75um step size

Of the more
than 20 cracked
boundaries only
one was a
special
boundary ($\Sigma 3$
see black
arrow). All
others were
GHABs (R).

06-17 35%cr
760°C, 220MPa;
4-10%cr str

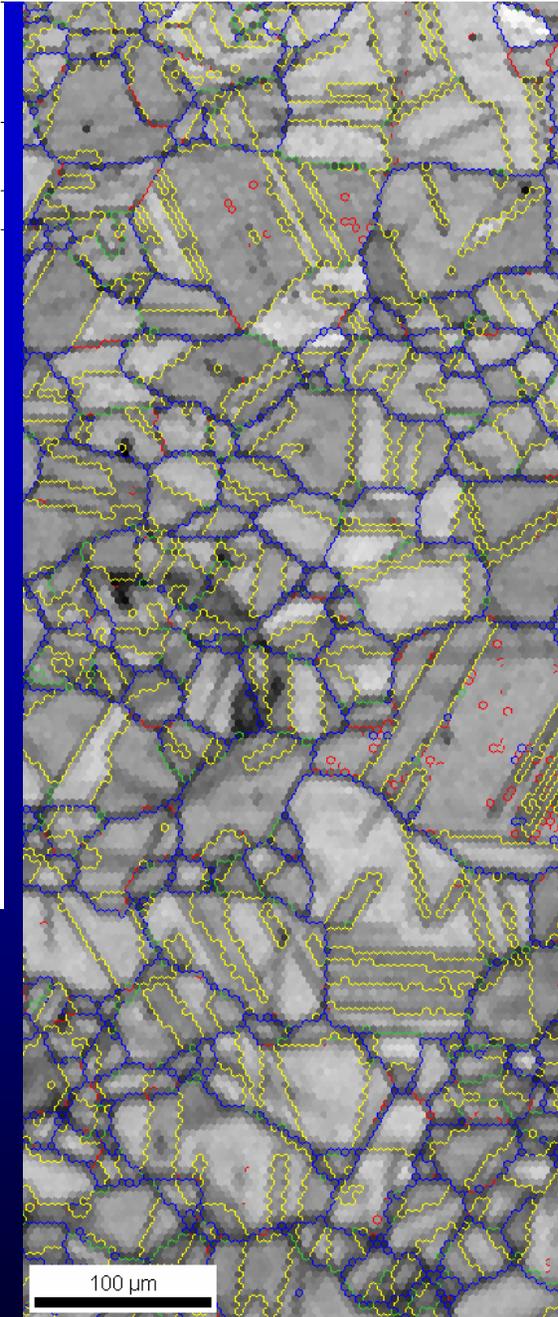
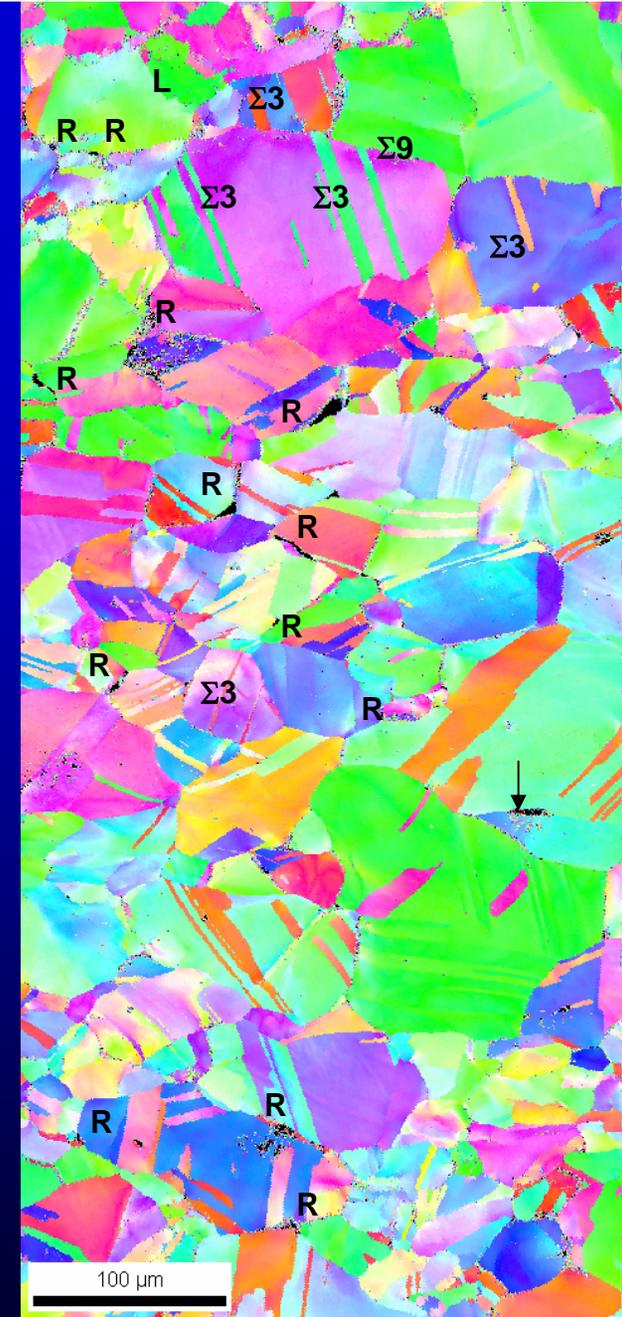
**Before –
Scan 2; 4µm
step size**

**35%cr UD 188
760°C, 220MPa;
4-10%cr str**

**Almost no cracks on Σ boundaries,
 about half of random boundaries cracked**

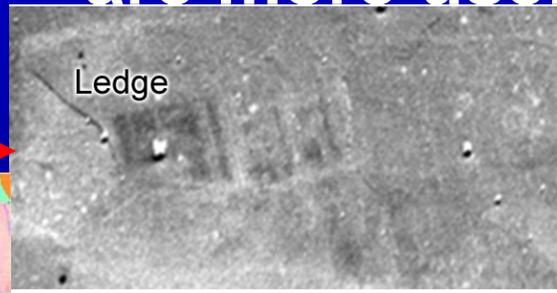
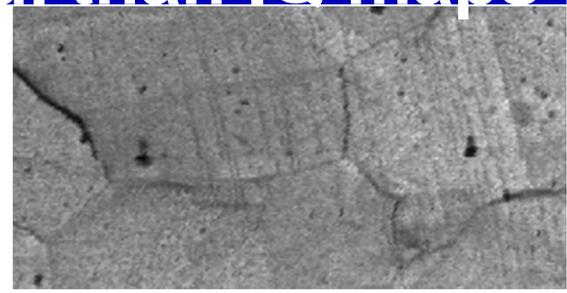
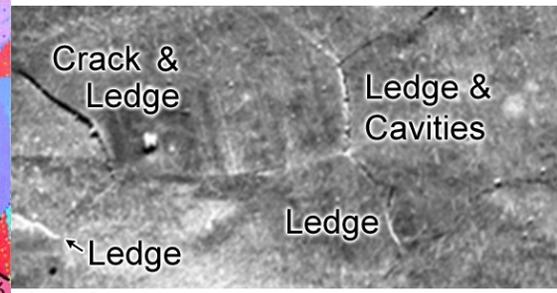
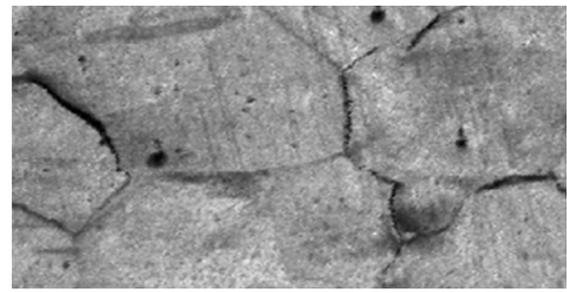
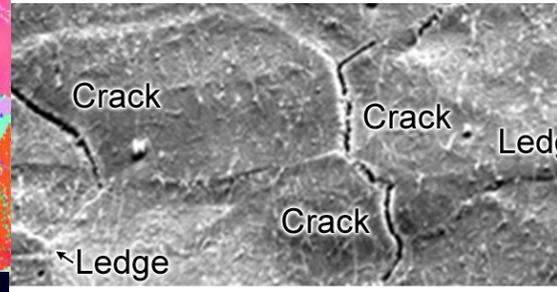
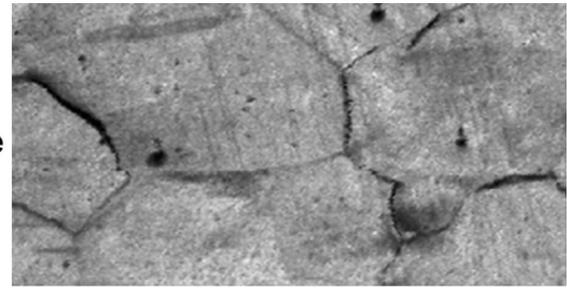
**Sequential imaging
 and OIM during *in-situ* creep
 deformation**

**Much care is needed to identify
 crack vs. ledge. SE imaging
 are more useful than IQ maps**

d=0.26 mm ($\epsilon \sim 2.5\%$)

d=0.37 mm ($\epsilon \sim 5\%$)

d=0.57 mm ($\epsilon \sim 10\%$)

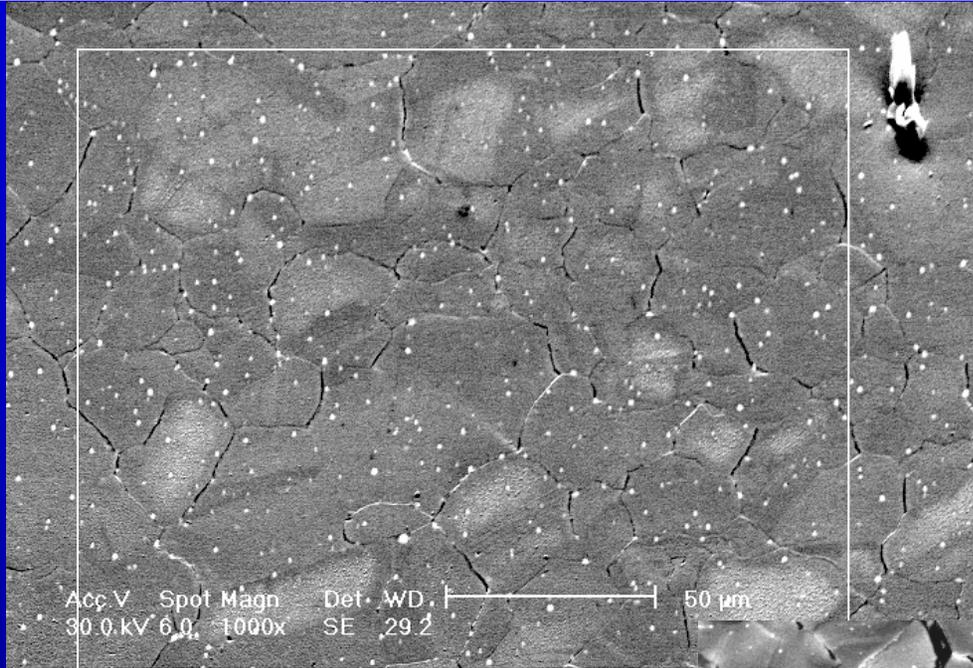
SE SEM micrographs for a 25% cold rolled specimen deformed at $T=760^{\circ}\text{C}$ and $\sigma=220\text{MPa}$ after (a) 0.117mm displacement, (b) more than 1.039mm displacement creep. The area within the boxes was characterized using EBSD. The loading axis was horizontal.

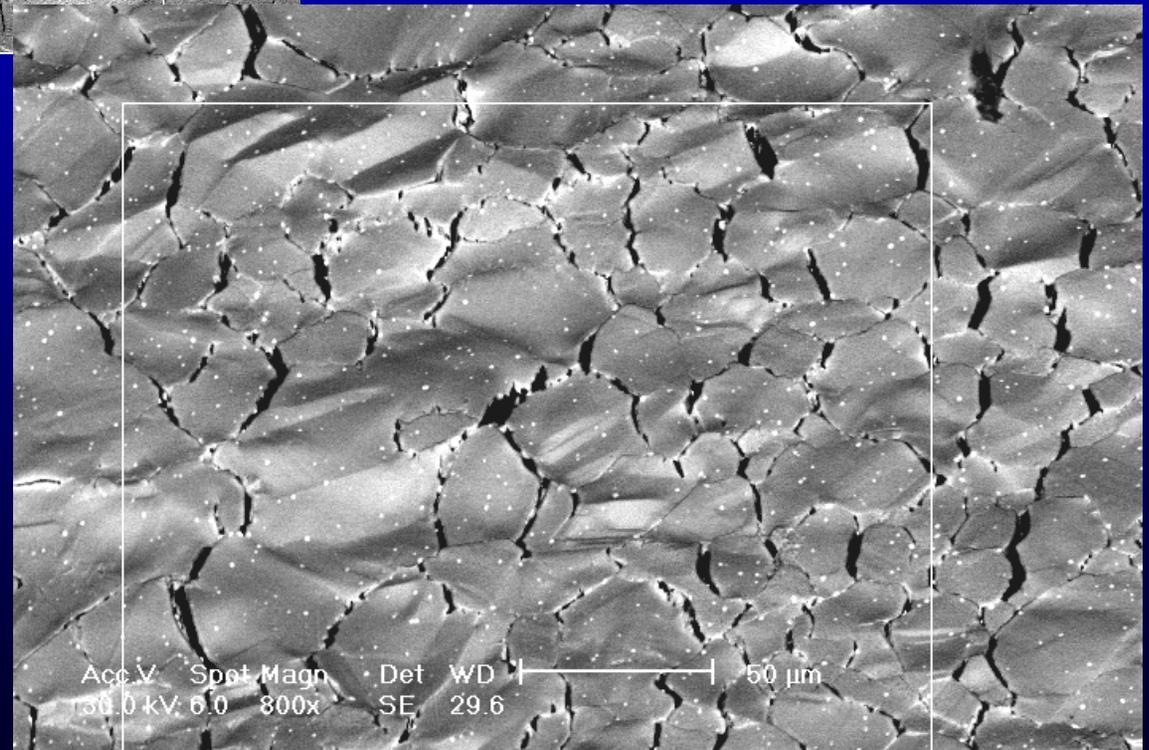
(b)

EBSD inverse pole figure orientation map for a 25% cold rolled specimen prior to creep testing at $T=760\text{C}$ and $\sigma=220\text{MPa}$. The GHABs and CSLBs that were analyzed are marked. The loading axis was horizontal.
