Aluminerie de Deschambault – Fluoride Reduction... Continuous Improvement

TMS Presentation – *February 2009*

Aluminerie de Deschambault

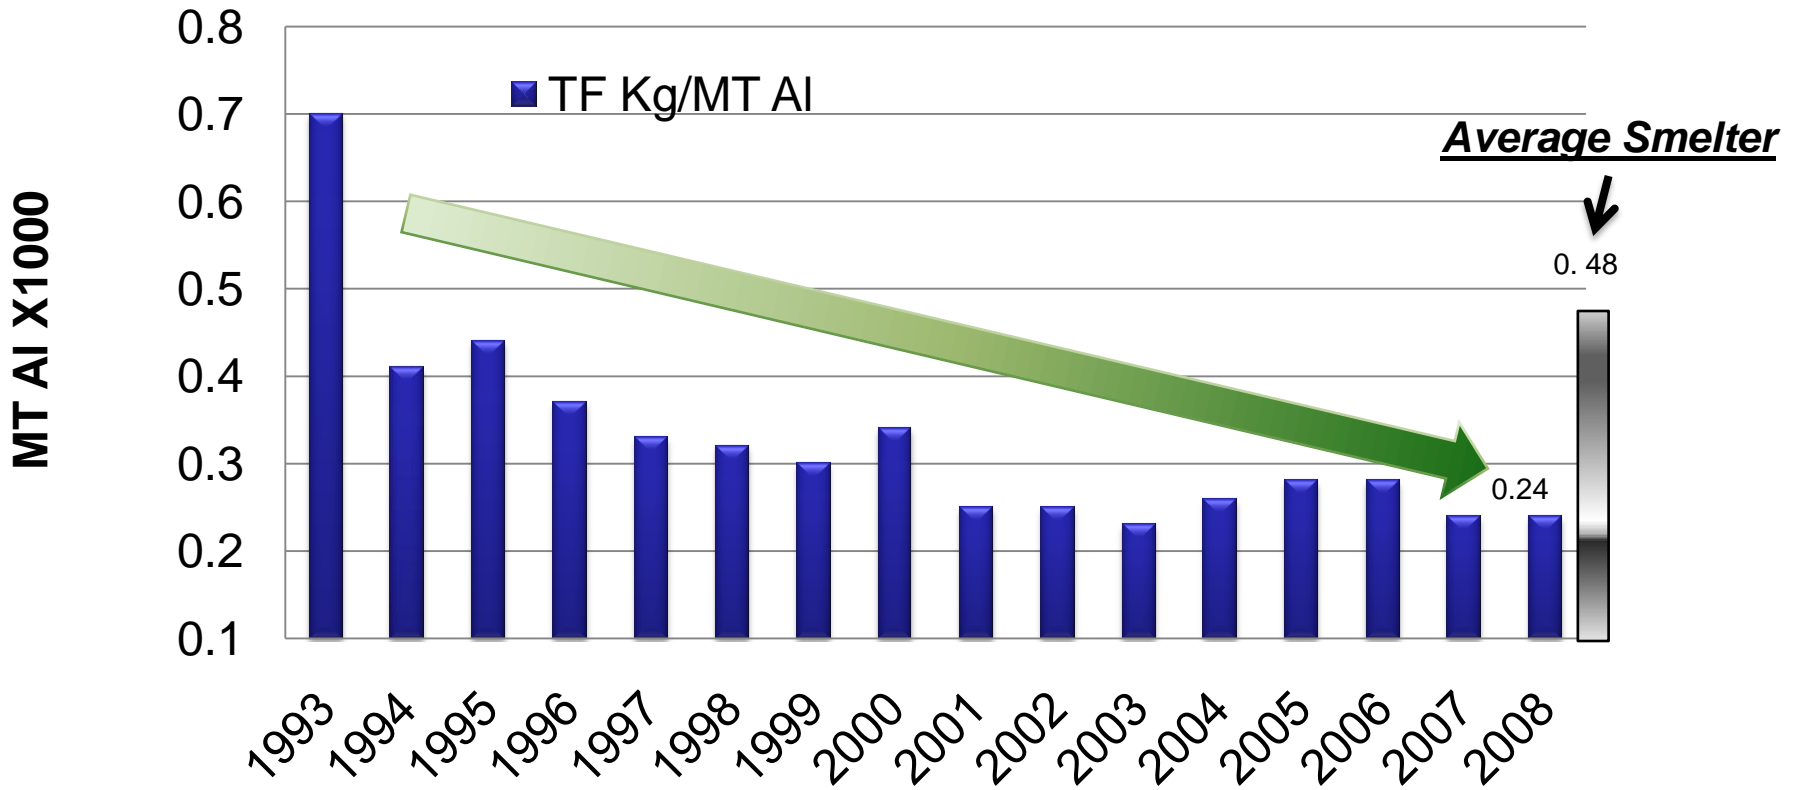
Fluoride Emissions at Deschambault

Deschambault - Worldwide Benchmark Fluoride Emissions

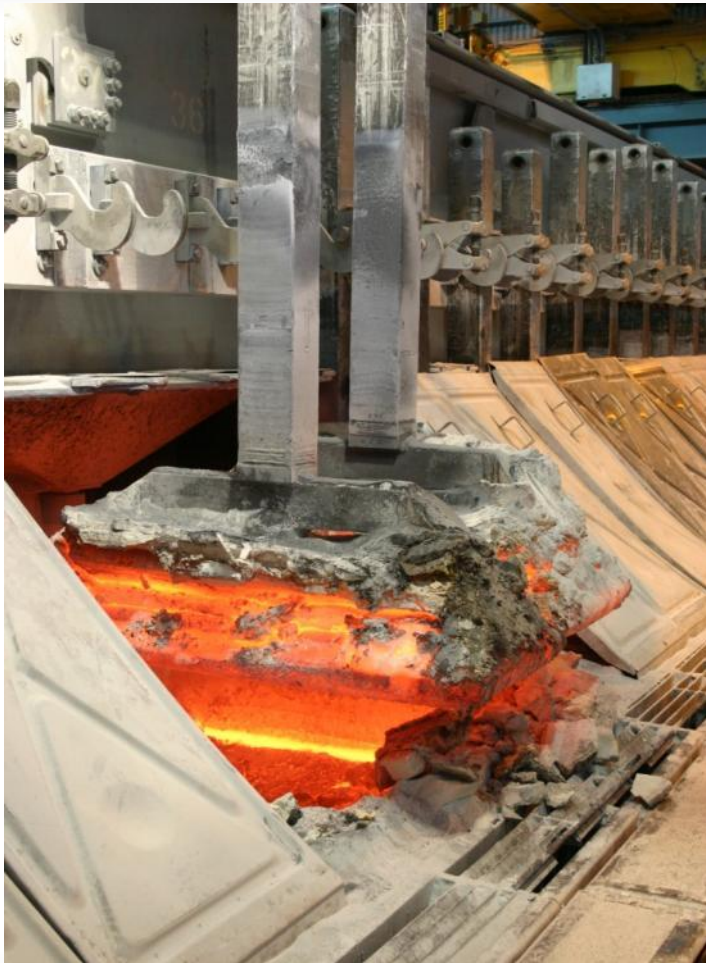
Results of anode setting leveling

- Since 1998 , follow-up shift by shift., per team, per operator and in real time
- To make sure that all respect the rule of not more than 4 anode settings per hour.

Peak HF concentration >15ppb (ambient station in trees decline area)

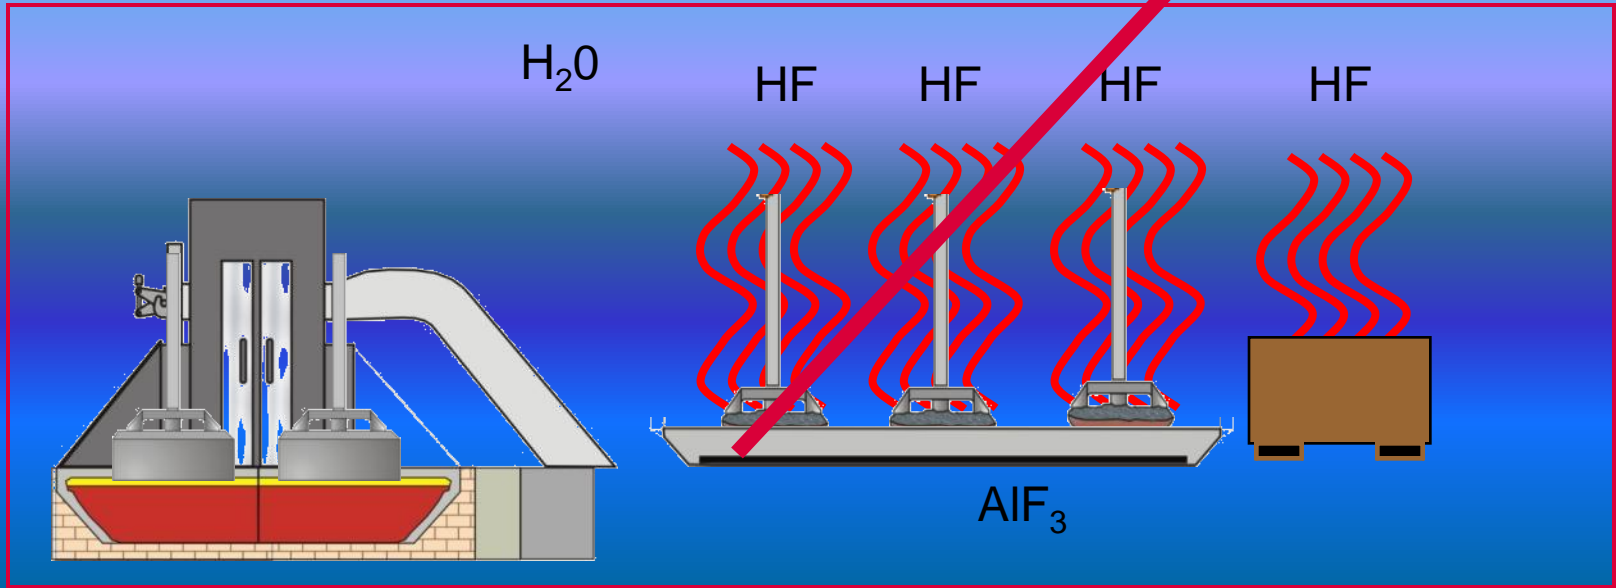
**HF emitted in the Potrooms .
The importance of the anode tray is:
80% emissions occur in first 20 minutes**

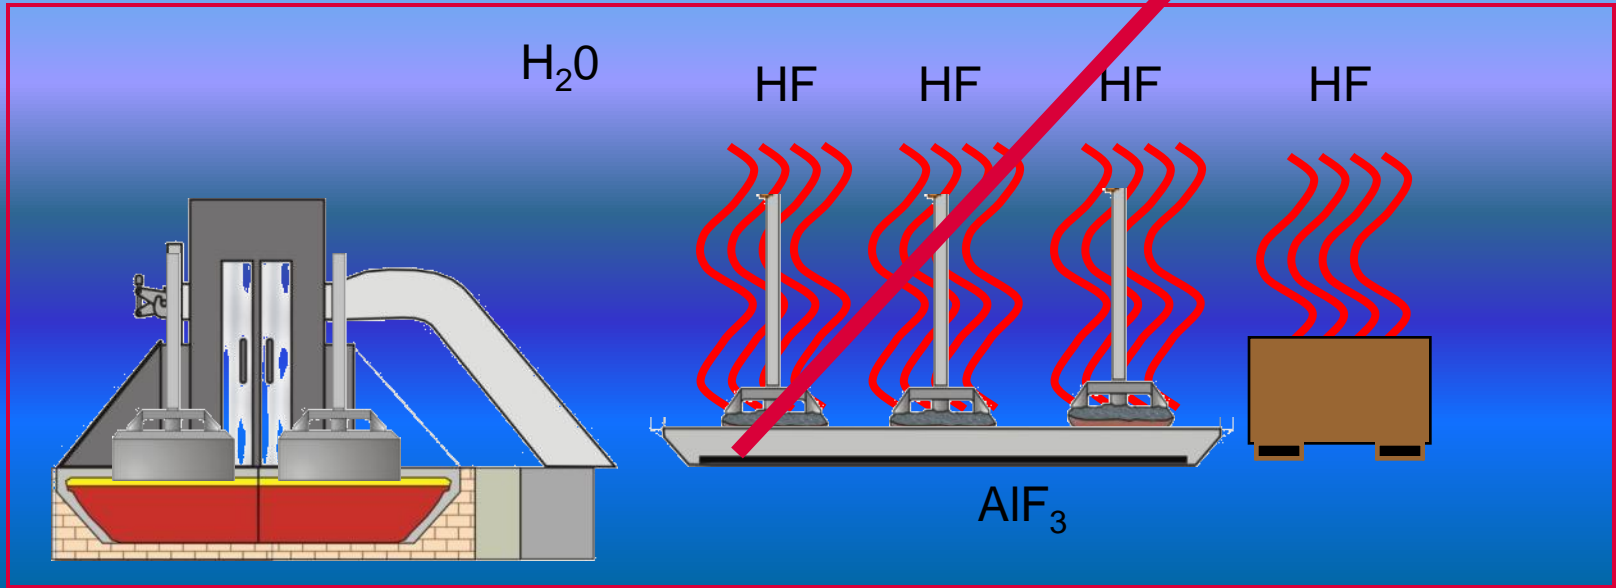
**HF emitted in the Potrooms .
The importance of the anode tray is:
80% emissions occur in first 20 minutes**

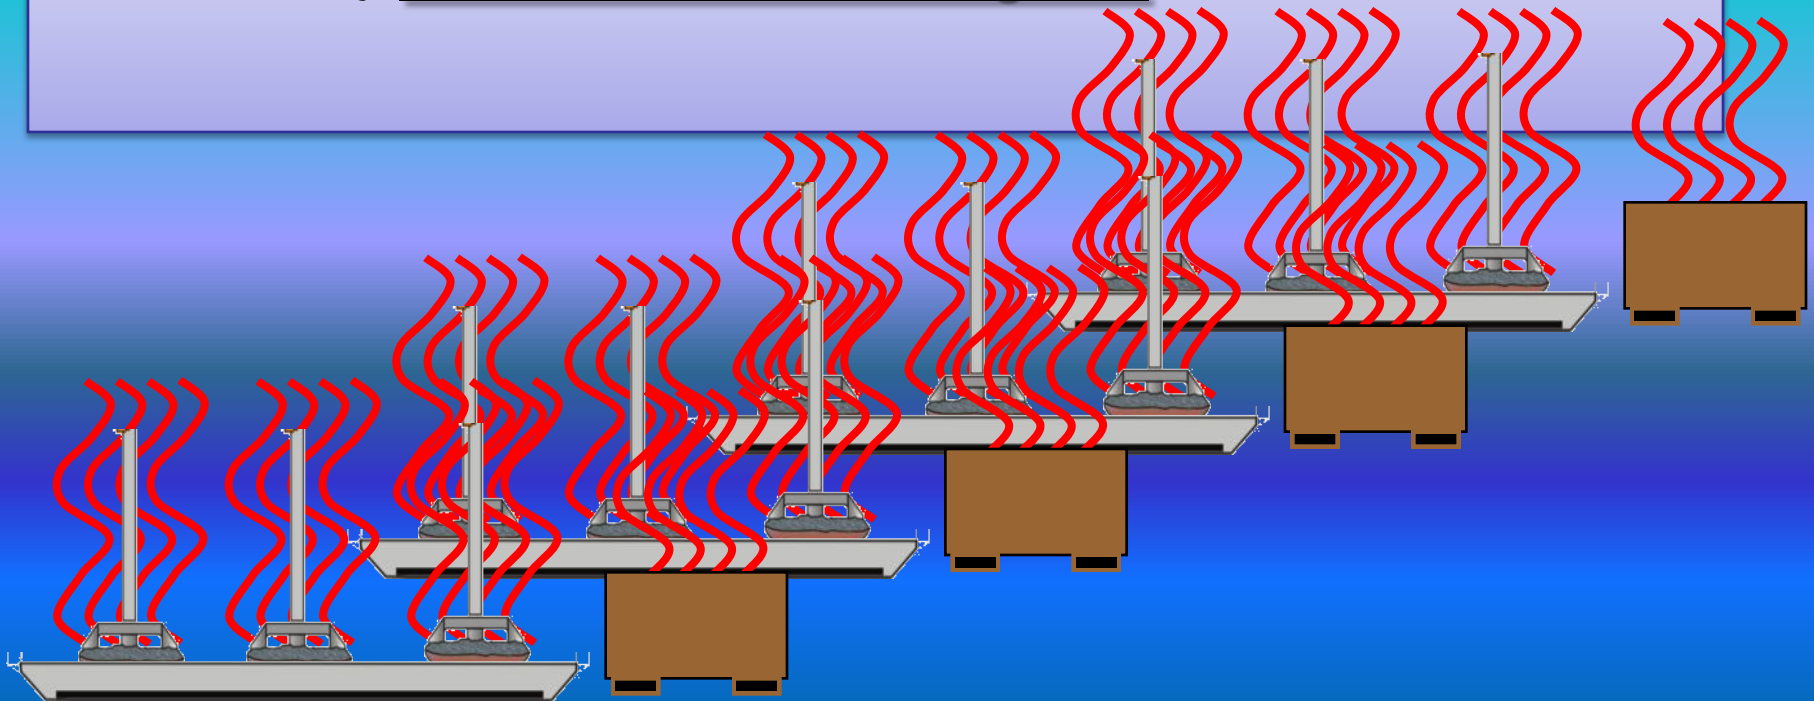
Butt cooling area... Major cause of tree damage

To make a step change reduction for fluoride emitted by roof fans at butt cooling area

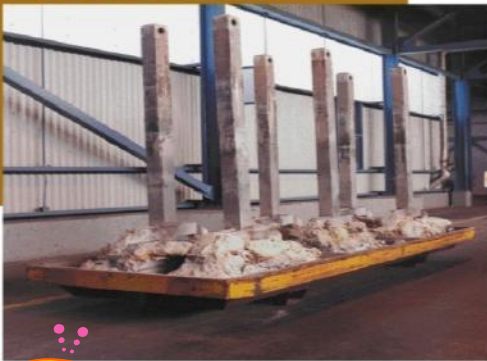
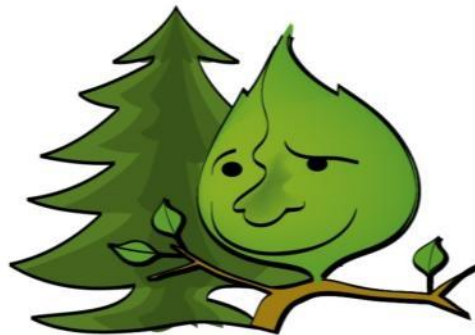
Passé / Before

Bath Processing (cooling process)

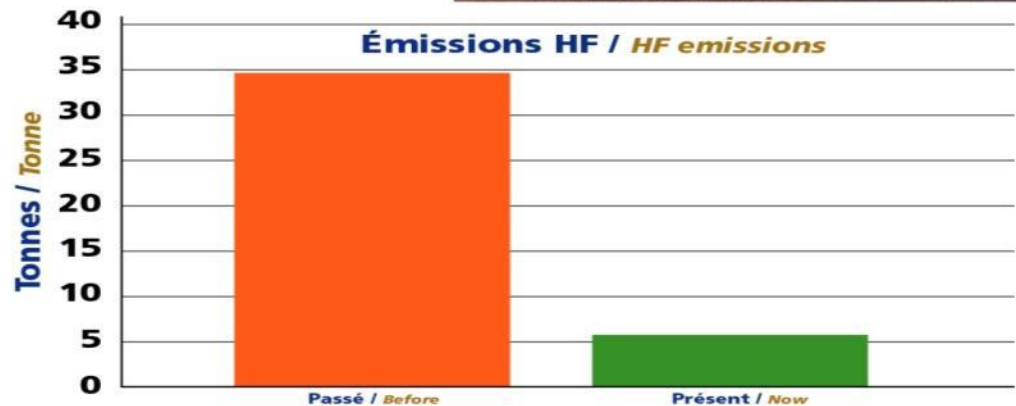
Results at cooling area... 80% reduction HF at roof fan

80 %

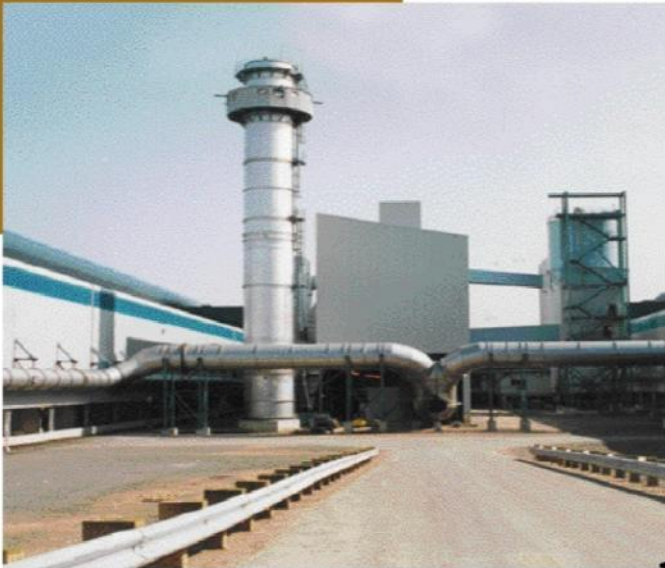
Passé / Before

Pot Ventilation Increase

Ventilation flow 2.1 Nm³/sec

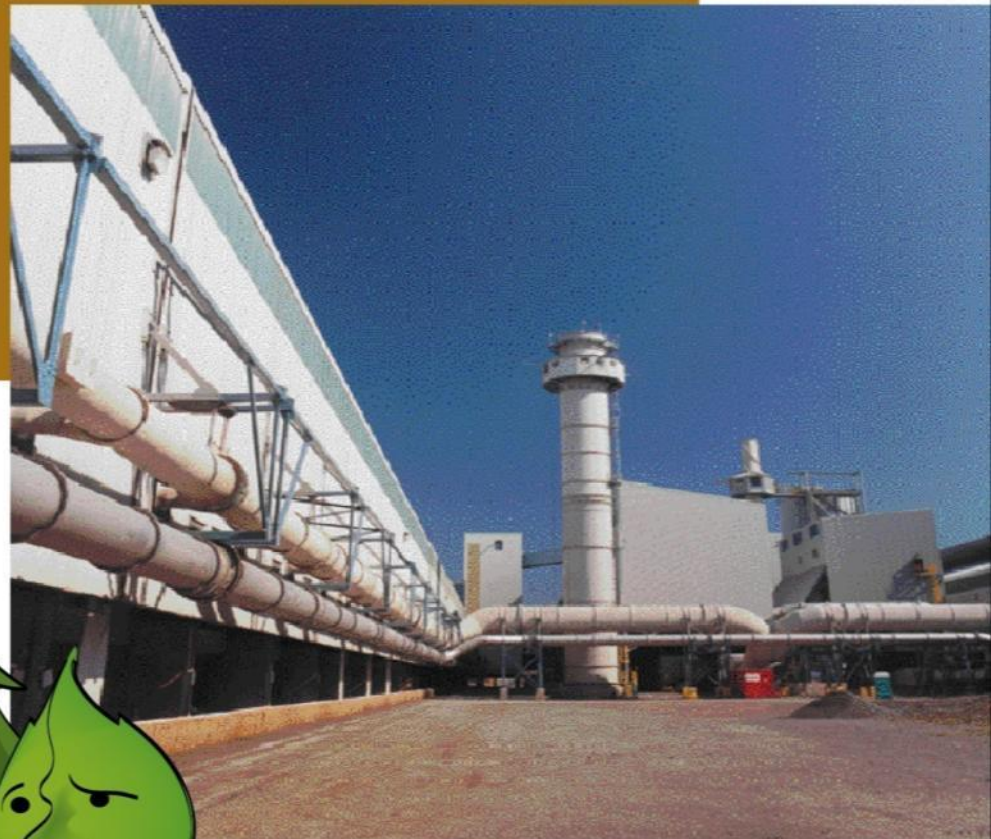
Présent / Now

Increase ventilation at each pot... A new network ducting with new CTG

Ventilation flow 2.4 Nm³/sec

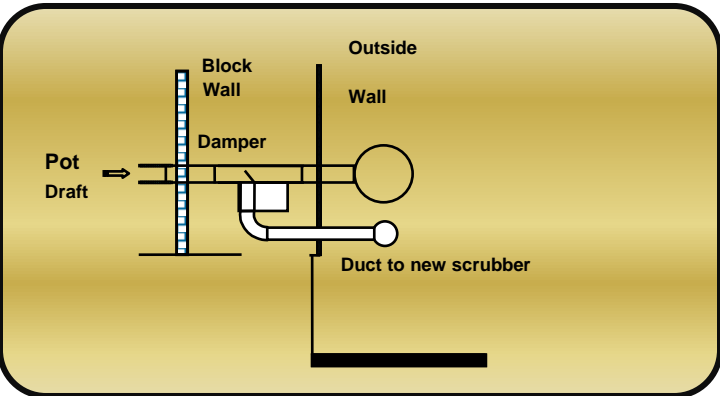
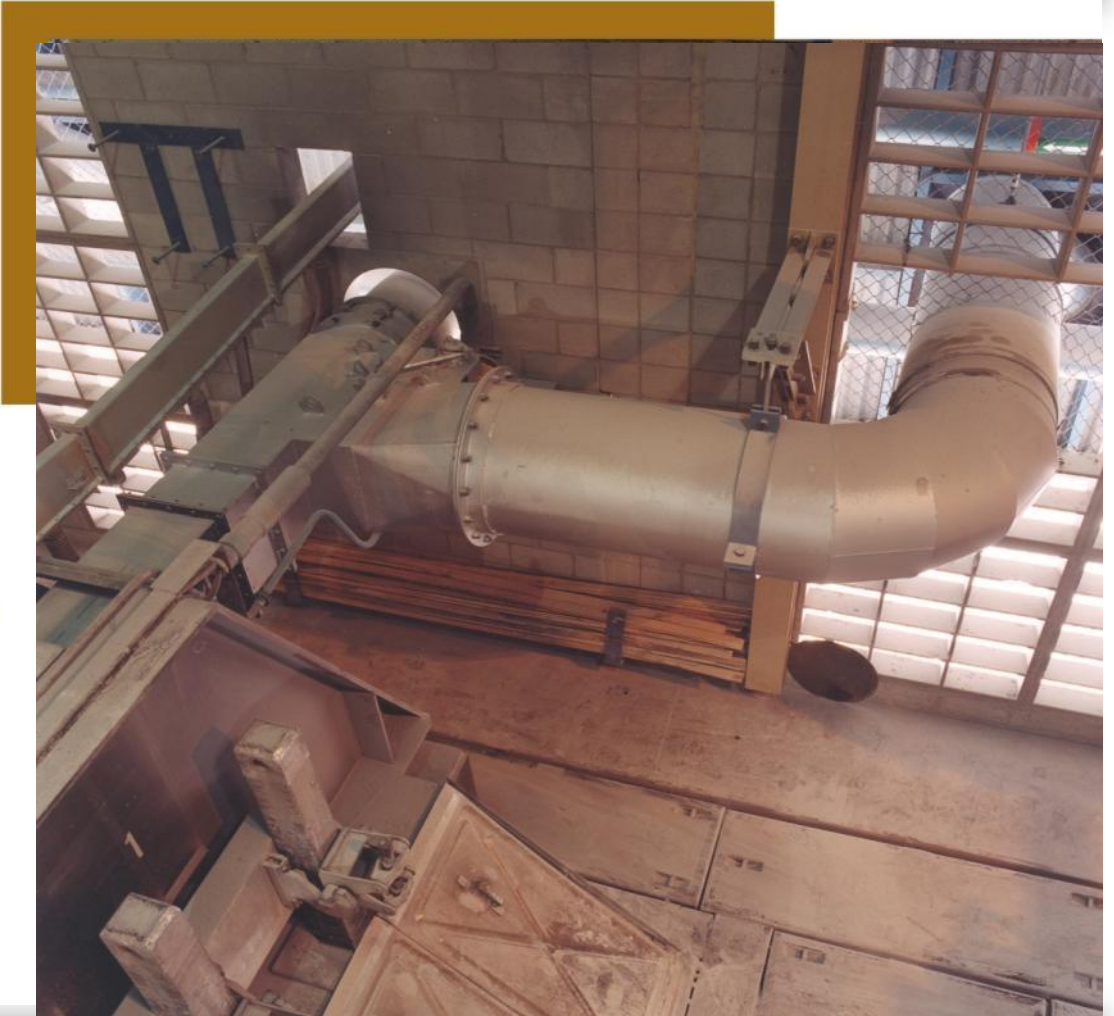
High draft mode.... Installation diverter valve for each pot

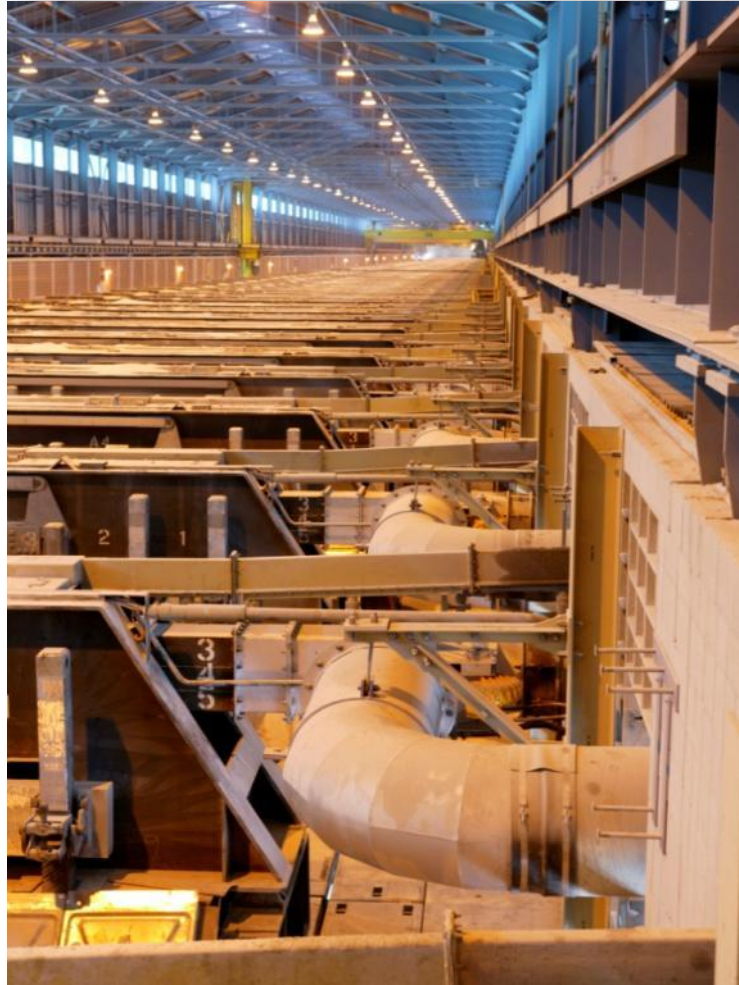
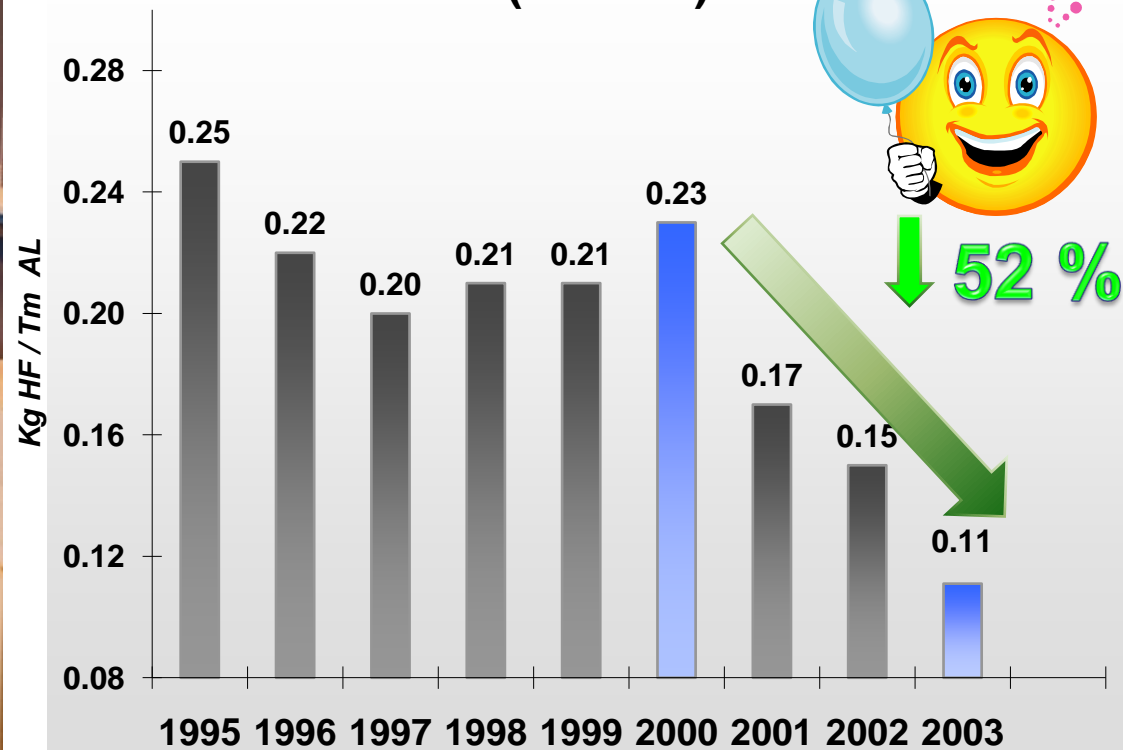
HF at roof vents (Potline)

Results : Upgrade Ventilation Project...

52 % HF reduction

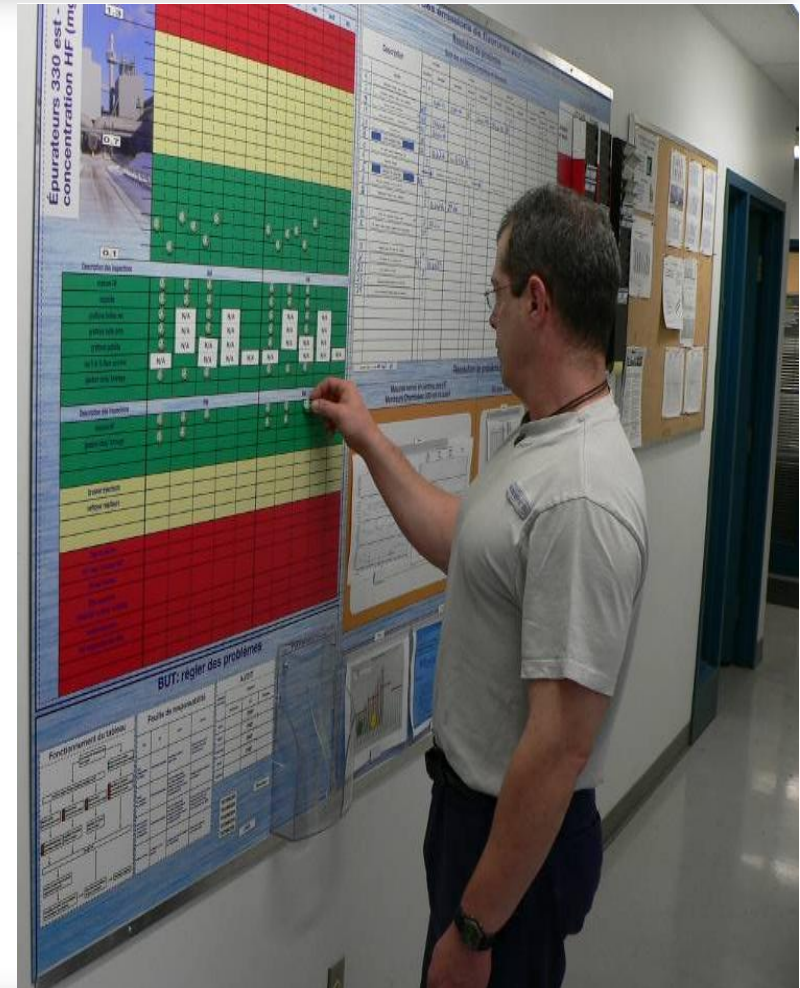
2003 : New visual board For best efficiency at pot-line scrubber

- ✓ Rapid problem identification
- ✓ Leveling of actions
- ✓ Establish action plan for yellow and red zones
- ✓ Ensure and clarify “Job to do “
- ✓ Easy monitoring
- ✓ Development of new tools directly in the field

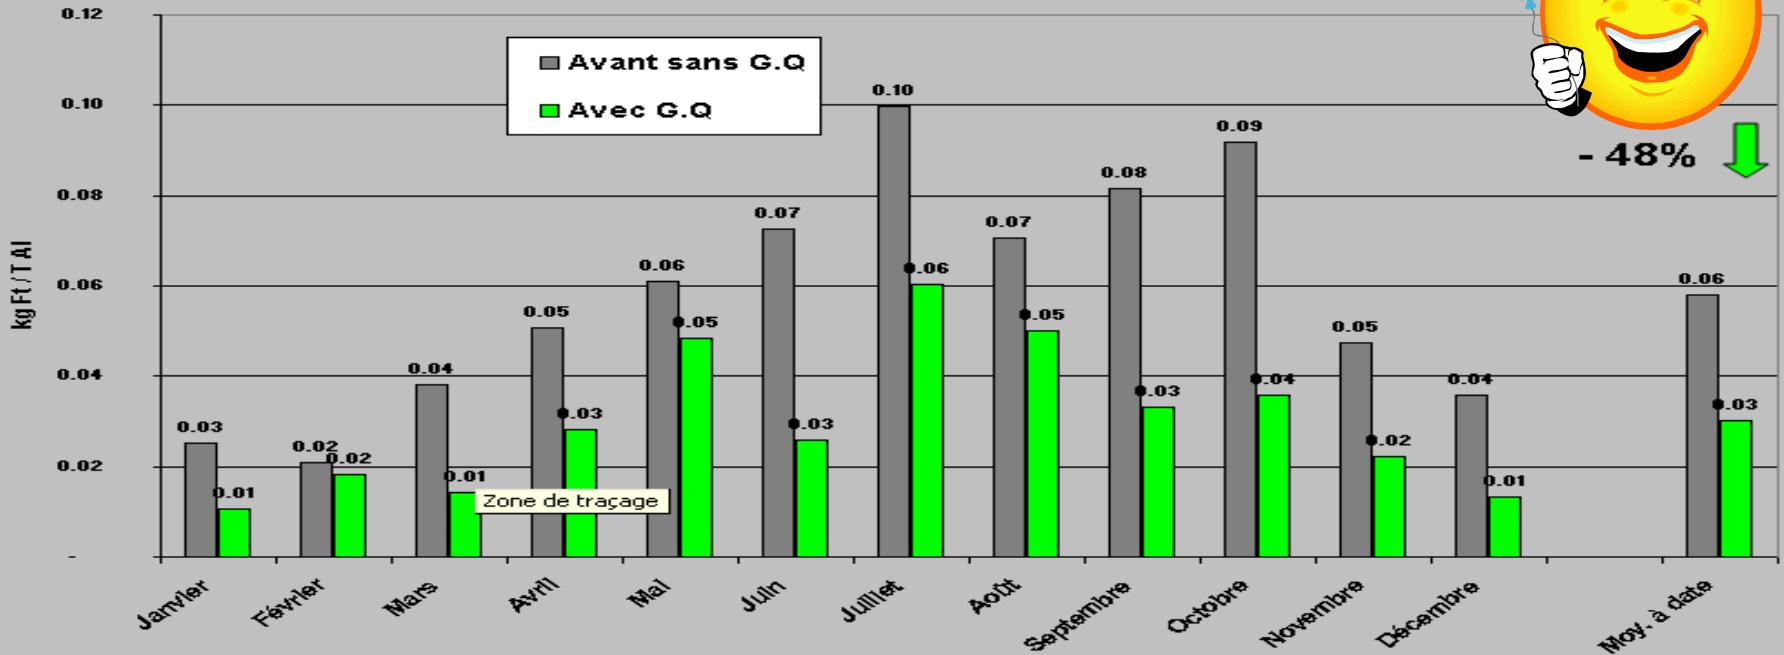
Émissions de FT depuis 2003 des CTG 330
et comparaison depuis l'établissement de G.Q. en septembre 2005

Impressive efficiency at scrubbers

Average: 0.02 kg FT / MT Al outlet stack

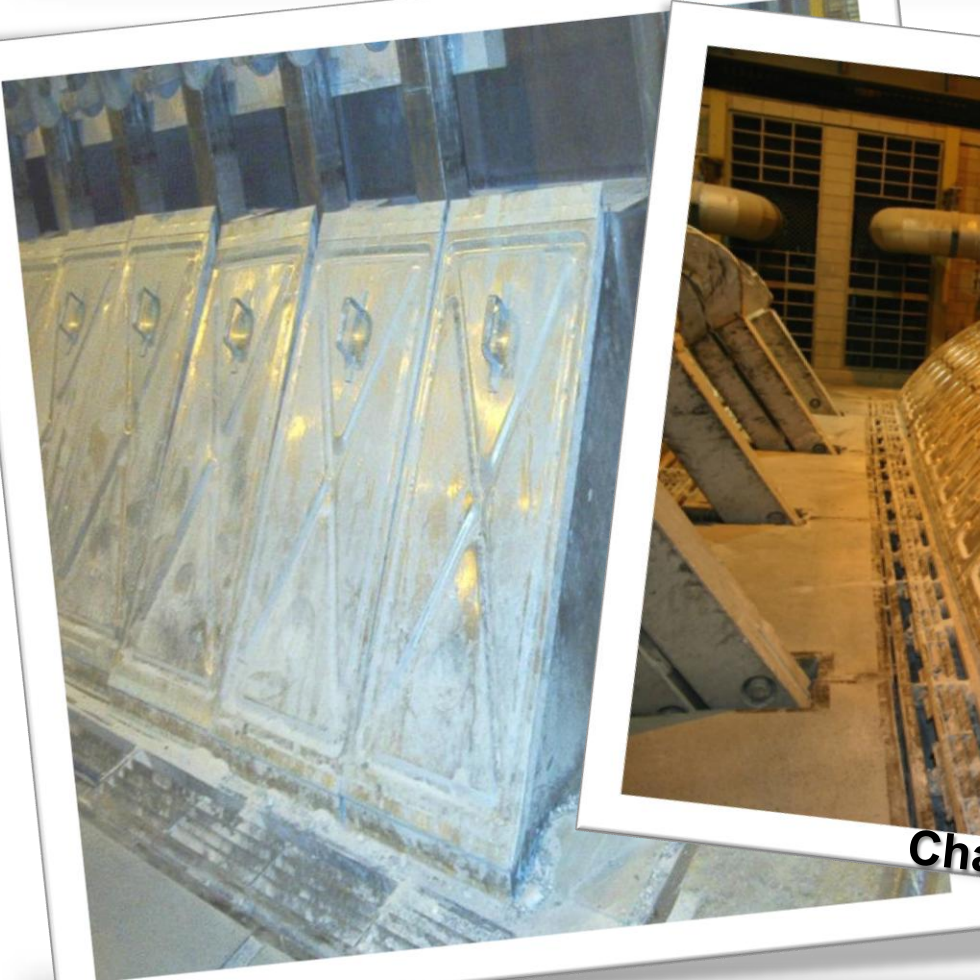
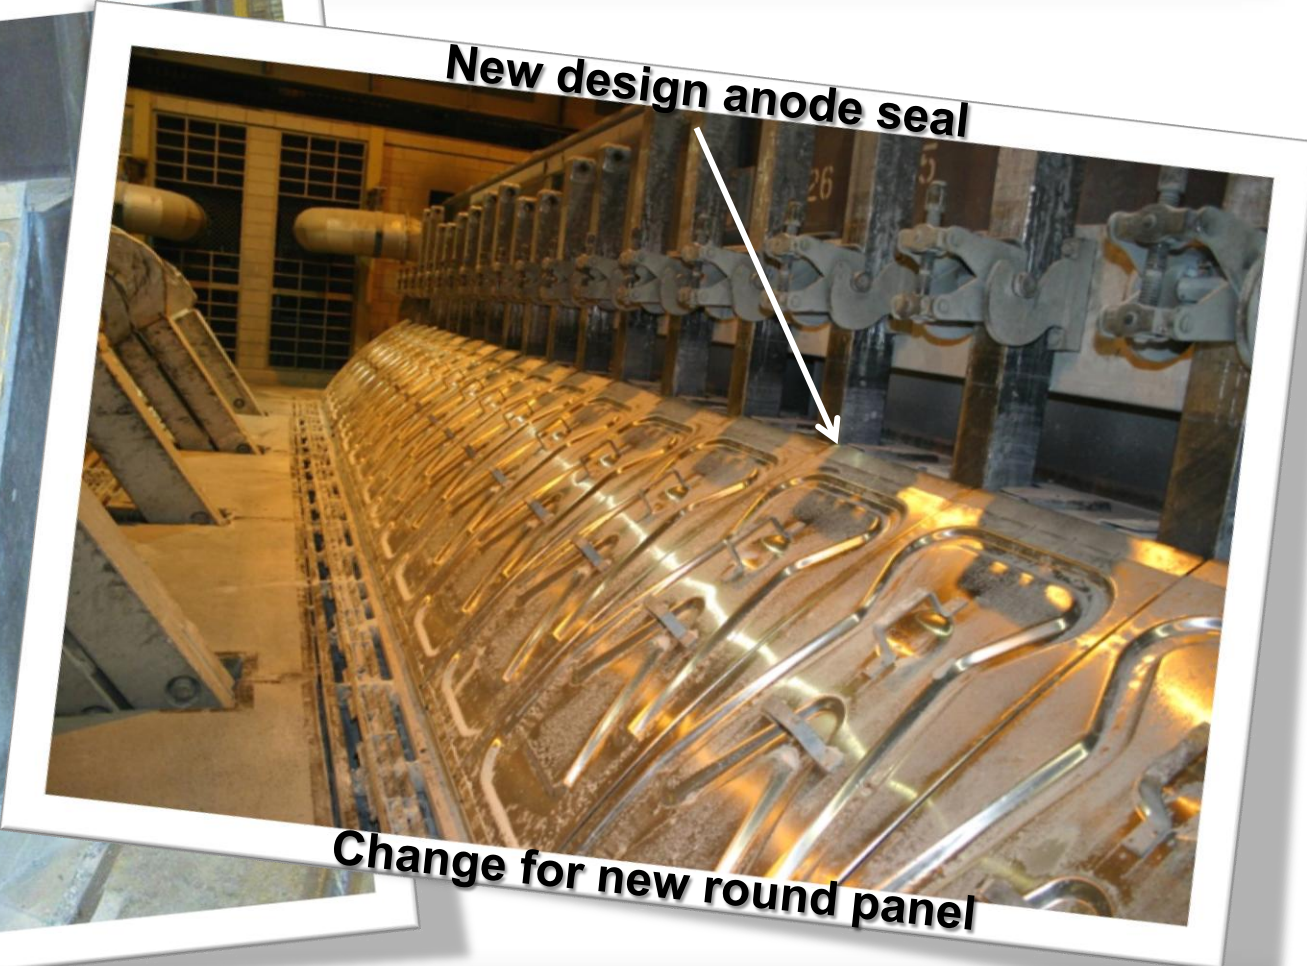
New pot hood design improved the robustness

2004 : Hood, anode seal, and pot triangle ...

All components that have an impact on fluoride emissions were improved

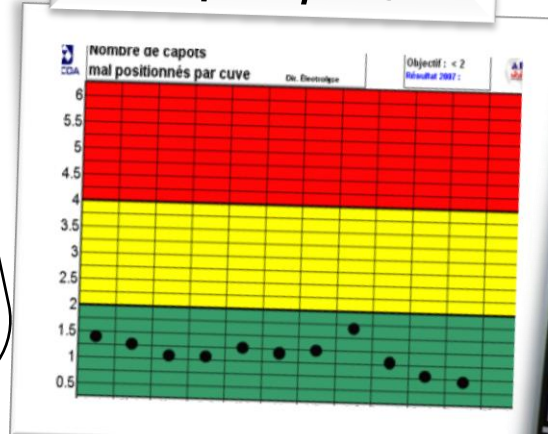
Bimestriel audit
Misplaced panels

Clear rules – misplaced panels

- La règle de mesure s'insère dans l'espace entre 2 capots pour plus de la moitié de la hauteur du capot (réf.: poignée horizontale). (photos 3 et 4)
- La règle de mesure s'insère dans l'espace entre la tablette et le capot pour plus de la moitié de la largeur du capot (réf.: poignée verticale). (photo 5)

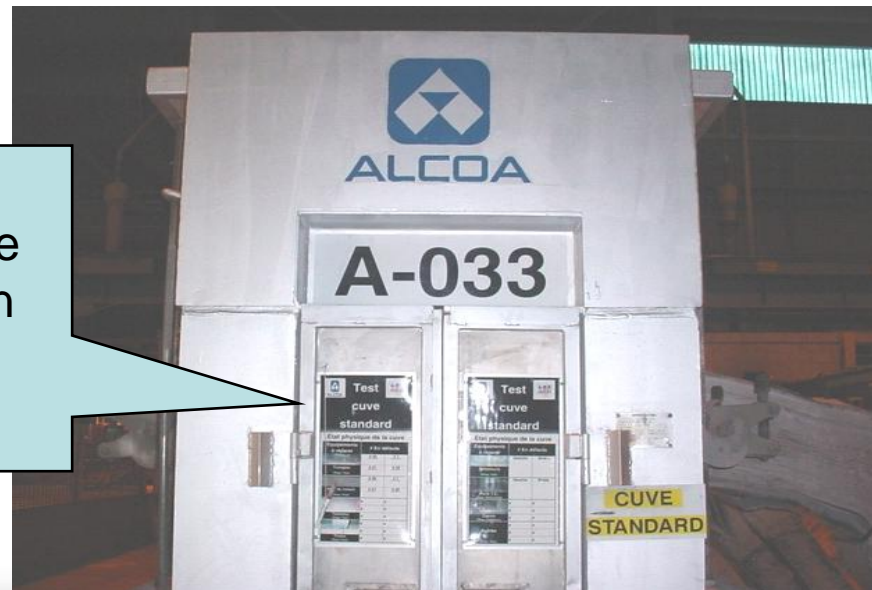
- Anode seal, pot triangle, tapping door ...all components that have an impact on fluoride emissions are recorded and repaired
- A new vision was implemented ...just-in-time principle on these components

When a pot seal component needs to be replaced it is written on the pot's visual board.
