Effects of Long-Time Exposure in Alloy 625 at

1200°F, 1400°F and 1600°F

John F. Radavich and Andrea Fort

School of Materials Engineering, Purdue University, W. Lafayette, IN 47907

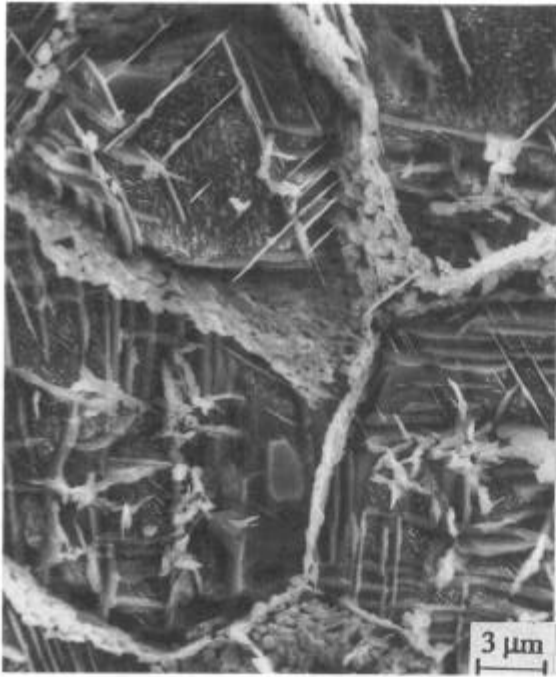
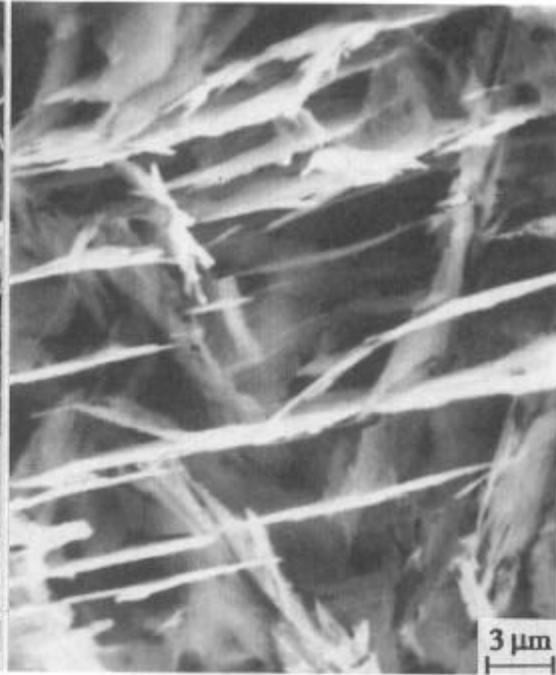
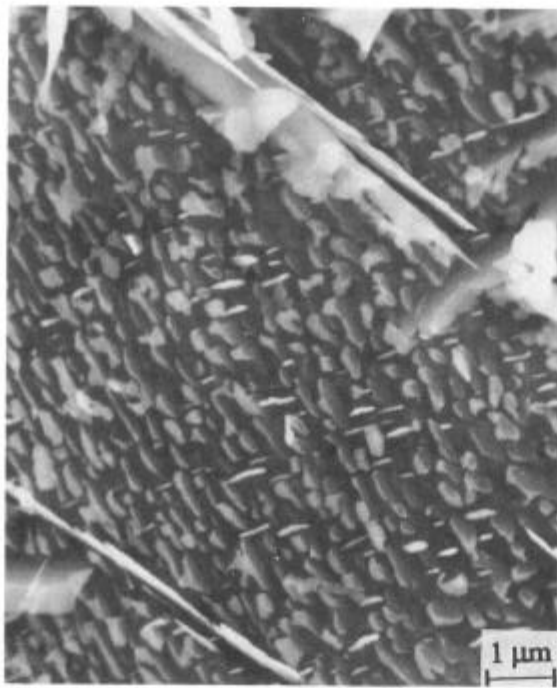
Fig. 5 Extraction Sample
1200°F/46000h

When the 46,000 hour sample which was used for extraction of phases was evaluated on the SEM, the grain boundary phase appeared to be continuous, delta plates were large and extensive, and the γ' phase was still heavily precipitated in the grains, Figure 5.

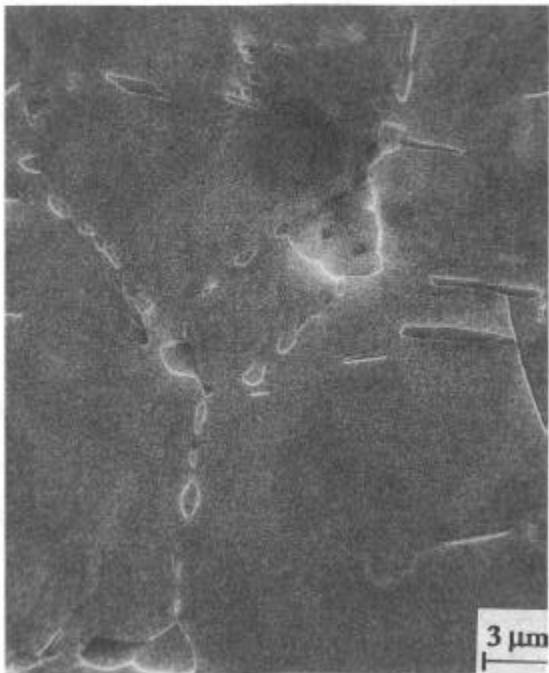
Fig. 8. As Electropolished
Only - 46000h.

It appears that the microstructures developed in longtime exposures of alloy 625 at 1200°F are similar to some of those found in alloy 718 in longtime exposures at 1300°F and 1400°F, namely Ni_3Cb , γ' , and α Cr [4]. Unlike alloy 718, alloy 625 does not form sigma or γ because of the low Fe and Al + Ti contents but forms M_6C due to its high Mo content. In alloy 625 the γ' and α Cr phases found at 1200°F are not found at 1400°F and 1600°F. In addition to X-ray identification the absence of α Cr at 1400°F and 1600°F was verified by only electropolishing the 46,000 hour exposed samples. The α Cr phase is brought into relief and is easily seen in the SEM examination. Figure 8 shows the α Cr phase to be present only in the 1200°F exposed sample.
