Laser Powder Bed Fabrication of Nickel-Base Superalloys: Influence of Parameters; Characterisation, Quantification and Mitigation of Cracking

Luke N. Carter¹, Moataz M. Attallah¹, Roger C. Reed¹

¹School of Metallurgy and Materials, University of Birmingham, Edgbaston, Birmingham, B15 2TT, UK.

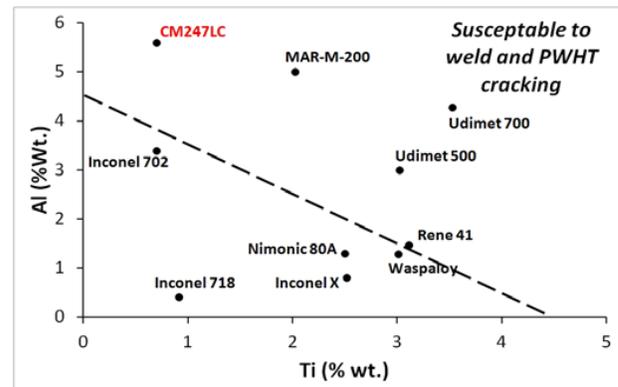
Figure 1. Plot showing increasing cracking susceptibility with γ' forming elements (Al and Ti) [5]. Alloys lying above the dotted line are particularly susceptible to cracking during welding or PWHT.

Laser fabrication process can be considered analogous to a continuous laser welding process. Due to this, an alloy weldability can be used as an indication as to its processability by SLM. Figure 1 [5] shows a number of typical Ni-based superalloys plotted according to their Al and Ti contents (γ' forming elements). The alloys lying above the dotted line show a high volume fraction of the γ' phase and are typically considered unweldable due to their cracking susceptibility. This relationship between the cracking susceptibility and γ' fraction is attributed to the precipitation hardening that occurs within the aging temperature of the alloy; reheating the material to within this region (either in the welding process or as part of a post-weld heat treatment (PWHT)) results in hardening accompanied by a reduction in ductility leaving the material prone to cracking [5]. A review of the relevant literature highlighted four potential cracking mechanisms associated with welding and reheating of Ni-based superalloys, which are:

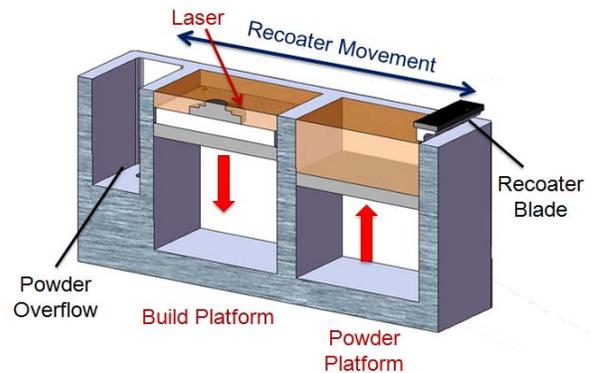
Figure 2. Schematic representation of the Concept Laser M2 Powder Bed Laser Cusing[®] facility. Each subsequent layer of powder is spread over the build area by the movement of the recoater blade and then selectively melted using the computer controlled laser.

All SLM fabricated samples were processed using the ‘Concept Laser M2 Cusing Laser Powder-Bed’ system located in the School of Metallurgy and Materials at the University of Birmingham. The M2 system has a maximum build area of 250 mm \times 250 mm and a maximum build height of 300 mm. The M2 facility is typical of a SLM powder-bed system, as shown schematically in Figure 2. A sequence of operation can be found elsewhere [1].

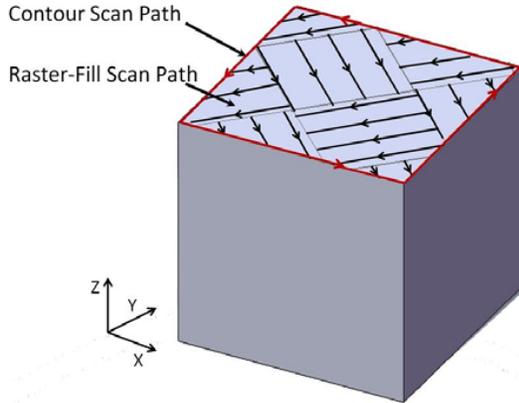
Figure 3. Schematic representation of the laser scanning regime for each layer; The raster filled area is scanned in 5 mm × 5 mm 'islands', this 'chess-board' pattern moves by 1 mm in both X and Y with each layer. The contour is scanned following the raster fill.

A scan regime was selected to best represent how the machine would be operated in a manufacturing situation. Under this regime, the filled area to be raster scanned is divided into small squares or ‘islands’. Within each island, the laser spot is scanned in a single direction, but perpendicular to the direction of the laser scan within the islands lying next to it. These islands are selectively melted in a random order in an attempt to evenly distribute the heating, and so reduce the residual stresses. Following the selective melting of the islands, the laser is scanned around the outer-contour of the slice to refine the surface finish of the fabricated part; Figure 3. For each subsequent layer, the pattern of islands (often referred to as the ‘chessboard’) is moved by 1 mm in both the X and Y directions thus varying the scan directions over the build height. This differs to the more conventional scan regimes where the entire slice is subject to a uniform or ‘cross-hatching’ scan pattern [42].

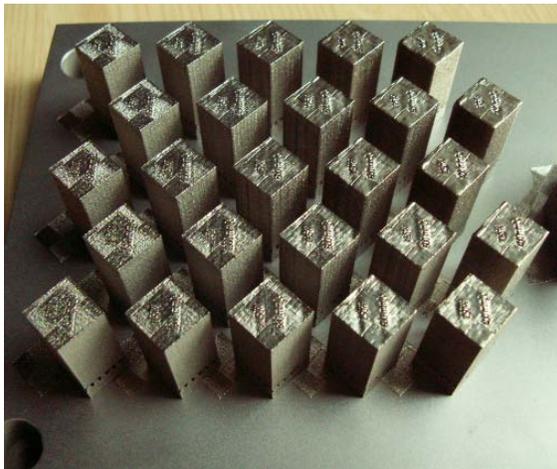
Figure 4. Photograph of matrix of blocks processed with varying scan speeds and laser powers

Figure 4 shows this array in the as fabricated condition still attached to the build plate. Following the examination and quantification of the cracks further samples were fabricated varying the scan spacing (h) in the raster fill area whilst keeping laser power and scan speed constant. This was carried out to investigate the effect of scan spacing on the void style of volumetric defects in the low-power samples.

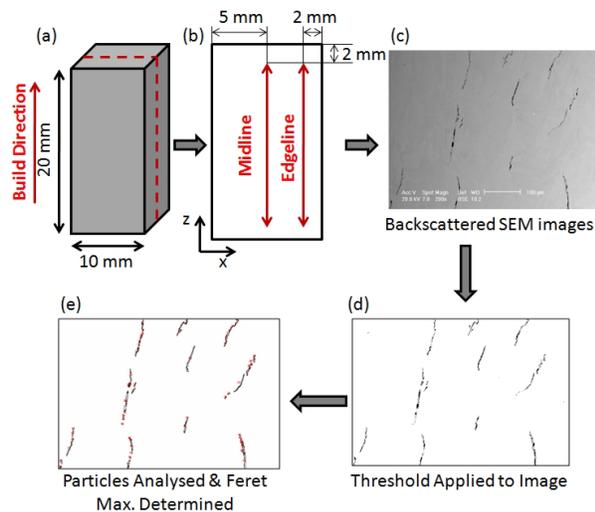
Figure 5. Schematic representation of sampling and analysis method: (a) blocks were sectioned longitudinally (parallel to build direction); (b) 30 images taken along midline and edgeline at 500 μ m intervals; (c) following standard grinding and polishing, low magnification BSe SEM images reveal cracks; (d) threshold applied to image to isolate cracks; and (e) image analysis carried out to determine feret max. of each crack segment

Figure 5 illustrates the preparation sequence and image analysis steps used to quantify the cracking density within each sample. The cuboidal samples were sectioned parallel to the build direction revealing the X-Z plane to be examined (Figure 5(a)). The samples were then mounted and polished to a 0.05 μ m oxide finish. Specimens were examined using a Phillips XL-30 (LaB6 source) operated at 20 kV for imaging. Further SEM investigations were performed using a JEOL-7000 Field Emission Gun (FEG)-SEM, equipped with an Oxford INCA electron backscattered diffraction (EBSD) detector, and INCA Crystal software for EBSD acquisition and analysis.

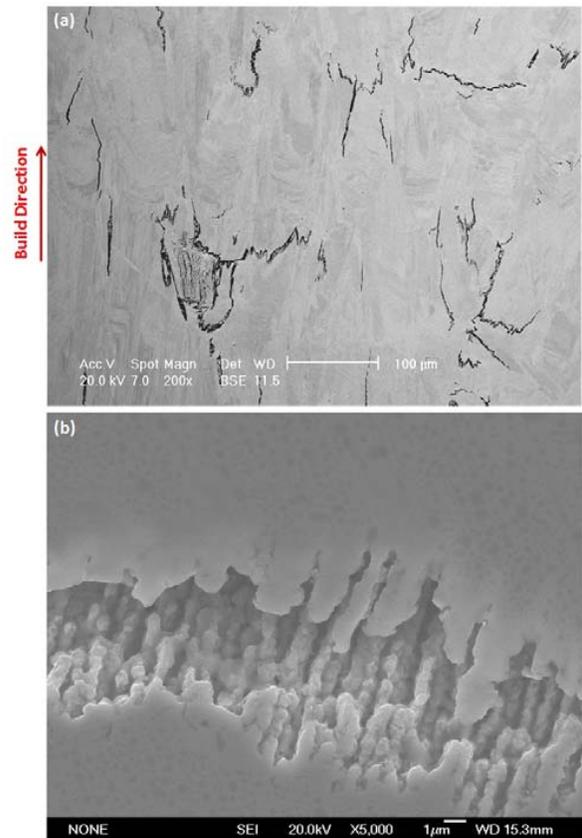
Figure 6. Micrographs showing crack detail in a 'high-energy' build (P2; 1.5v), (a) the dominance of the 'jagged' cracks which show little directionality with respect to the direction of grain growth (build direction). (b) a higher magnification image of a typical 'jagged' crack; note the dendritic growth from either side suggesting the crack has opened during a semi-liquid state typical of a solidification crack.

Micrographs taken from a typical 'high-energy' build (P2; 1.5v) are presented in Figure 6. Figure 6(a) shows a low magnification BSe SEM micrograph from the set used to quantify the cracks within the sample; there is a distinct dominance of a 'jagged' cracking morphology. The build direction also relates to the direction of grain elongation as it is characteristically aligned with

the flow of heat during the laser fabrication process [30]; conversely the cracks observed here move both longitudinally and transversely to this. Figure 6(b) shows a high magnification micrograph of a typical 'jagged' crack; both of the crack walls show clearly protruding dendritic structures. This is consistent with the formation of solidification cracks as discussed in the introduction.

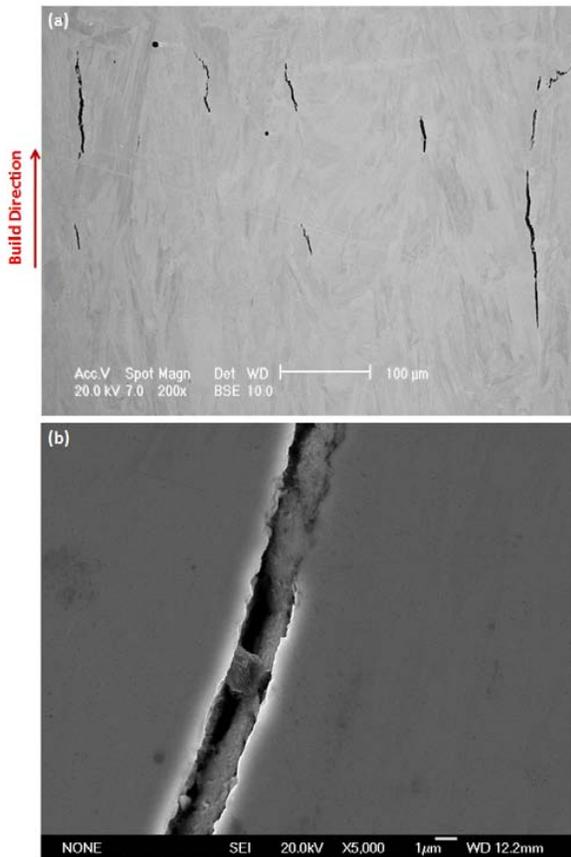
Figure 7. Micrographs showing crack detail in a 'low-energy' build (P1; 2.5v). (a) the dominance of the grain-boundary crack lying dominantly in the build direction. (b) a higher magnification image of a typical grain-boundary crack; note the clean edges indicating that the crack formed in the solid state.

Micrographs showing the cracks observed within a typical 'low-energy' (P1; 2.5v) build are presented in Figure 7. Figure 7(a) shows a typical low magnification BSe SEM micrograph from the set used for crack quantification. These cracks show some key differences compared to those observed in the high-energy fabricated samples. There is a clear directionality with the cracks being aligned almost exclusively in the build direction and consequently the direction of grain elongation. Structurally, they appear to be much cleaner and straighter. The high magnification micrograph shown in Figure 7 (b) shows clean smooth crack walls suggesting that the crack was formed during the solid state.

Based on the observations that the cracks shown in Figure 7 and Figure 8 have been formed in the solid state and lie at the grain boundaries, three potential cracking mechanisms can be suggested for their formation: Liquation cracking, SAC and DDC. The BSE micrographs have shown no evidence of liquation phases at the grain boundaries and their straight clean character suggests that liquation is not the primary cause of the cracking. The fine carbides observed on the boundaries indicate the possibility of DDC by either of the suggested mechanisms in the literature [18, 20]. At this stage in the investigation however, none of the three mechanisms can be entirely eliminated nor proven; further investigations have been planned in order to establish the primary mechanism or combined mechanisms responsible for these grain boundary cracks.

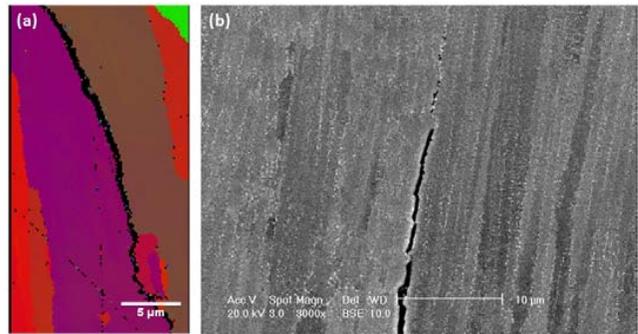
Figure 8. Grain-boundary crack detail: (a) a typical EBSD map of a grain-boundary crack observed in the as-fabricated material. (b) a backscattered SEM micrograph of a similar crack in high magnification; note the fine elongated grains and the particular carbide precipitates along the boundaries including the crack boundary.

Electron backscattered diffraction (EBSD) mapping of the 'low-energy' build cracks (Figure 8(a)) showed that the cracks typically

lie on grain boundaries. This is supported by the high magnification micrograph in Figure 8(b) showing the crack lying along a line of fine particles, most likely grain boundary carbides.

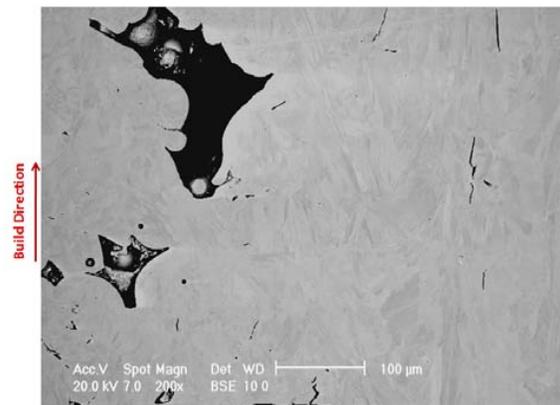
Figure 9. BSe SEM micrograph showing the onset of void formation occurring during a 'very low-energy' build (P1; 3.75v). This is likely to be caused by a smaller melt pool during processing resulting in incomplete consolidation.

The final processing region observed occurs under 'very low-energy' (P1; 3.75v) processing conditions and represents the failure of the process to fully consolidate the powder. The micrograph shown in Figure 9 shows clearly this onset of 'void formation' caused by the shrunken melt-pool under the low-energy conditions.

The increase in crack density indicated on the plot in Figure 10 relates to void formation (as seen in Figure 9) and does not represent an increase in the cracking level but a limitation of the image analysis method used. The onset of void formation is due to the shrinking of the melt pool under 'very low-energy' conditions, as previously discussed. It was observed however that other than the presence of voids, the amount of cracking in this sample appeared to be relatively low (Figure 9). Therefore, in an attempt to eliminate the voids, the scan spacing (h) was reduced in order to compensate for the shrinking of the melt pool. This scan space reduction was carried out for the laser power and scan speed that initially displayed voids (P1; 3.75v) and also for a second parameter set of a greater laser power and faster scan speed (P3; 5v) in order to see the effect of this scan spacing reduction under conditions where the material had fully consolidated.

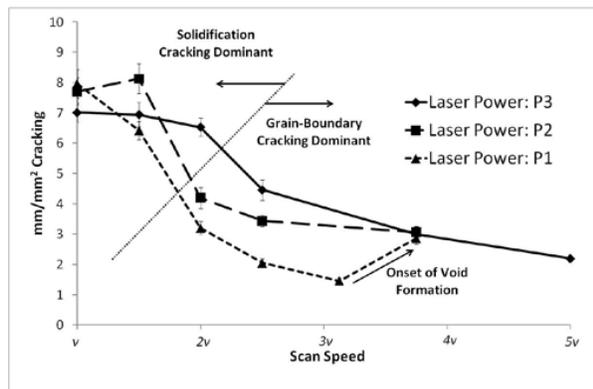
Figure 10. Plot showing the variation of cracking with laser scan speed and power for sample midlines. Arrows indicate the conditions where each of the cracking types is dominant. Note the increase in cracking of the P1 line caused by the onset of void formation

The cracking quantification results obtained for the midline of the SLM samples are presented in Figure 10. The plots show the variation of cracking with laser scan speed for three different laser powers. All three laser powers show a distinctive drop in cracking level occurring at either the 2v or 2.5v scan speeds; this boundary is represented by the dotted line. When these results are compared against the microstructural observations, it can be seen that the drop in recorded cracking levels coincides with the change in the dominant cracking type; the high-power conditions resulting in solidification cracking and the lower-power conditions resulting in grain-boundary cracking as indicated in Figure 10.

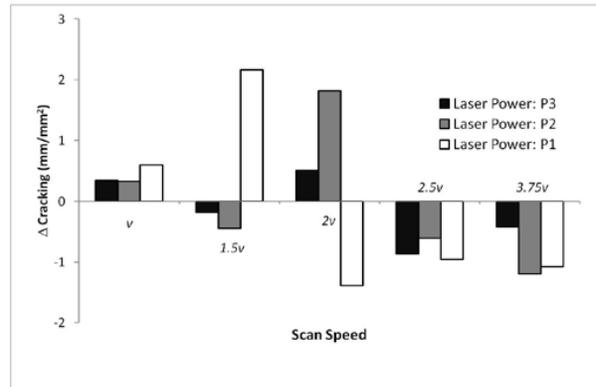
Figure 11. Plot showing Δ Cracking (Edgeline Cracking - Midline Cracking values) for complete data sets. The lower energy builds (faster scan speeds) show a clear concentration of the grain-boundary cracking grouped in the middle of the sample.

Figure 11 shows the difference in cracking levels between the edgeline of the sample and the midline of the sample for increasing laser scan speeds and three different power levels. These results represent the observed variation in cracking levels across the sample. Under the slower scan speeds, there appears to be no clear trend. However, under the faster scan speeds (2.5v and 3.75v), there is a consistently higher cracking level in the middle of the sample when compared to the edge (as represented by the negative values); additionally these processing conditions show a dominance of grain-boundary cracking (as previously discussed). It is clear that the specific thermal history along the midline of the sample therefore leaves it more prone to cracking either due to elevated residual stress or unfavourable heat transfer behaviour.

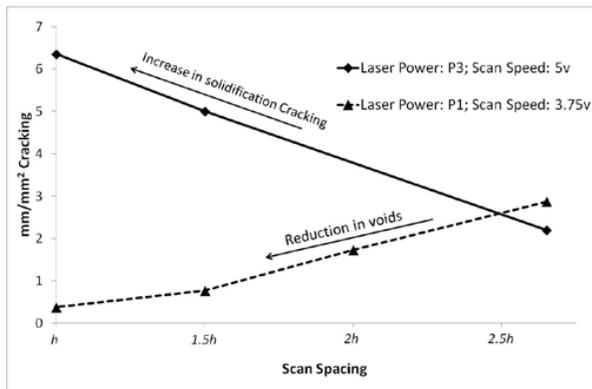
Figure 12. Plot showing the variation of cracking with scan spacing (h). Shows the ability of a reduction in scan spacing to close voids, however in fully dense builds using a higher laser power the instance of solidification cracking appears to be increased with a reduction in scan spacing

The crack quantification results based on the scan spacing reduction are presented in Figure 12. These show that the reduction in scan spacing succeeded in eliminating the voids in the P1; 3.75v parameter set; there were no visible voids for that parameter set in the samples produced at scan spacing of 1.5h and h. However under the higher laser power condition (P3; 5v), the results showed a distinct increase in cracking levels and the micrographs showed an increase in the instances of solidification cracking with the decreasing scan spacing. The exact reason for this remains unknown, however it is suggested that the decreased scan spacing, coupled with the high power, high scan speed conditions produced an effect similar to a 'band' of heat moving slowly across the powder, rather than a rapidly scanning point source which could have facilitated the formation of the solidification cracks.

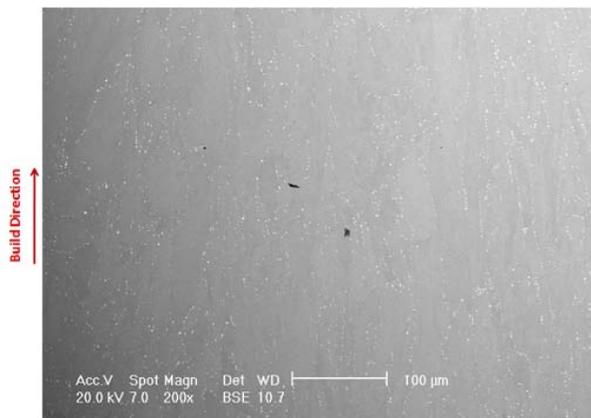
Figure 13. Laser fabricated sample following a post-fabrication HIP treatment. The internal structure appears to be crack free with only some small isolated porosity remaining.

Following the crack quantification to establish a set of processing parameters to produce a cracking minimum, a laser fabricated sample was HIP treated in order to close the internal cracks; The HIP treated sample is shown in Figure 13. The internal cracking appears to have fully closed with only some very small isolated porosity remaining. The HIP treatment has also caused the additional precipitation of particulate carbides along the grain boundaries, which can also be seen in the micrograph. It should be emphasised however that this 'retro-fix' solution to the cracking phenomenon is only effective in closing internal cracks and surface connected cracks remain unaffected.
