Engineering Disasters: Learning from Failure

N. Chawla

School of Materials
Fulton School of Engineering
Arizona State University
Tempe, AZ 85287-8706

TMS Education Resource Awards
November 2007

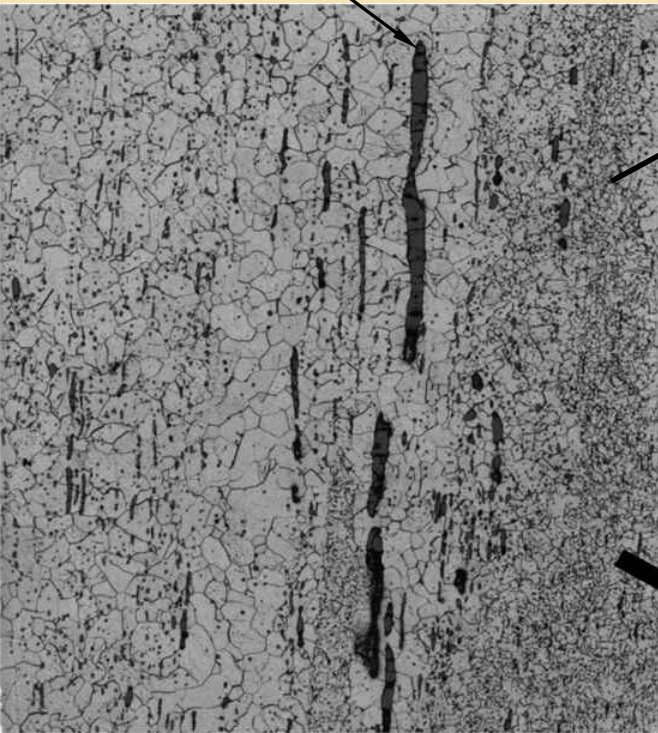
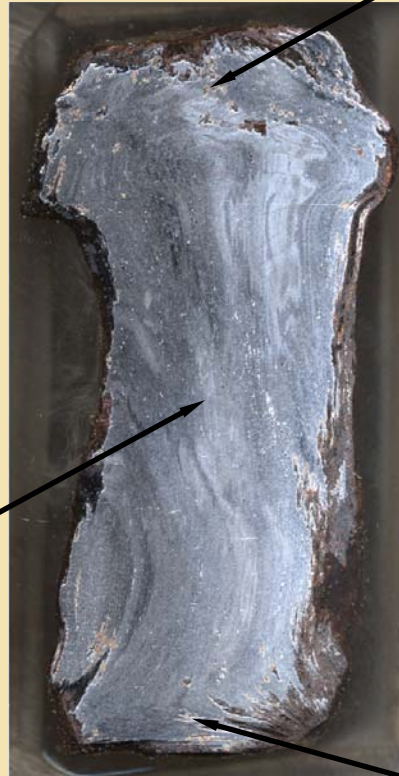
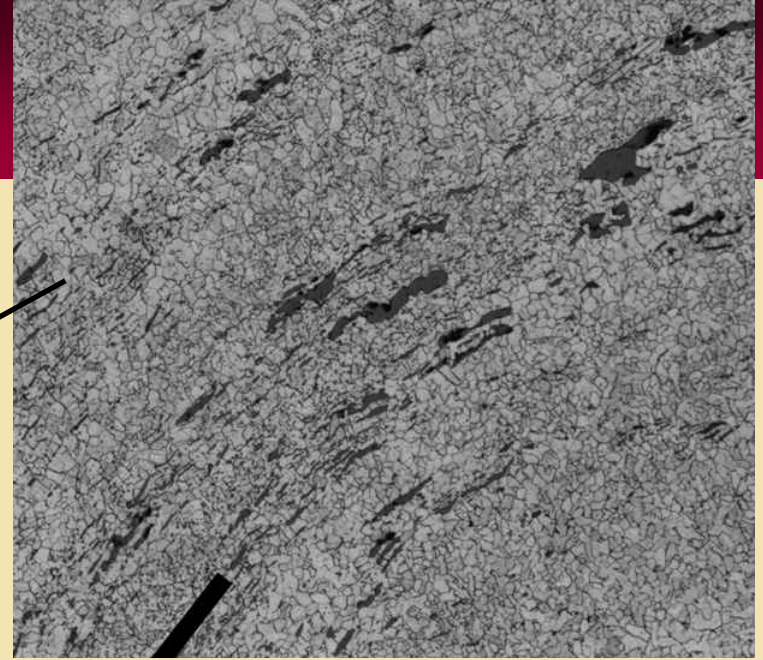
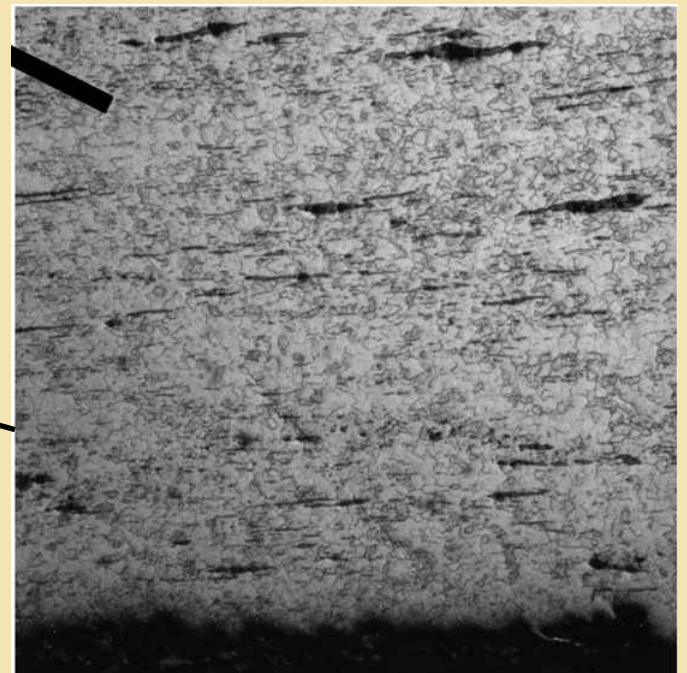
Microstructure of Titanic Rivet

Fe-silicate "stringers"

- Orientation of Fe-silicate stringers is perpendicular to loading axis at the end of the rivet
 - Much lower strength and inferior resistance to crack propagation

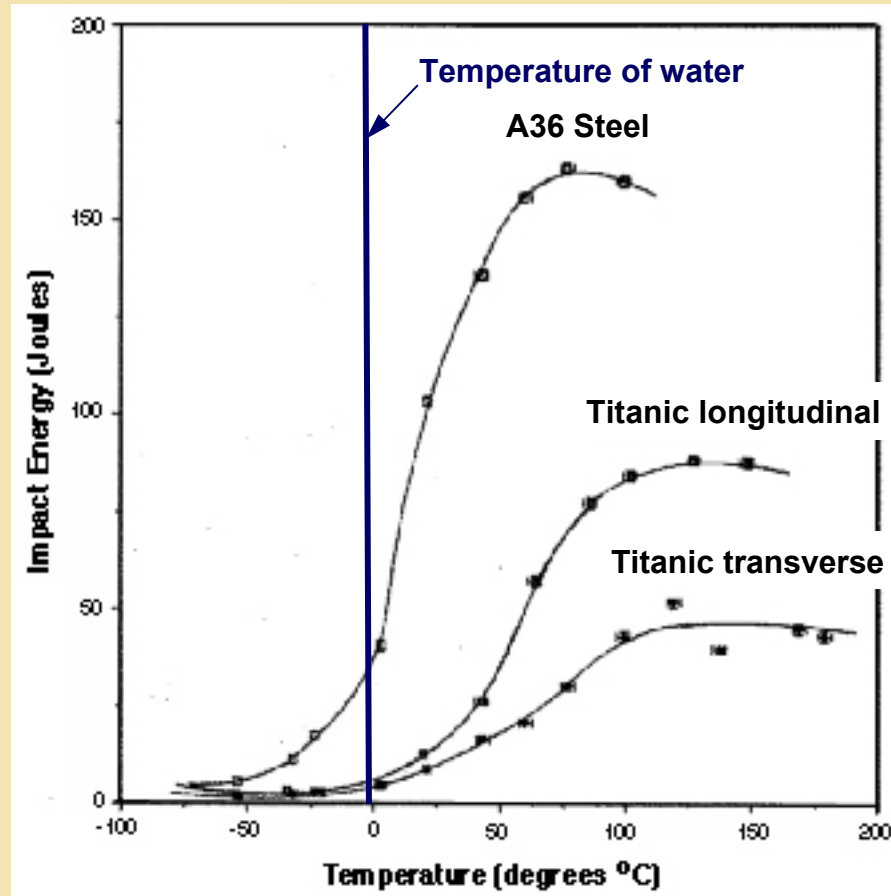
Impact Energy versus Temperature

Temperature of the water was -2°C !!

These factors appear to have contributed to a higher DBTT in Titanic Steel, which made it extremely brittle at the water Temperature (-2°C)

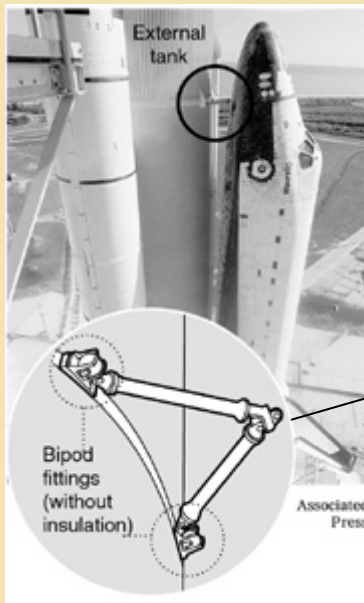
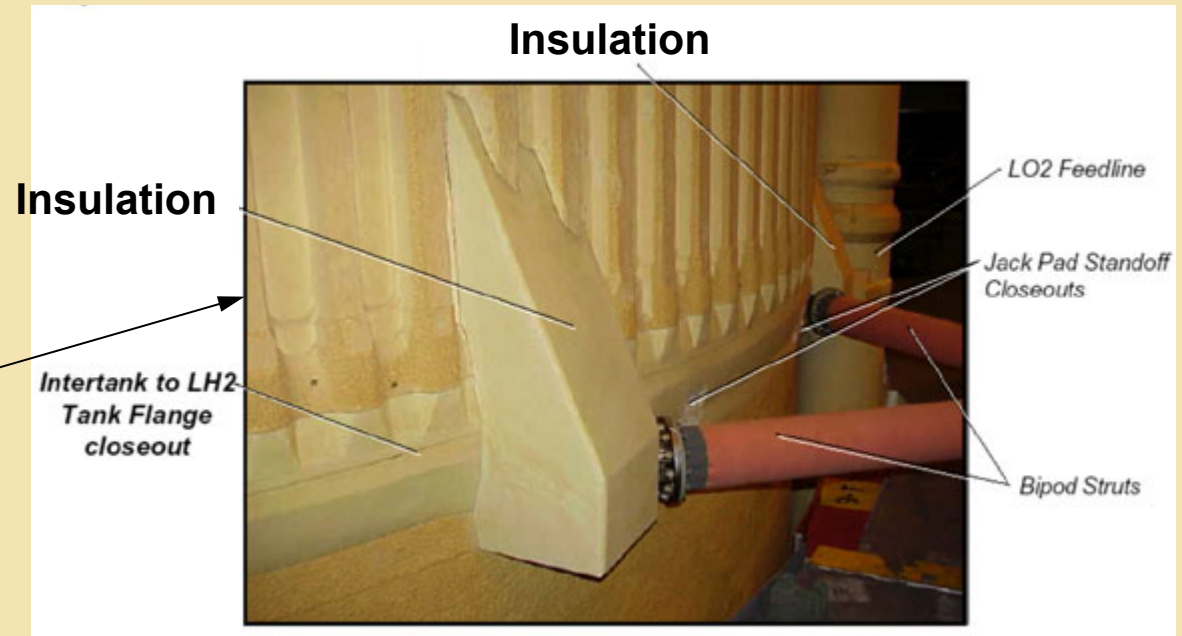
Schematic and Photograph of Bipod/Flange Area with Insulation

Bipod/Flange Area

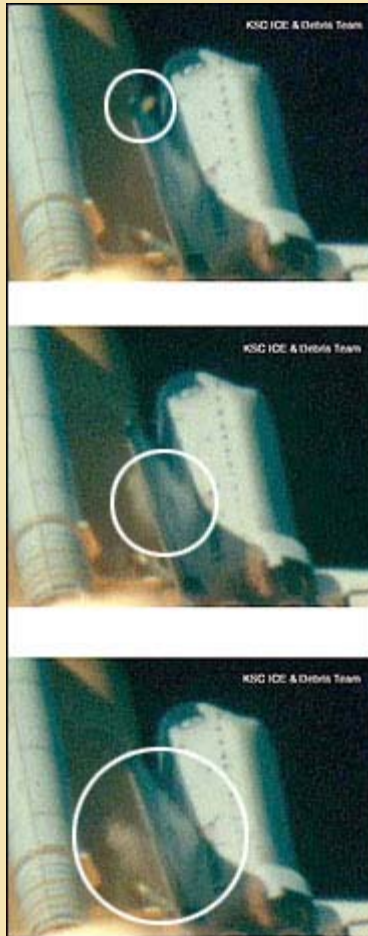
Foam Striking Left Wing of Shuttle

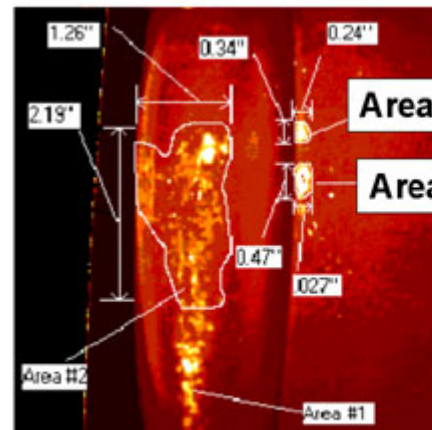
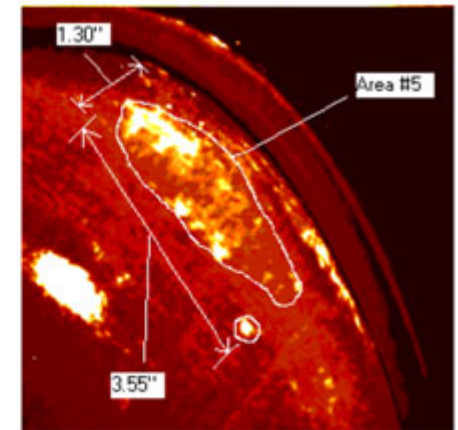
Space Shuttle Atlantis – 11/2002

Oxidation flaws

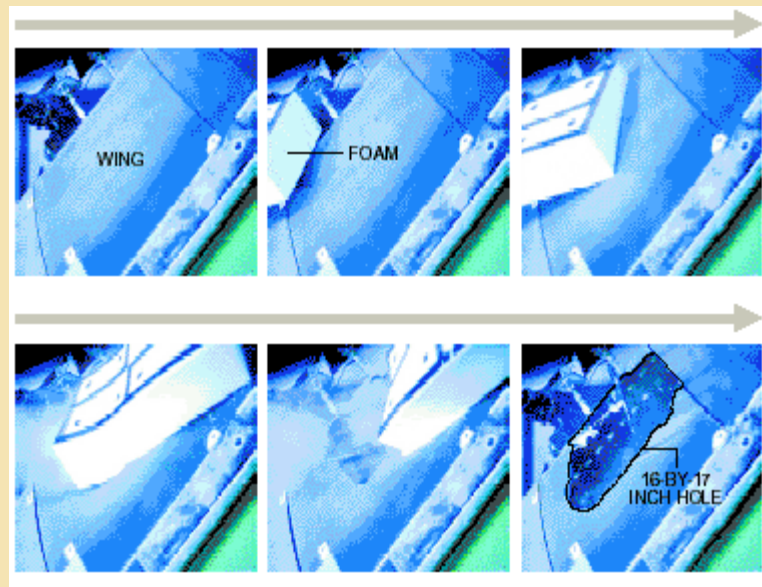
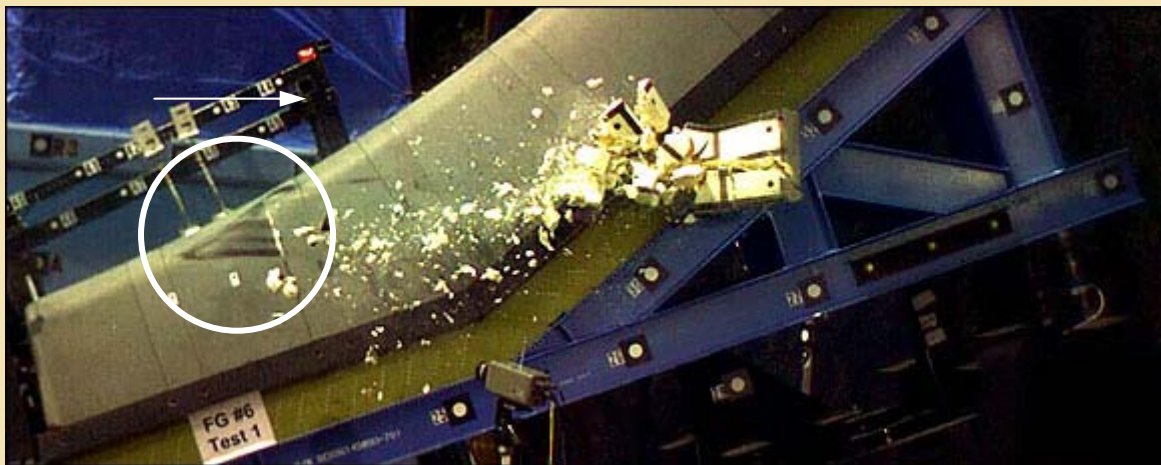
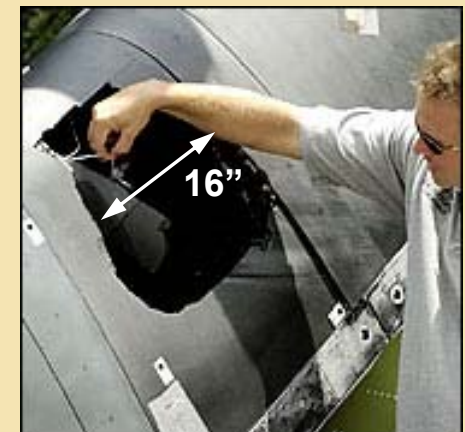
Estimating the Damage During Impact

Foam impact testing on wing of shuttle Atlantis

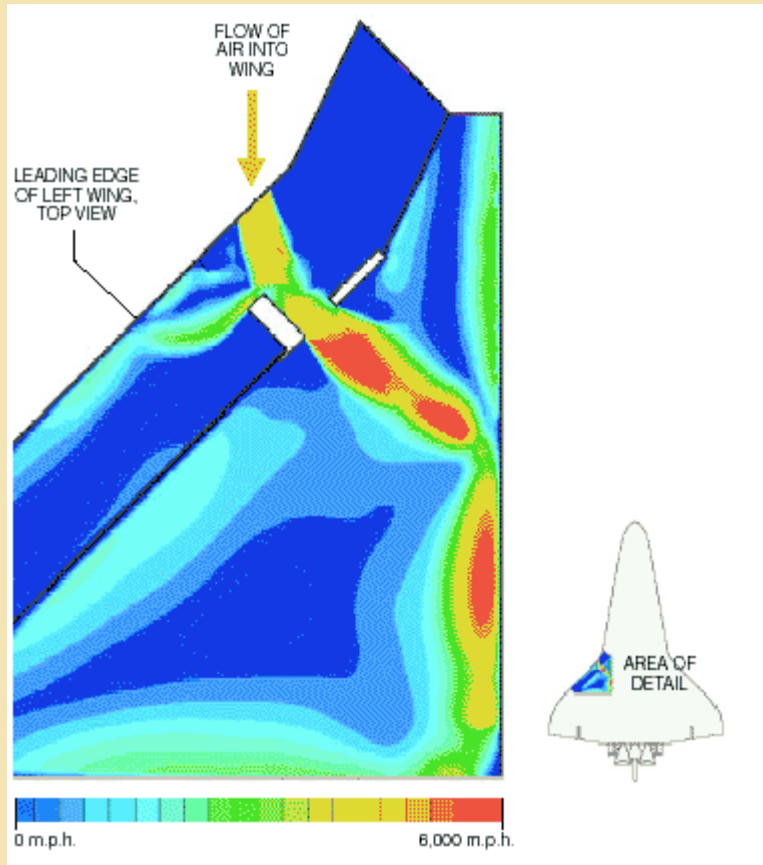
Summary of Damage Sequence (contd.)

Speed of air moving through wing

**Superheated air flowed through wheel well
- Al trusses melted, weakening shuttle structure**
