Improving Repair Quality of Turbine Nozzles Using SA650 Braze Alloy

Wayne A. Demo, Stephen Ferrigno, David Budinger, and Eric Huron
GE Engine Services, Cincinnati, OH

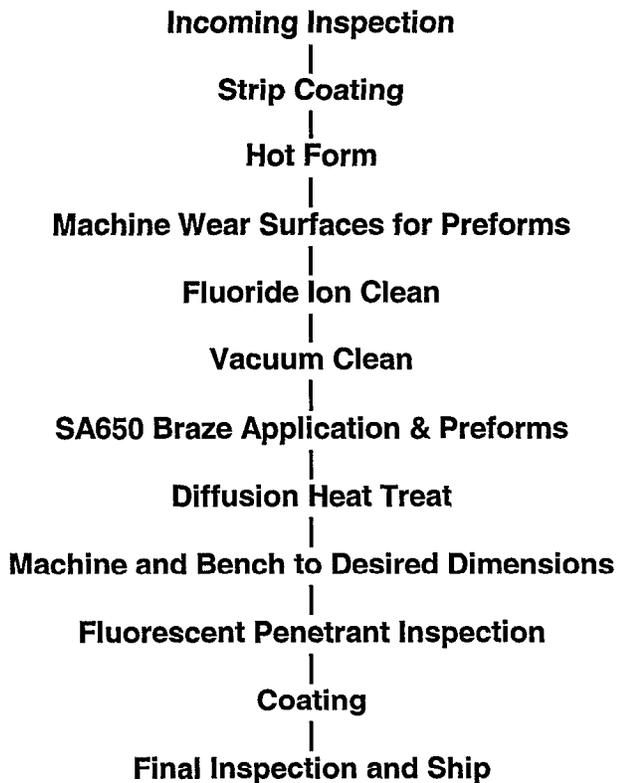
The repair process (Figure 2) begins with incoming inspection. The part is characterized for location and size of defect. Parts with cracks over

Figure 2: Typical High Pressure Turbine nozzle process map

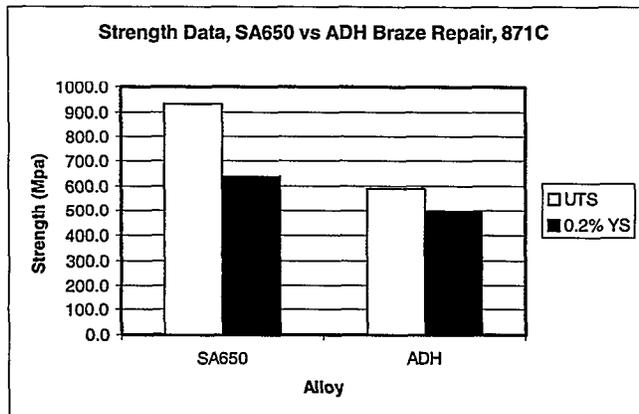
Extensive property testing has been done to evaluate SA650 mechanical properties. SA650 is considerably stronger than the earlier generation ADH composition (Figure 5). In fact, SA650 approaches the strength of the R'80 base alloy (Figure 6). For some alloys such as X40 the braze joint exceeds the strength of the parent metal. This is verified by test bars which break away from the braze joint.

Figure 5: Comparison of SA650 Braze Strength with ADH Braze Strength. SA650 is considerably stronger.

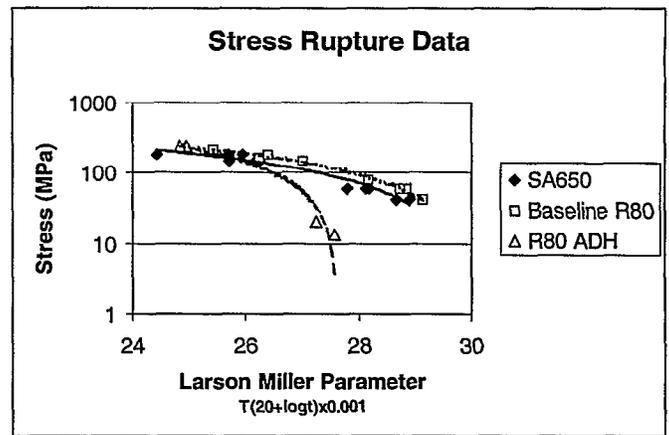
Similarly, stress rupture shows the same trends as tensile data (Figure 7). SA650 has significantly improved rupture performance over the earlier ADH braze compositions, and comes very close to the stress rupture properties of the base substrate

R80 alloy. This allows restoration of cracks with properties much closer to the original new make part and enhances life after component repair.

Figure 7: Stress Rupture Comparison Between SA650 braze alloy, ADH braze alloy, and R80 Base metal. The improvement offered by SA650 is clear.

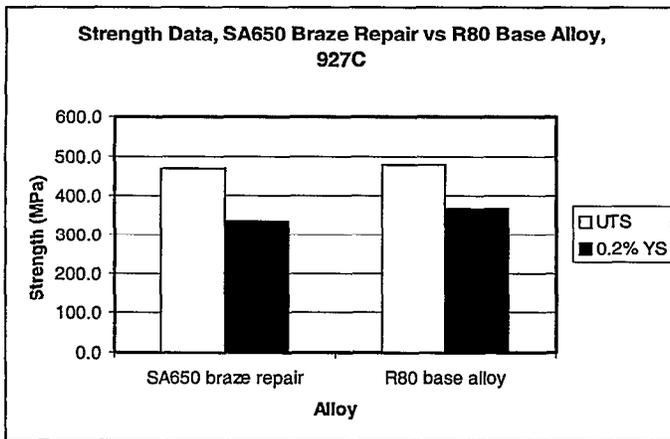
Figure 6: Strength comparison between SA650 braze repair alloy and baseline R80 properties. SA650 braze strength in the repaired regions of the part approaches that of the substrate alloy being repaired.

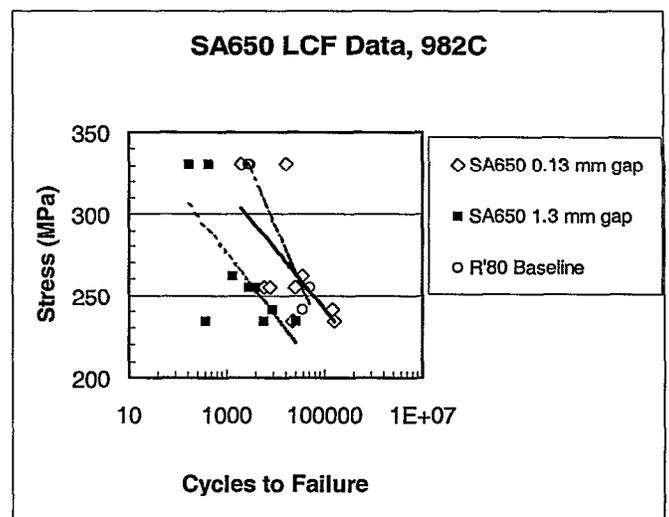
Figure 8: Low Cycle Fatigue properties of SA650 braze repair compared to baseline R80 properties

Results of fatigue testing are presented in Figure 8. Here the data is compared to R'80 base metal and properties approach common equiaxed airfoil alloys for the narrow gap test specimens which had braze gaps up to 0.13 mm, while properties were slightly lower for the wide gap specimens. The excellent fatigue performance is achieved despite the minor porosity typical of braze alloy shrinkage.

LCF failures typically occur at pores. This is common in braze repair alloys (Reference 6) due to the inherent nature of the process. Boron is a

key melt point depressant used in braze alloys. The boron level of LPM™ IN738 (Reference 6) is similar to that of SA650, and SA650 displays similar failure modes. Boron has been found to influence porosity in Ni-base powder superalloys (Reference 7 and 8), thus it would be of interest to compare LCF properties with brazeability across boron levels for the same base braze composition. However, extensive testing, characterization, and field experience have shown that typical porosity levels associated with these alloys allow good performance.
