THE EFFECT OF CARBIDE DECOMPOSITION AND REFORMATION ON RUPTURE LIVES OF IN738LC DURING MULTIPLE REHEAT TREATMENT AND DEGRADATION CYCLES

S. Pahlavanyali^{1*}, M Wood¹, G. Marchant²

- 1) ERA Technology, Cleve Road, Leatherhead, KT22 7SA, UK
- 2) Siemens Industrial Turbomachinery, Waterside South, Lincoln LN5 7FD, UK

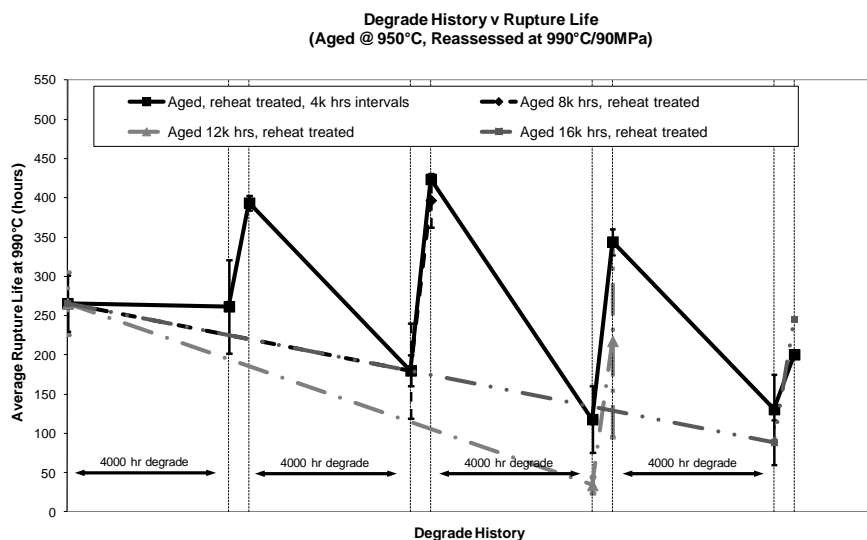
Figure 2: Rupture life of the alloy after every a series of aging at 950°C and (standard) reheat treatment

The changes in the alloy rupture lives with the aging and heat treatments have been reported before [5 and 6]. Figure 2 shows the rupture life of the alloy following a series of aging and (standard) reheat treatment cycles.

As was expected there was a marked increase in the rupture life after every reheat treatment of the degraded material. However the resilience of the improvement seen in the rupture life, after the standard reheat treatment cycle, was limited as the stress rupture life of the alloy decreased again after each additional degradation cycle (of 4,000h) following the 1st 4,000h cycle.

One surprising point was that the aged and then reheat treated material had much longer rupture lives than that of the virgin alloy. The possible reasons for this longer rupture lives will be discussed later.

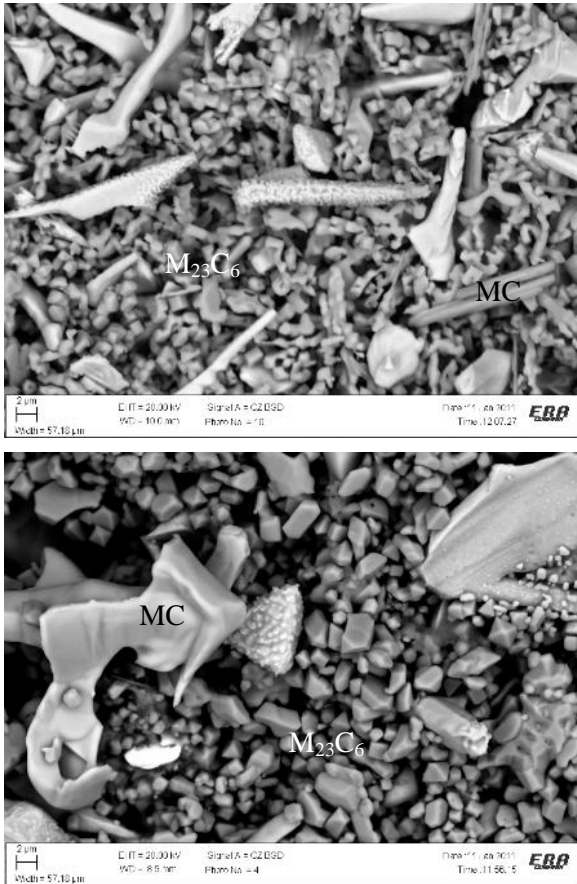
Figure 4: Formation of the $M_{23}C_6$ after 16,000 hours exposure at 875°C (upper) and 950°C(lower)

The $M_{23}C_6$ carbide size was generally larger after 950°C exposure relative to those seen after the 875°C exposures, Figure 4. In this Figure the very large particles are remnant MC carbides from the virgin alloy and the small $M_{23}C_6$ particles were formed during thermal exposure. By comparing the Figure 3 (extracted carbides) and Figure 4 one can notice that a large number of $M_{23}C_6$ particles have formed after 16,000 hours exposure at 875°C.
