Effect of Carbonization Process Conditions on Surface Morphology of 3C-SiC Films Grown on Si Substrates

Byeung C. Kim¹, John Coy, Sangho Kim, and Michael A. Capano

(1) School of Electrical and Computer Engineering, Purdue University, West Lafayette, IN 47907, USA

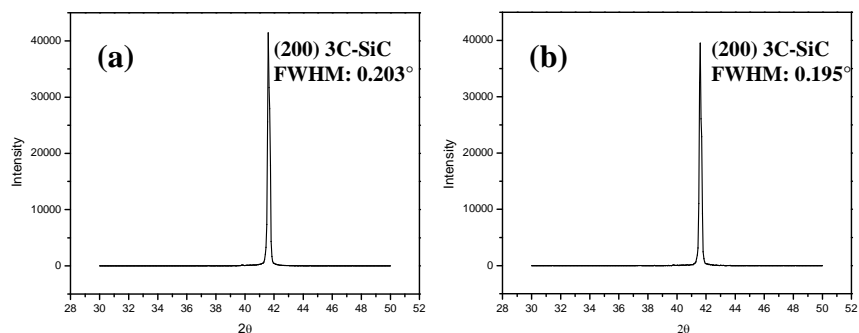
Fig. 5 XRD patterns from 3C-SiC films with two different carbonization temperatures: (a) sample No. 4 (3 sccm propane) and (b) sample No. 5 (15 sccm propane).

Carbonization temperature is shown to strongly affect surface defect densities in 3C-SiC films. Surface investigation in 3C-SiC films with carbonization performed at 1150°C or 1250°C reveals a significant decrease in the density of surface protrusions with decreasing carbonization temperature, with greater than $400/\text{mm}^2$ for 1250°C carbonization, and less than $30/\text{mm}^2$ for 1150°C carbonization. Using SEM and scanning probe microscopy, these protrusions appear to originate from voids caused by Si out-diffusion from the substrates during carbonization process [2]. Si out-diffusion during carbonization is enhanced with an increase of carbonization temperature, resulting in an increased density of surface defects. Comparing different propane gas flow rates of 3 sccm and 15 sccm during carbonization, x-ray diffractometry indicates little influence on crystalline quality as flow rate changes.
