FRACTURE TOUGHNESS VARIATIONS FOR ALLOY 718 BASE METAL AND WELDS

W. J. Mills

Westinghouse Electric Corporation P.O. Box 79 West Mifflin, PA 15122

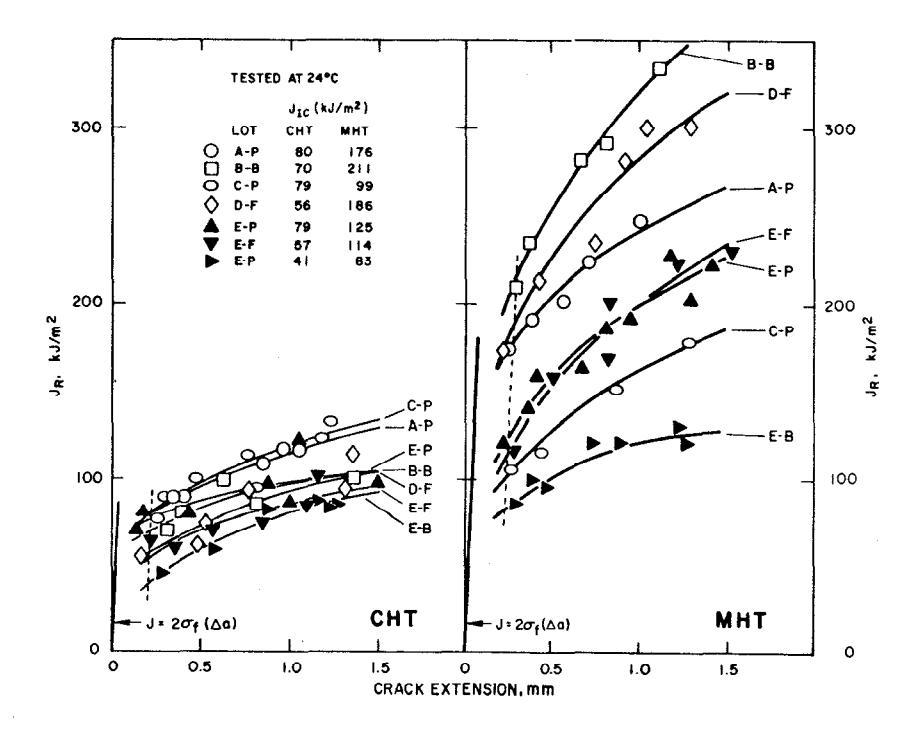
Figure 1. J_R curves for CHT and MHT Alloy 718 tested at 24° C.

The effect of heat treatment on the $J_{\rm R}$ curve response for the seven base metal lots tested at 24, 427 and 538°C is illustrated in Figures 1-3. Results for the CHT material are shown on the left, while those for the MHT alloy are shown on the right. Comparison of the fracture resistance for CHT and MHT conditions on a lot-to-lot basis revealed that the MHT improved the $J_{\rm IC}$ and stable tearing properties for each material over the entire test temperature range. This improvement was most apparent in heats A, B and D, whereas heats C and E showed only modest increases in fracture resistance.

Systematic heat-to-heat variations were displayed by both heat treatments with the same ordering of heats observed over the entire test temperature regime (i.e., decreasing fracture toughness values were observed in essentially the same sequence: MHT lots B-B, D-F, A-P, E-F, E-P, C-P and E-B; CHT lots A-P, B-B, E-P, C-P, D-F, E-F AND E-B). Note that heats with the highest J_{IC} initiation values also yielded the highest stable tearing resistance. The microstructural features responsible for the heat treatment and heat-to-heat variations in fracture toughness will be discussed later.

The fracture toughness response for the plate, bar and forging from Heat E, represented by the solid symbols in Figures 1-3, revealed significant product-form differences for both heat treatments. In the CHT condition, $J_{\rm IC}$ values for the plate were consistently higher than those for the bar and

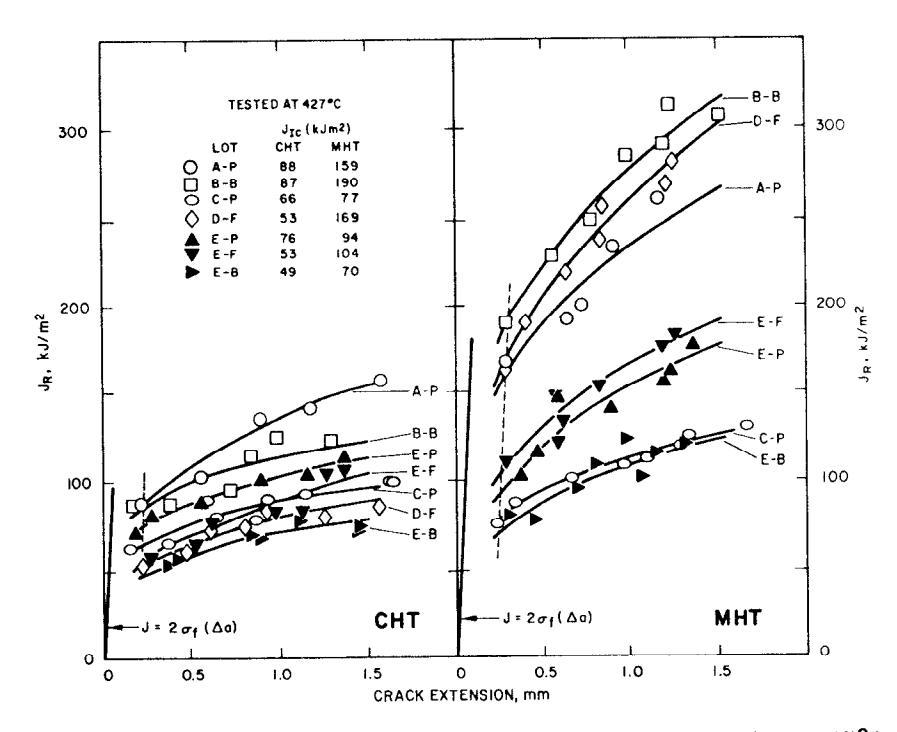
Figure 2. JR curves for CHT and MHT Alloy 718 tested at 427° C.

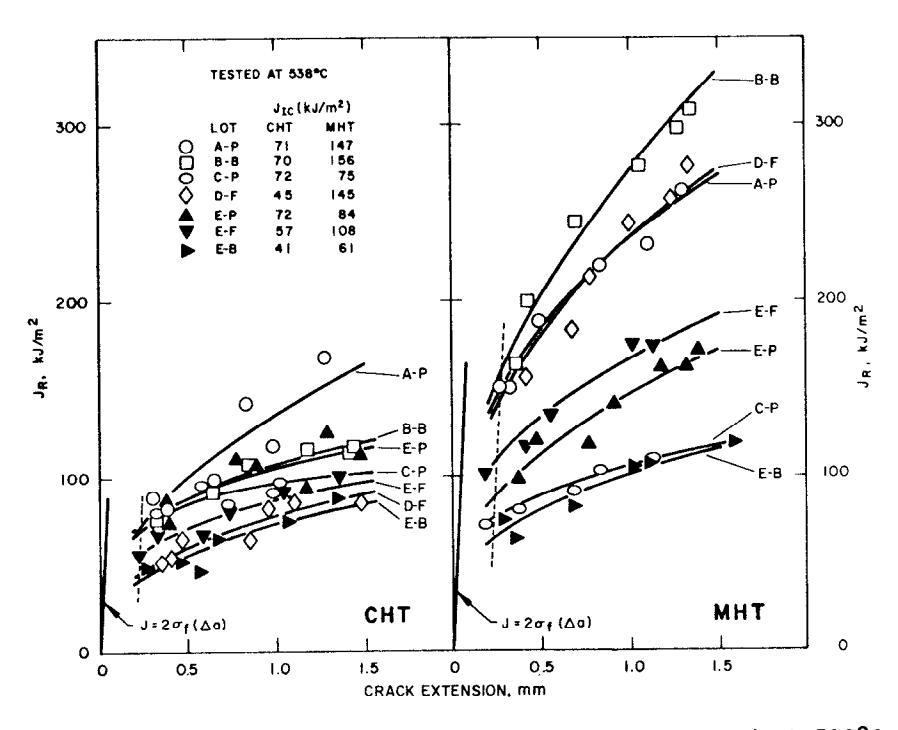
Figure 3. JR curves for CHT and MHT Alloy 718 tested at 538° C.

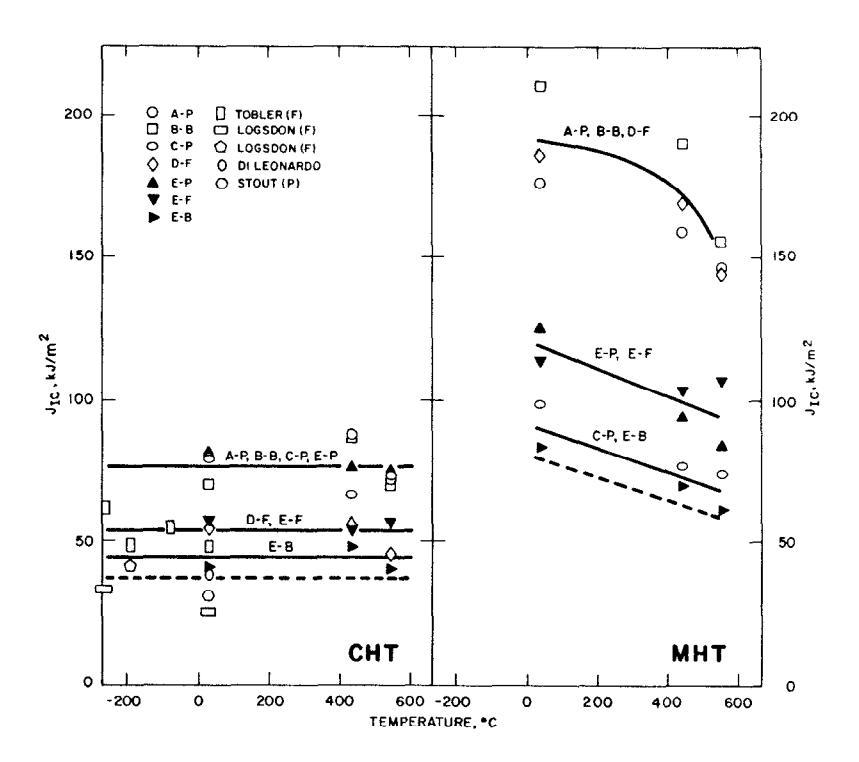
Figure 4. Summary of J_{IC} values for CHT and MHT materials. Solid lines denote mean J_{IC} levels for each statistically distinguished population of heats. Dashed lines represent lower tolerance limits for the lowest toughness populations.

forging. Comparison of the present results with those reported elsewhere[13-17], however, revealed no consistent trends with respect to product form (Figure 4). While the CHT round bar and forgings studied here and the forgings studied by Logsdon[13] had relatively low fracture resistance, the rectangular bar (lot B-B) and forging in Reference 14 displayed relatively high J_{IC} values. Similarly, the high toughness CHT

plates (lots A-P, C-P and E-P) were contrasted by the low toughness exhibited by Stout and Gerberich's plate[16]. This behavior was also observed in the MHT condition. Hence, while different thermo-mechanical processing histories apparently resulted in fracture toughness variations, a unique relationship between a particular product form and $J_{\rm IC}$ response did not exist.

Lower bounds for tolerance limits bracketing 90% of a total population at a 95% confidence level were evaluated for the CHT and MHT populations with the lowest fracture resistance. These lower bounds are denoted by the broken lines on Figure 4. For the CHT material, only two base metal heats exhibited toughness values that fell below the lower bound of 36 kJ/m^2 and the inferior fracture resistance for these materials was believed to be associated with anomalous microstructures: Logsdon's[13] low toughness forging had a contiguous grain boundary carbide network that induced intergranular fracture; and Stout's[16] plate received a high temperature duplex age (760 and 648°C) that caused its yield and ultimate strength levels to exceed those for the other CHT heats. These observations indicate that care should be taken to avoid anomalous microstructures, particularly contiguous intergranular precipitate networks, because they can degrade the toughness below the minimum-expected $J_{\rm IC}$ level.

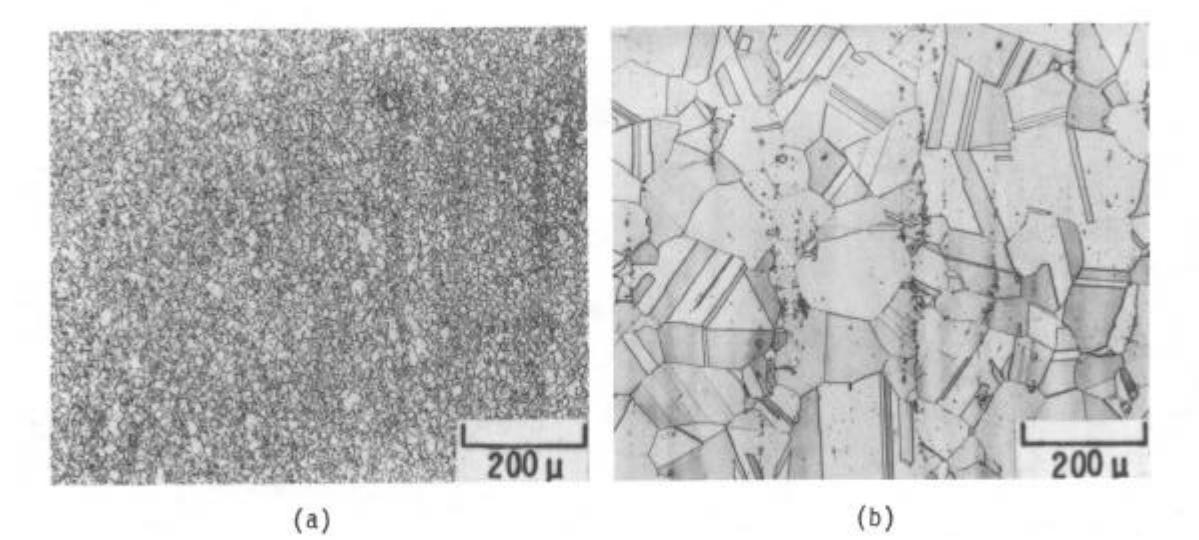
Figure 5. Typical microstructures for wrought Alloy 718. (a) CHT Lot E-P. (b) MHT Lot E-P.

The microstructure and fracture surface appearance for the seven material lots were studied to relate key microstructural features and operative fracture mechanisms to macroscopic fracture toughness behavior. A summary of these findings is given in Table II (material lots were separated into distinguishable toughness populations as determined above). Representative microstructures for the CHT and MHT materials are displayed in Figures 5 and 6. All lots exhibited large niobium-rich and titanium-rich MC-type carbides regardless of heat treatment. Coarse orthorhombic & precipitates and a few Laves particles decorated the CHT grain boundaries and annealing twins. Intragranular & particles were also observed in some CHT heats. Grain sizes for the CHT material ranged from ASTM 5 to 12. The high temperature MHT anneal resulted in considerable grain growth (ASTM 2-1/2 to 4) and it completely dissolved the coarse & and Laves particles, with the exception of lot E-B in which ghost boundaries containing small & remnants survived. Unique microstructural features and qualitative ranking of the carbide and & phase densities are listed in Table II. Typical low, medium and high densities of carbides and & precipitates were illustrated in Figures 5 and 6 of Reference 10.

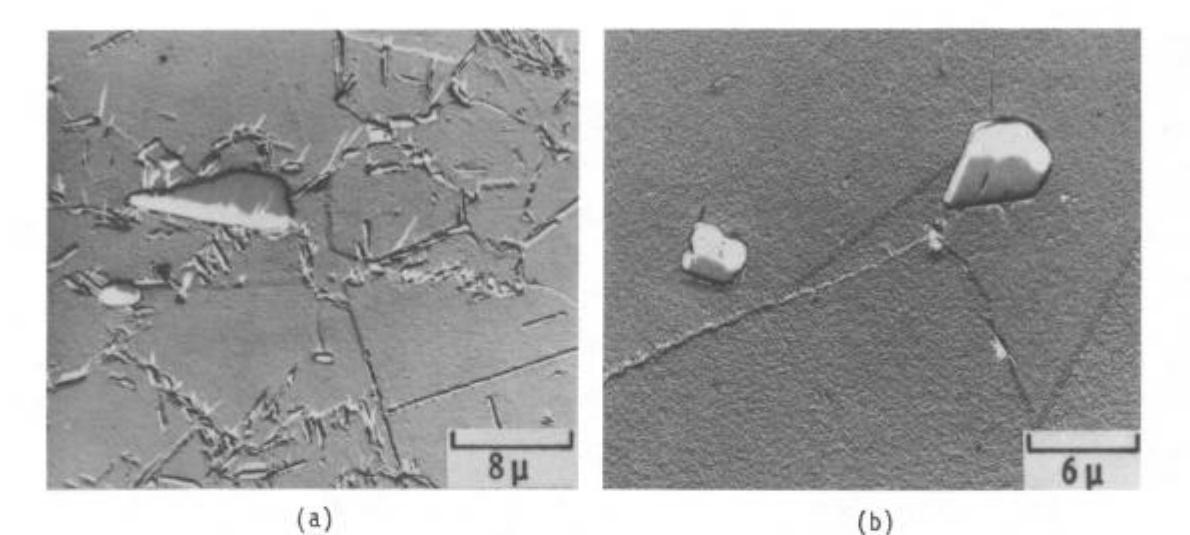
Figure 6. TEM surface replica micrographs showing precipitate morphology.
(a) CHT Lot D-F. MC-type carbides and acicular & precipitates were observed throughout the matrix.
(b) MHT Lot E-P. The MHT solution anneal dissolved the & particles, but it had no effect on the MCtype carbides.

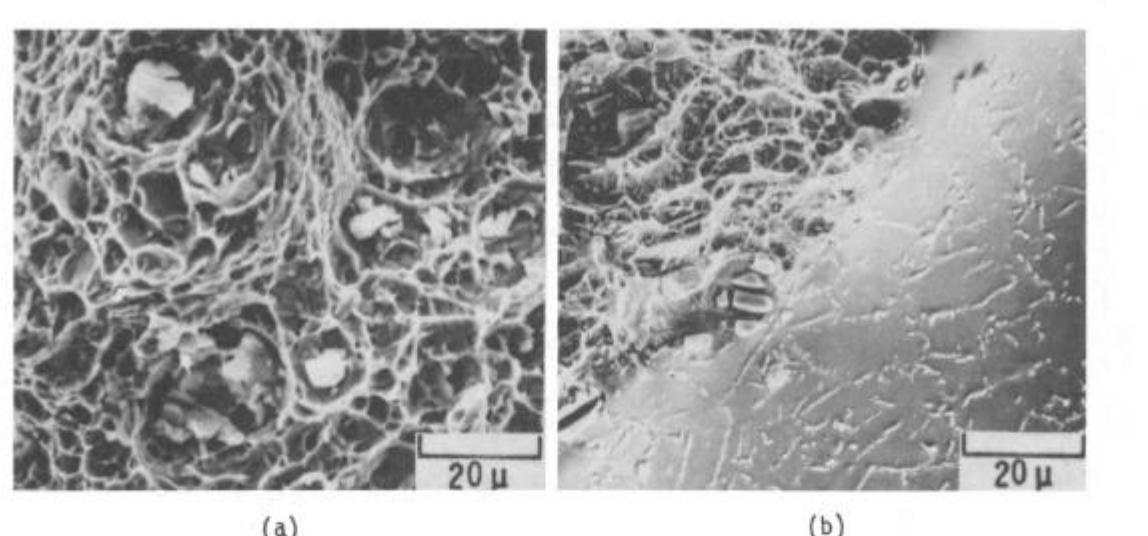
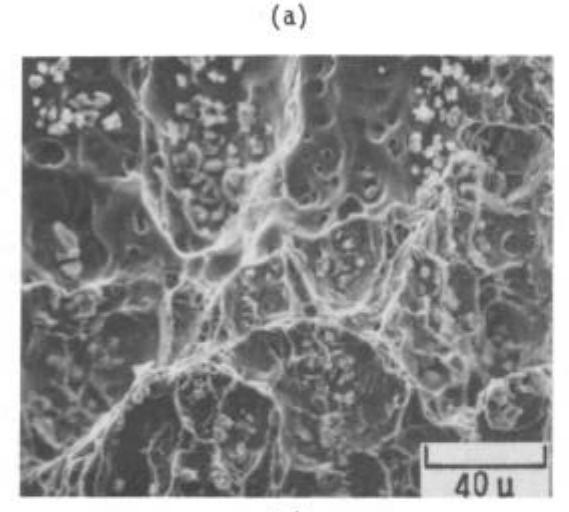
Figure 7

Electron fractographs of CHT material. (a) Primary dimples surrounded by secondary dimple rupture network. Note that the primary dimples were nucleated by broken carbides (b)

Note that the primary dimples were nucleated by broken carbides. (b) Metallographic-fractographic profile showing that the acicular & particles served as microvoid nucleation sites for the secondary dimples. (c) Metallographic-fractographic interface for CHT lot E-B illustrating the dominant primary dimples in regions with very high carbide density.

resulted in an advance of the crack front; hence, the secondary cracking mechanism responsible for linking the primary microvoids controlled the overall fracture behavior. In the CHT material, primary dimple growth was pre-empted by nucleation of a secondary microvoid population at the δ particles, as shown in Figures 7a and 7b. Table II shows that the fracture toughness was related to the inverse of δ phase density.

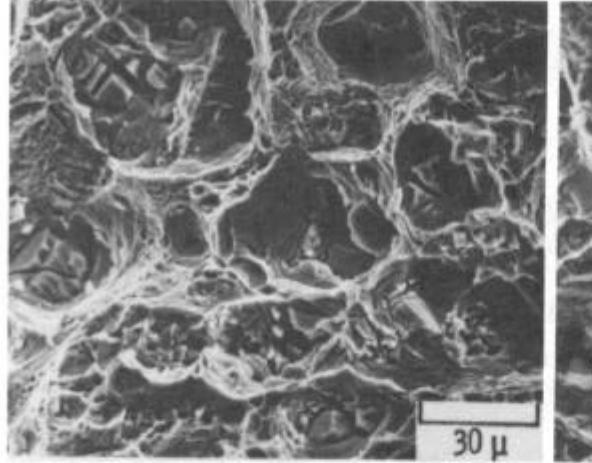
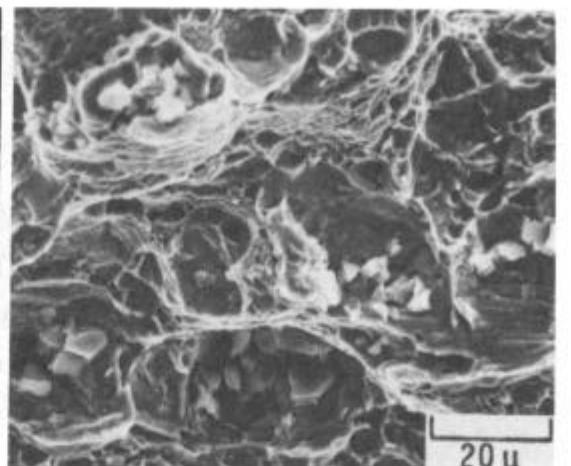
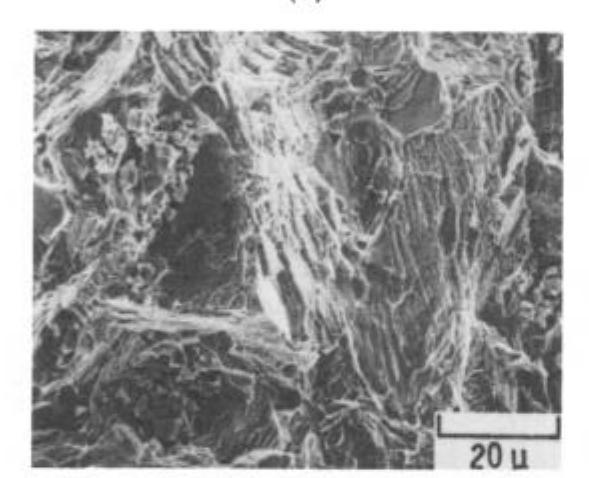
Figure 8 SEM fractographs illustrating fracture mechanisms in MHT material. (a) Coalescence of the primary microvoids. Slip markings on dimple walls indicate that microvoid growth involved extensive plastic straining. (b) Primary dimples separated by small regions of void sheets nucleated by the r" precipitates. (c) Lot C-P. Channel fracture between the primary dimples.

Separation of ligaments between primary dimples in the MHT alloy involved three mechanisms (Figure 8): coalescence of microvoids, void sheet formation[19] initiated by the γ " phase, and channel fracture[20] associated with localized tearing along planar slip bands. These mechanisms usually operated during the final stages of fracture as the primary microvoids were about to impinge; hence, they did not necessarily degrade an alloy's fracture resistance. Because primary microvoid growth was not interrupted prematurely, MHT alloys exhibited superior fracture resistance and larger primary dimples

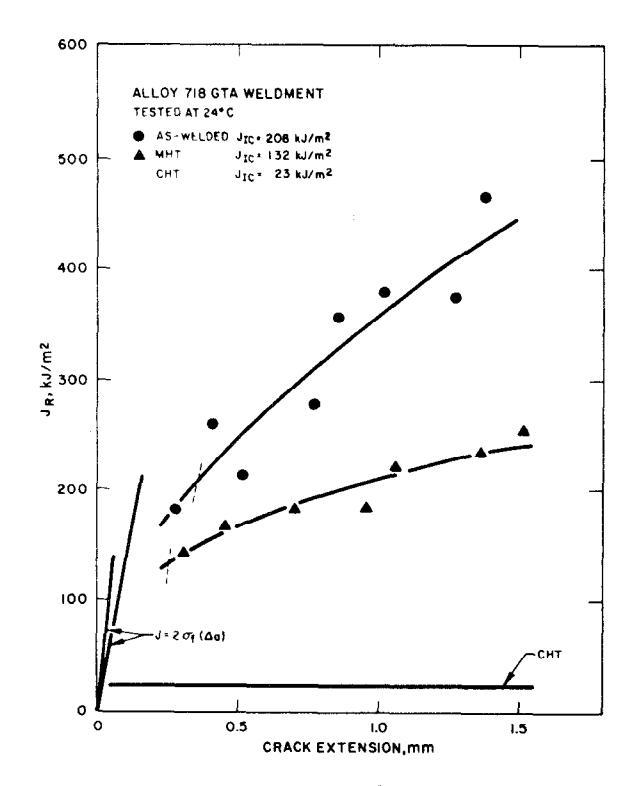
Figure 9. J_R curves for welds tested at 24° C. J_{IC} for the CHT weld was calculated from experimental K_{IC} values, per Equation 3. The horizontal J_R curve indicates that the CHT weld had essentially no tearing resistance once J_{IC} was exceeded.

The fracture response for the weld in the as-welded, CHT and MHT conditions is illustrated in Figures 9-11. At 24°C, the CHT weld failed via an unstable cracking mode at K_{IC} levels between 62 to 73 MPa/m, corresponding to J_{IC} levels between 19 to 27 kJ/m². The unstable fracture behavior was represented by the horizontal J_R curve in Figure 9. The K_{IC} values for the CHT weld were slightly higher than the 55 MPa/m obtained by Forman[21] and Lorenz[22] for GTA welds containing surface flaws. At elevated temperatures,

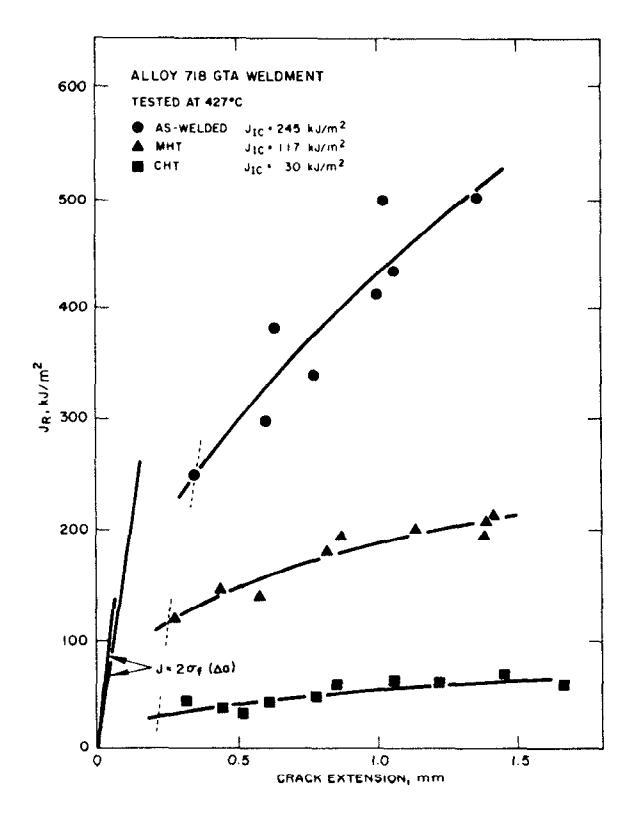
Figure 10. $J_{\mbox{R}}$ curves for Alloy 718 welds at 427°C.

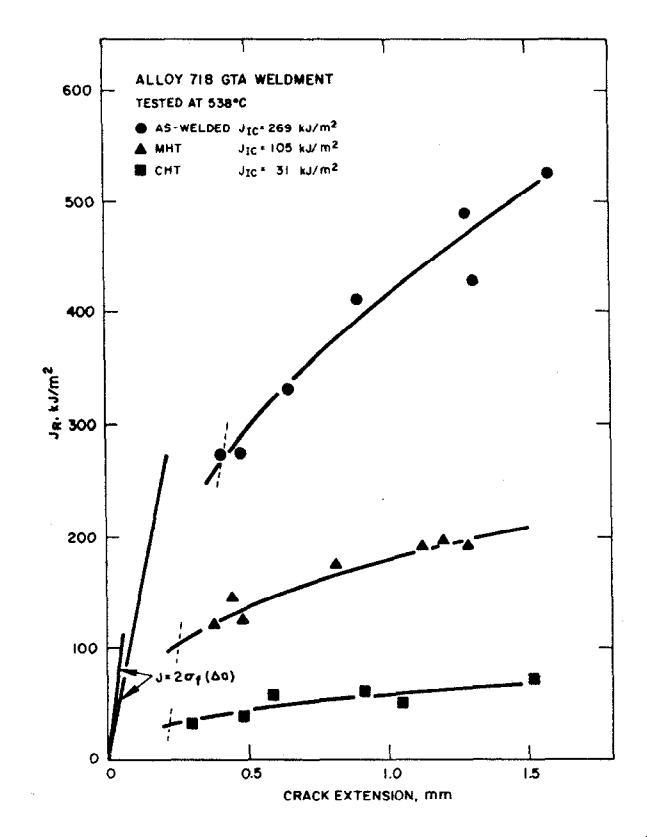
Figure 11. J_R curves for Alloy 718 welds at 538°C.

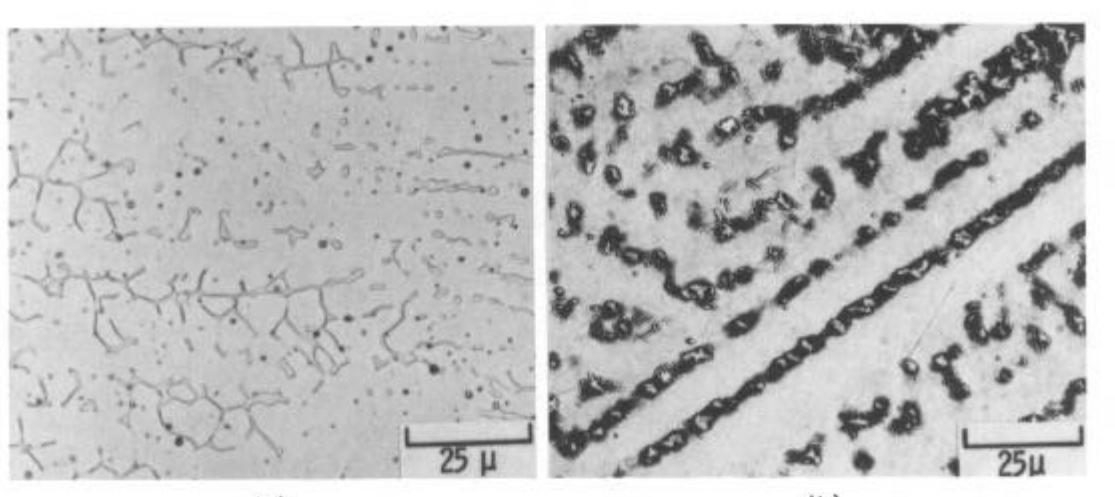
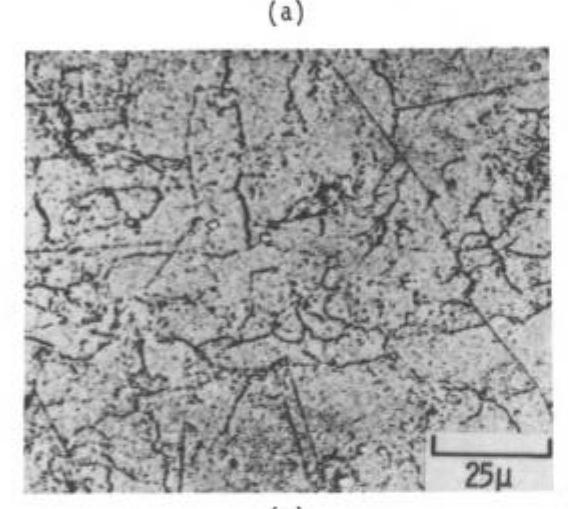
Figure 12 Microstructures for the welds. (a) Aswelded condition exhibiting Laves particles in the interdendritic regions. (b) CHT weld. Evidence of blocky Laves particles (white) surrounded by & needles (dark region). (c) MHT weld. Traces of Laves phase remained in the weld zone.

Metallographic and fractographic examinations were performed to characterize the effect of microstructure on fracture toughness response. Typical microstructures for the three weld conditions are shown in Figure 12. The as-welded structure exhibited extensive interdendritic Laves phase in the microsegregated regions enriched in niobium content. CHT welds exhibited a blocky Laves phase in the interdendritic regions which was surrounded by Widmanstatten δ precipitates. The 954°C CHT anneal did not homogenize the interdendritic structure in the fusion zone; moreover, significant amounts of δ precipitated in Nb-rich regions at this temperature. Unfortunately, Laves and δ precipitates contributed little to the strength of the welds and they acted as localized crack initiation sites that degraded ductility and toughness. The MHT, with a 1093°C solution anneal, homogenized the interdendritic structure and drastically reduced the amount of Laves phase in the fusion zone. Only traces of randomly distributed Laves particles remained within the MHT weld, which is consistent with results from References 5 and 6.

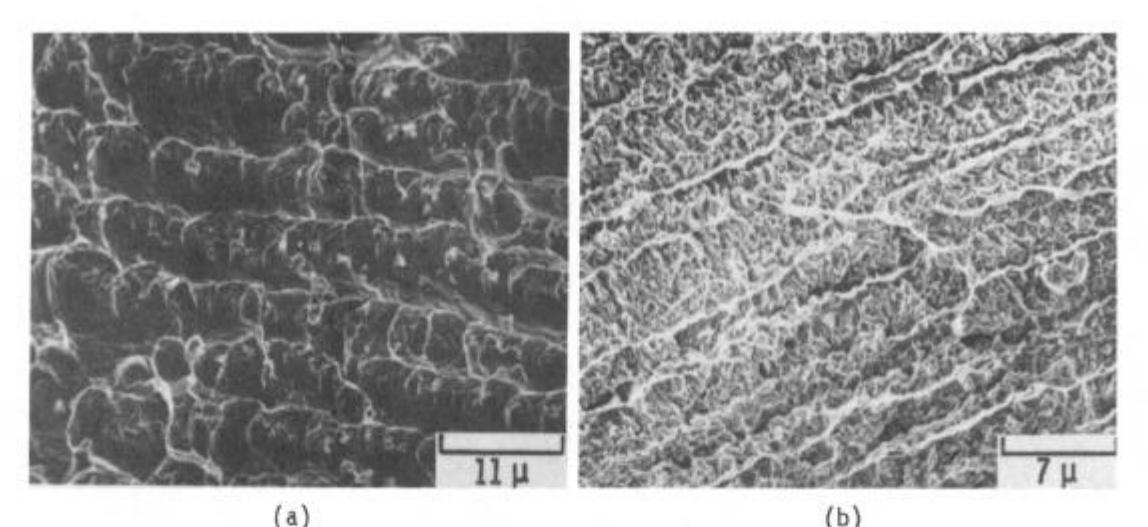
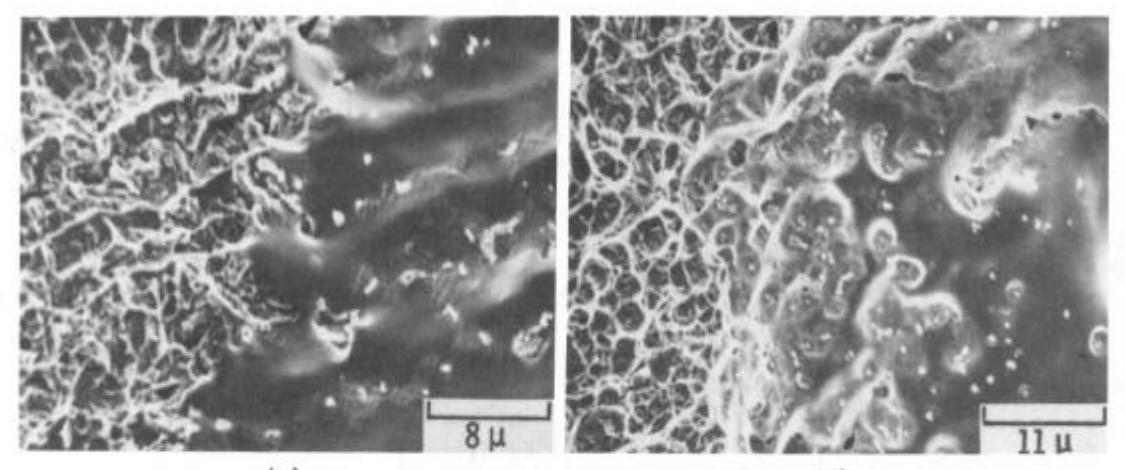
Figure 13. Electron fractographs of the Alloy 718 welds. (a) As-welded condition. Rows of dimples nucleated by the interdendritic Laves particles. (b) CHT weld. Rows of ill-defined dimples associated with the tearing topography surface mechanism. (c) CHT weld. Metallographic-fractographic profile illustrating that the high density of Laves and & particles provided closely spaced microvoid initiation sites. (d) MHT weld. Metallographic-fractographic interface showing equiaxed dimples nucleated by Laves remnants.

Representative fractographs of the weld toughness specimens are displayed in Figure 13. In the as-welded condition, fracture surfaces consisted of a dimple rupture network initiated by fractured Laves particles. The alignment of Laves particles in the interdendritic regions was responsible for the well-defined rows of dimples evident in Figure 13a. Metallographic profiles illustrated that fractured Laves particles nucleated microcracks away from the primary fracture surface, but these microcracks were arrested in the surrounding ductile nickel matrix. This observation demonstrated that the fracture-resistant matrix in the unaged weld accommodated cracking of the Laves phase, thereby accounting for the superior fracture properties exhibited by the as-welded material.

CHT welds exhibited rows of shallow, ill-defined dimples that initiated at interdendritic Laves and δ particles (Figures 13b and 13c). The poorly defined dimple structure, reminiscent of a tearing topography surface,[23] resulted from a combination of the high density of microvoid nucleation sites and the high strength matrix that suppressed plastic deformation around the growing microvoids. The limited amount of void growth precluded development of well-defined dimples. Metallographic profiles of CHT weld specimens revealed that fractured Laves and δ particles were confined solely to the region immediately adjacent to the primary fracture surface. The low fracture-resistant CHT matrix was unable to arrest the microcracks initiated by the coarse second phase particles. As a result, these microvoids coalesced

The MHT weld fracture surfaces exhibited well-defined, equiaxed dimples (Figure 13d) that were nucleated by the Laves phase remnants. The microvoids initiated as a result of decohesion of the particle/matrix interface, in contrast to the catastrophic fracture of large Laves particles in the as-welded and CHT welds. The Laves phase remnants in the MHT weld were more resistant to fracture than the larger particles present in the other two conditions. Hence, the reduction of the size and density of coarse particles in the fusion zone was responsible for the drastic improvement in fracture resistance for the MHT weld.
